SERVICE BULLETIN

APPLICABILITY: 2019-22MY Impreza
 2019-22MY Crosstrek (Including Hybrid Model)
 2019-22MY Forester
 2019MY Legacy/ Outback
 2019-22MY WRX
 2019-21MY WRX STI
 2019-21MY BRZ- Navigation -equipped ONLY
 2019-22MY Ascent

NUMBER: 15-236-18R

SUBJECT: Reprogramming File Availability for Optimization of Harman Gen 3.1 and Gen 3.1α Audio and Navigation Head Units

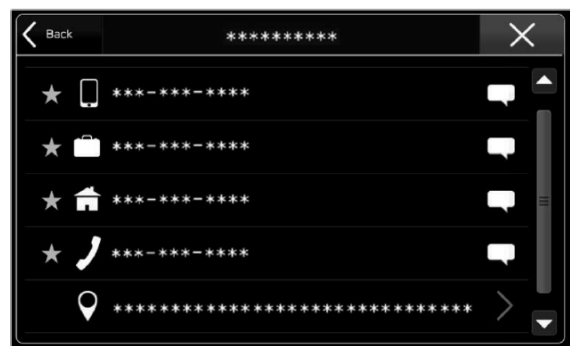
- 1) AM/FM radio station presets are lost.
- 2) Favorite Phone Contacts list is lost.

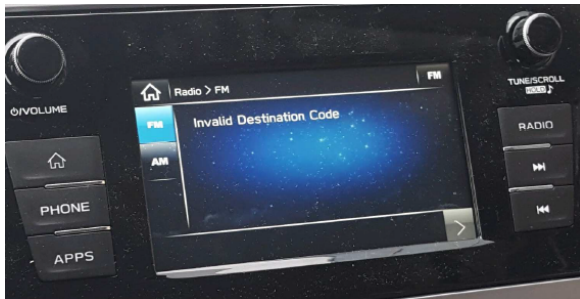
- 3) US State names corrected when using voice guidance.
- 4) Correction made for Pop / Crackling-type sound when using AM radio.
- 5) Navigation system freezes during loading / start-up.
- 6) Music skips/cuts out while using Apple CarPlay.
- 7) Hands-free feature freezes intermittently while loading.
- 8) Navigation system freezes after entering a particular address using Voice Recognition.
NOTE: All other functions are not affected.
- 9) The voice guidance volume no longer changes After Ignition Off/On. Once the Voice Guidance has been muted, the system retains that setting even after switching the ignition Off/On.
- 10) Invalid Destination Code message appears on the display while listening to the radio.

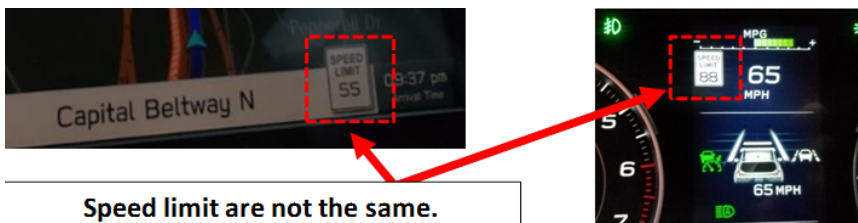
- 11) Spanish version FOTA (Firmware Over The Air) translation corrected.
- 12) Mismatch of Speed Limit between Navigation display and the Speed Limit displayed in the Combination Meter Multi-Function Display (MFD).
