SERVICE BULLETIN

APPLICABILITY: 2013-20MY BRZ **NUMBER:** 02-136-12R
SUBJECT: Oil Seepage Diagnosis and Repair Procedures **DATE:** 09/26/12
REVISED: 07/11/22

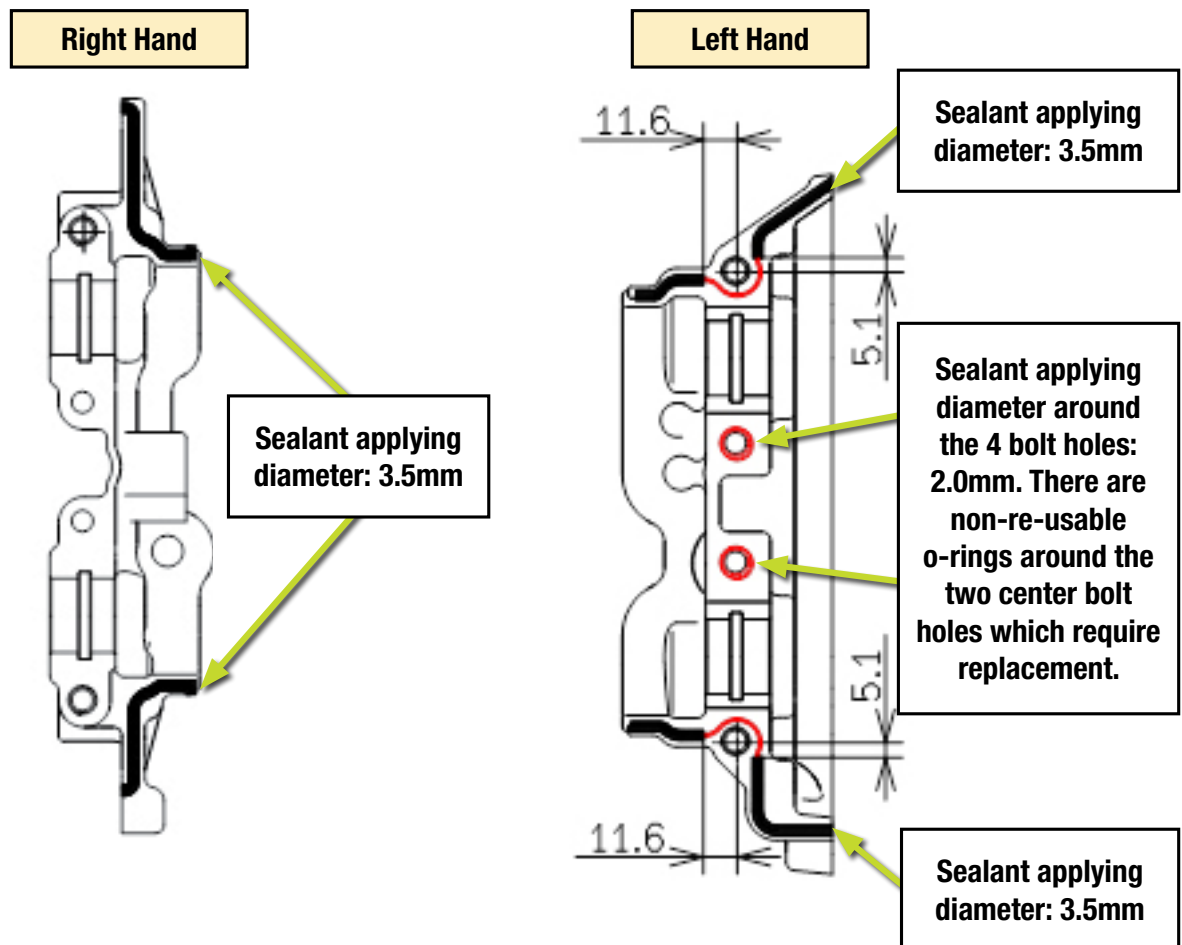
If oil seepage is verified coming from the front camshaft cap and/or camshaft carrier as shown in the photos below, remove the cam cap and clean both surfaces thoroughly before applying sealer. **Note:** The 2 o-rings between the camshaft cap and the cam carrier will need to be replaced as they are not re-usable.

Apply Liquid Gasket, ThreeBond 1217H (SOA868V9610) or equivalent* as shown below:

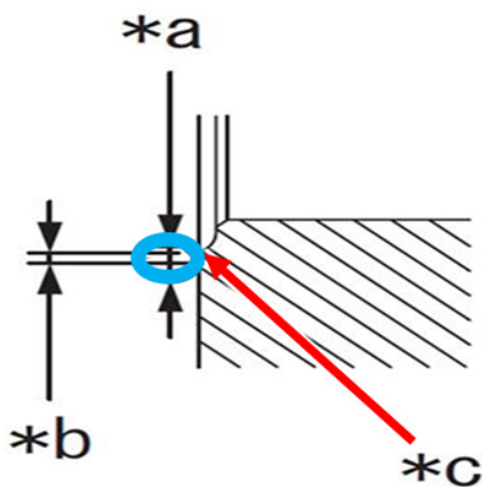
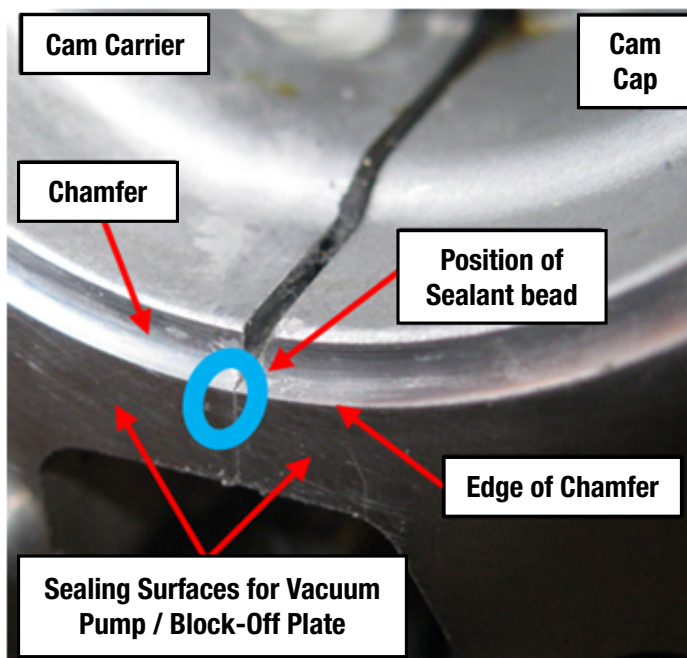
If oil seepage is verified at the bottom of the cylinder head block-off plate (on M/T models) or bottom of the vacuum pump assembly (on A/T models), the source may be the area between the cam carrier and the intake cam cap. The seeped oil then collects at the bottom of the block-off plate or vacuum pump as shown in the photo and illustration below.

Remove the cylinder head block-off plate (or vacuum pump) following the procedure outlined in the applicable Service Manual and thoroughly clean all the machined sealing surfaces. Be sure to trim away any sealant which may have squeezed out during installation of the intake cam cap onto the cam carrier. Apply ThreeBond 1217H (SOA868V9610) sealant as shown in the reference illustrations below.

*a	Sealant Bead Diameter: 2.0 - 4.0mm
*b	Location of bead: Within 1.0mm of Chamfer Edge
*c	Edge of Chamfer
