Service Bulletin

Bulletin No.: 18-NA-020

Subject: Malfunction Indicator Lamp Illuminated with DTCs P0300, P0299, P0234 and/or P2227 Set

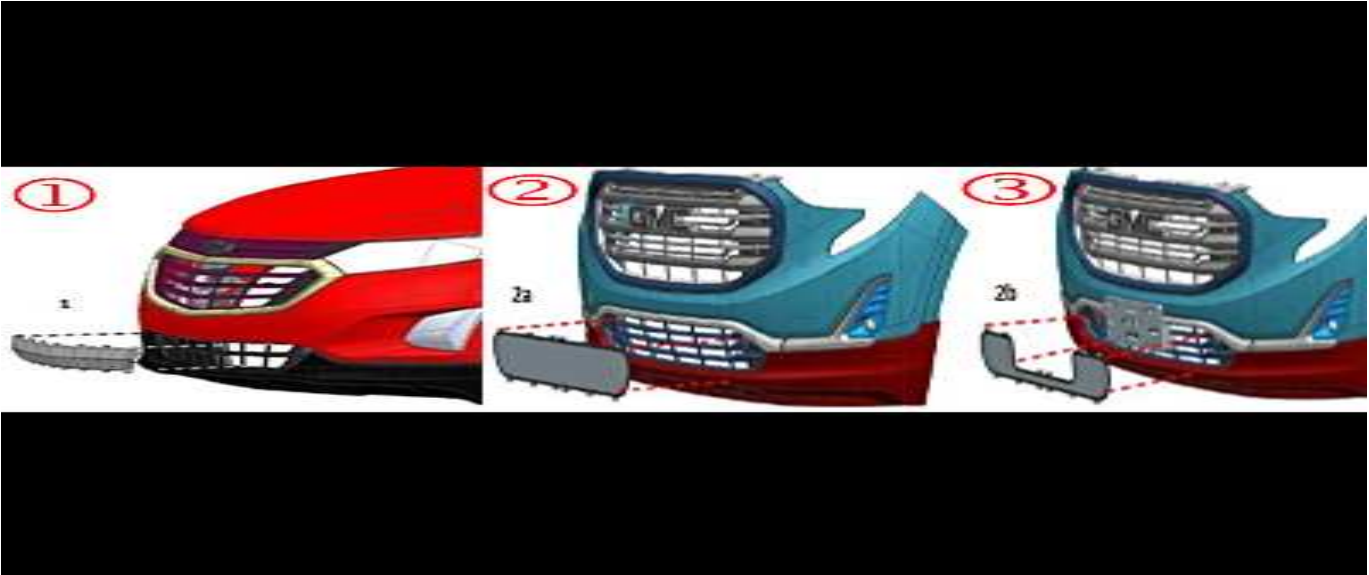
Examples of the Grill Opening Covers (Installation instructions included in the part packaging)

Shown in the picture above are examples of the grill opening covers for the Equinox (1), Terrain without (RPO VK3) (2) and Terrain with (RPO VK3) (3).
