SERVICE BULLETIN

APPLICABILITY: 2020-2022 Outback & Legacy **NUMBER:** 15-270-20R
SUBJECT: FOTA (Firmware Over-The-Air) Reprogramming for DENSO Gen 4 Audio / Navigation Infotainment Systems **DATE:** 8/19/2020
REVISED: 08/02/2022

INTRODUCTION:

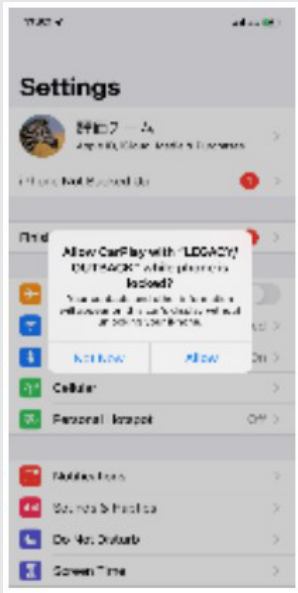
3	Cannot finish registration, DMS user registration
4	Cannot select Wi-Fi to ON, button is gray out
5	Intermittent loss of Bluetooth connection
6	Phone contacts transfer fails, when pairing iPhone with Bluetooth
7	Blank display when connecting CP1 to Wi-Fi network with long name (over 32 characters)
8	<p>While using Apple CarPlay, "SUBARU" is displayed on the iPhone Setting menu instead of vehicle name <LEGACY/OUTBACK></p>

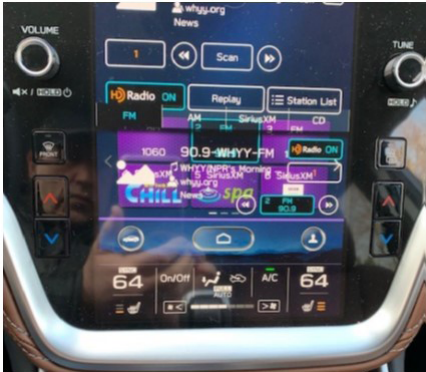
No.	Conditions/Symptoms to be improved
10	Screen is no changed to Composer or Album screen, iPhone /iPod connected as iPod mode
11	<p>CID shows multiple images simultaneously</p>

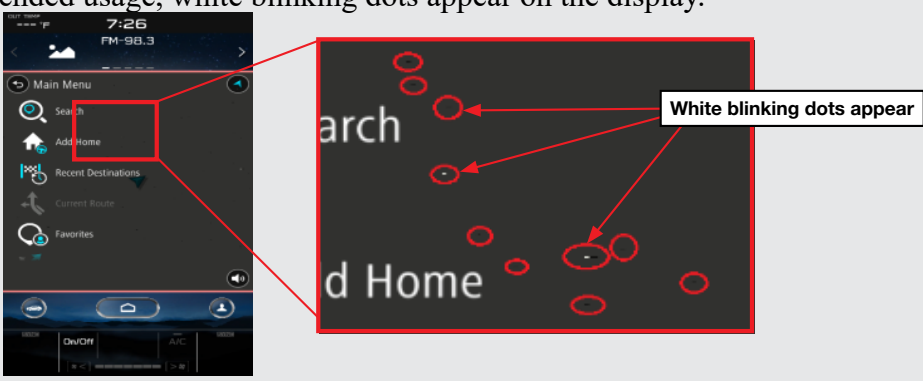
No.	Symptom to be improved	FOTA
1	Several minutes after Engine start, Center Information Display (CID) reboots itself	Yes
2	After extended usage, white blinking dots appear on the display.

USB ONLY

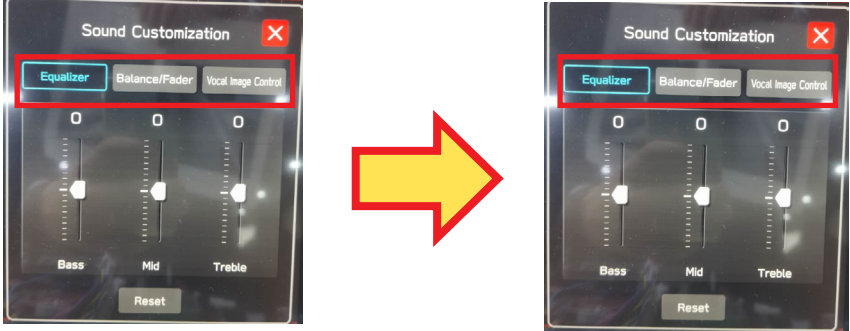
7	Equalizer setting returns to default setting. After ignition switch is turned Off and ON, the equalizer returns to default setting.

Yes
8	The media source cannot be changed. Even if the <Radio> or the <Media> is selected, the media source does not change. Also, voice recognition stops functioning at the same time. It occurs when the volume setting is continuously changed during the specific process of booting the CID.	USB ONLY
9	Navigation screen goes blank (black screen) after disclaimer display. In case the system was shut down with the Navigation map being displayed, the Navigation goes to blank (black screen) soon after the disclaimer has been displayed.	Yes
10	CID repeats rebooting. After setting a destination on the Navigation system, the CID repeats rebooting.	Yes
11	CID rebooting while using CarPlay. Using Pandora App via CarPlay, the CID is rebooted.	Yes
