**SERVICE BULLETIN**

**APPLICABILITY:** 2017-18MY Impreza  
 2018MY Crosstrek  
 2018MY Legacy and Outback  
 2018MY BRZ\*

**NUMBER:** 15-211-17R  
**DATE:** 06/13/17  
**REVISED:** 08/12/22

**SUBJECT:** Reprogramming File Availability for Additional Optimization of Harman Gen 3 Audio and Navigation Head Units

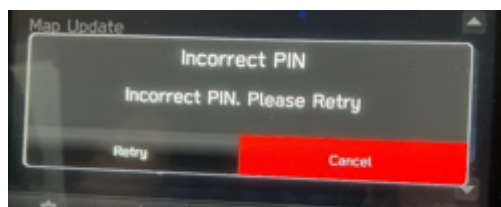
- Poor FM radio reception performance.
- **Activation Code Not Accepted by Navigation System when updating Map Data**

**NOTE (NAVI only):** Software version **Rel\_A2.22.10.20** is not bundled with the latest map version. If the customer desires to obtain the latest **MAP UPDATE**, install the latest MAP UPDATE software version **Rel\_A3.22.05.25** prior to installing software version **Rel\_A2.22.10.20**.

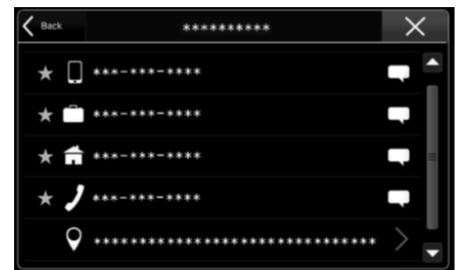
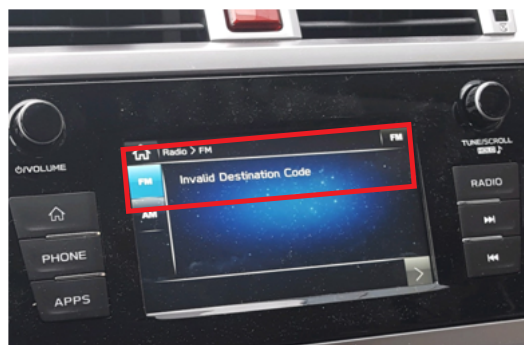
- Update to address display of “Invalid Destination Code” message

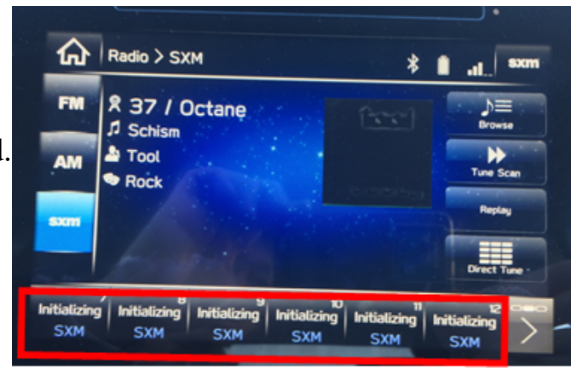
- On 2018MY Legacy / Outback models with Navigation (High) head units, the update corrects a condition where the head unit remains powered even after the ignition is OFF and the driver door is opened.
- Update for a condition where the SXM presets become lost and only “Initializing” appears as shown below.
- Update for condition where only the star field background is displayed (without icons) after the HOME button is pressed.

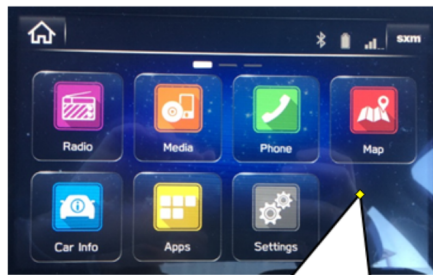
**Normal HOME screen with icons**

**Background shown, but no icons**
