**SERVICE BULLETIN**

**APPLICABILITY:** 2020-22MY Legacy and Outback Models      **NUMBER:** 15-261-20R  
**SUBJECT:** Reprogramming File Availability for Optimization of Gen 4 Denso CP1 Infotainment Systems      **DATE:** 03/10/20  
**REVISED:** 01/12/23

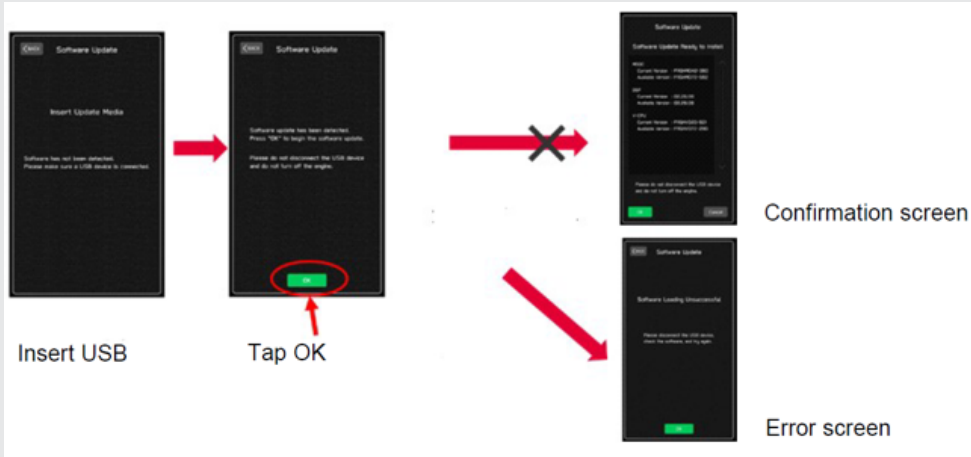
Number	Symptoms to be Improved:
12	<p>When conducting USB reprogramming, the screen transition to error screen instead of confirmation screen.</p>

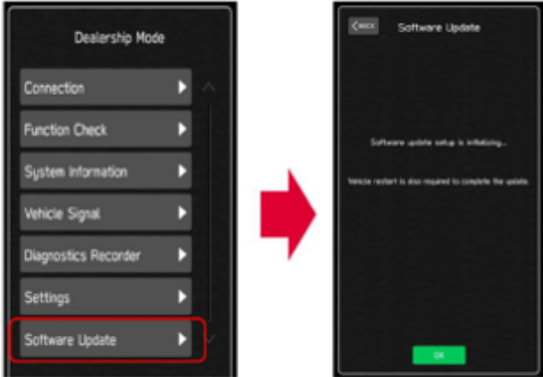
<p>The diagram shows the transition from Dealership Mode to Software Update. The 'Software Update' option is highlighted in the Dealership Mode menu, and the next screen shows 'Software Update' with an 'OK' button.</p> <p><b>Note*</b> In case this USB update failure occurs, retry updating according to the instructions in “Appendix A”</p>

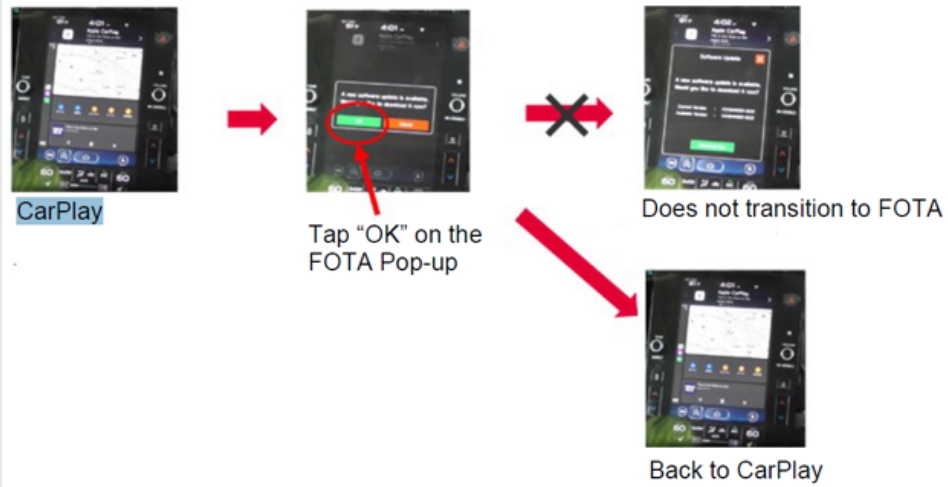
14	<p>When the FOTA pop-up (new software availability notification) is displayed while the CarPlay is being used, the display comes back to CarPlay screen even if the customer tries to get into the FOTA screen.</p>

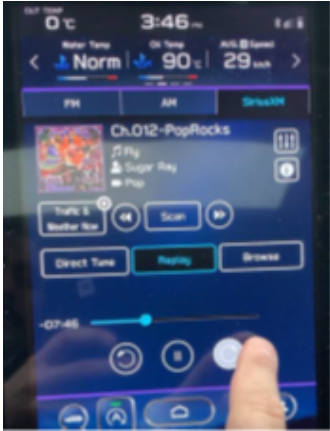
Number	Symptoms to be Improved:
28	SXM has blank screen and no sound when the audio source is change to SXM.
29	<p>“Fast forward” does not work in SXM replay function. (Fast Rewind works.)</p>

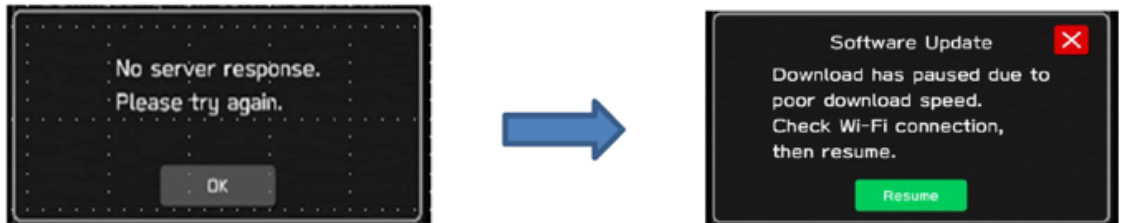
Number	New Functions and Enhancements
1	Icons of home screen change to those of the US specifications even though the original specification is not of the US.
2	Two ways of MOTA operations, i.e., by connect CCM to Wi-Fi or by transferring the downloaded map data to CCM via smart phone are executed simultaneously by error.
3	<p>"One of the Pop-up Error Messages displayed during the FOTA operation in case of weak Wi-Fi signal is not intuitive. Even if the customer tap "OK," it does not transit to another screen.</p>

<p>As the improvement for this inconvenience, the message is changed so that the customer finds the reason why the FOTA operation has been paused. Also a "Resume" button is prepared so that the customer can do the rest of operations after necessary action (moving the vehicle to another place with better Wi-Fi connection**, or tethering the CP1 to a mobile phone, etc.)</p> <p><b>Note**</b> The FOTA operation can be paused when the Wi-Fi indicator at the upper right corner of the CID is not in "Good" or "Excellent" as shown below."</p>

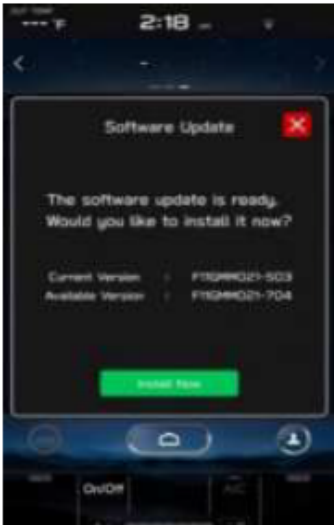
<p><b>Note*</b> Even if this symptom occurs, after approximately 2 minutes, the system resumes, and the CID comes back to the below screen. Customer can then push the “Install Now” to proceed with the installation.</p>

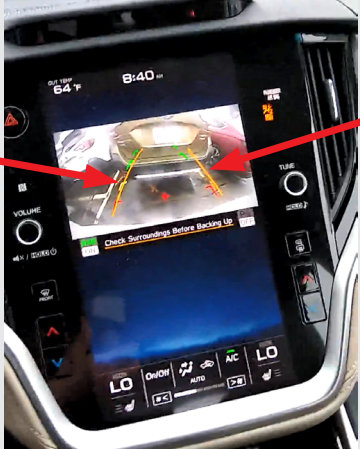
Symptom #	Description of Symptom:
2	<p>Delayed response of rear view camera guide lines. When the rear view camera is activated and the steering wheel is turned, there is a delay before the steering-responsive guide lines respond to the steering wheel input.</p>
