SERVICE BULLETIN

APPLICABILITY: 22MY WRX Models **NUMBER:** 15-301-22R
SUBJECT: Reprogramming File Availability for Optimization of Gen 4 Denso CP1 Infotainment Systems **DATE:** 09/09/22
REVISED: 01/12/23

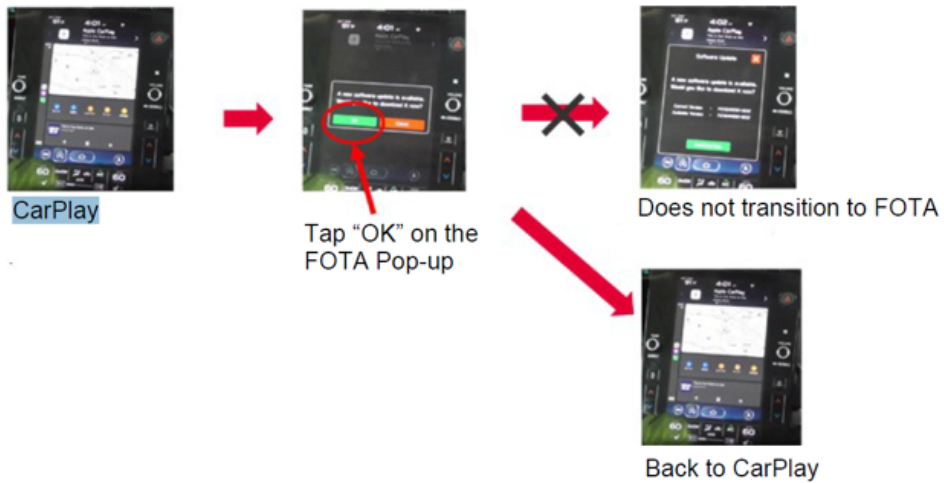
<p>Dealership Mode</p> <p>Software Update</p> <p>Software Update</p> <p>Software update setup is initializing...</p> <p>Vehicle restart is also required to complete the update.</p> <p>Note* In case this USB update failure occurs, retry updating according to the instructions in “Appendix A”</p>
14	<p>When the FOTA pop-up (new software availability notification) is displayed while the CarPlay is being used, the display comes back to CarPlay screen even if the customer tries to get into the FOTA screen.</p>

<p>CarPlay</p> <p>Tap “OK” on the FOTA Pop-up</p> <p>Does not transition to FOTA</p> <p>Back to CarPlay</p>

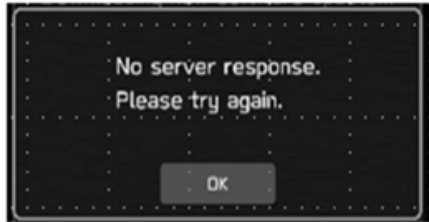
1	Icons of home screen change to those of the US specifications even though the original specification is not of the US.
2	Two ways of MOTA operations, i.e., by connect CCM to Wi-Fi or by transferring the downloaded map data to CCM via smart phone are executed simultaneously by error.
3	<p>One of the Pop-up Error Messages displayed during the FOTA operation in case of weak Wi-Fi signal is not intuitive. Even if the customer tap “OK,” it does not transit to another screen.</p> <div style="display: flex; align-items: center; justify-content: center;">
