SERVICE BULLETIN

APPLICABILITY: 2020-22MY Legacy and Outback Models **NUMBER:** 15-261-20R
SUBJECT: Reprogramming File Availability for Optimization of Gen 4 Denso CP1 Infotainment Systems **DATE:** 03/10/20
REVISED: 02/13/23

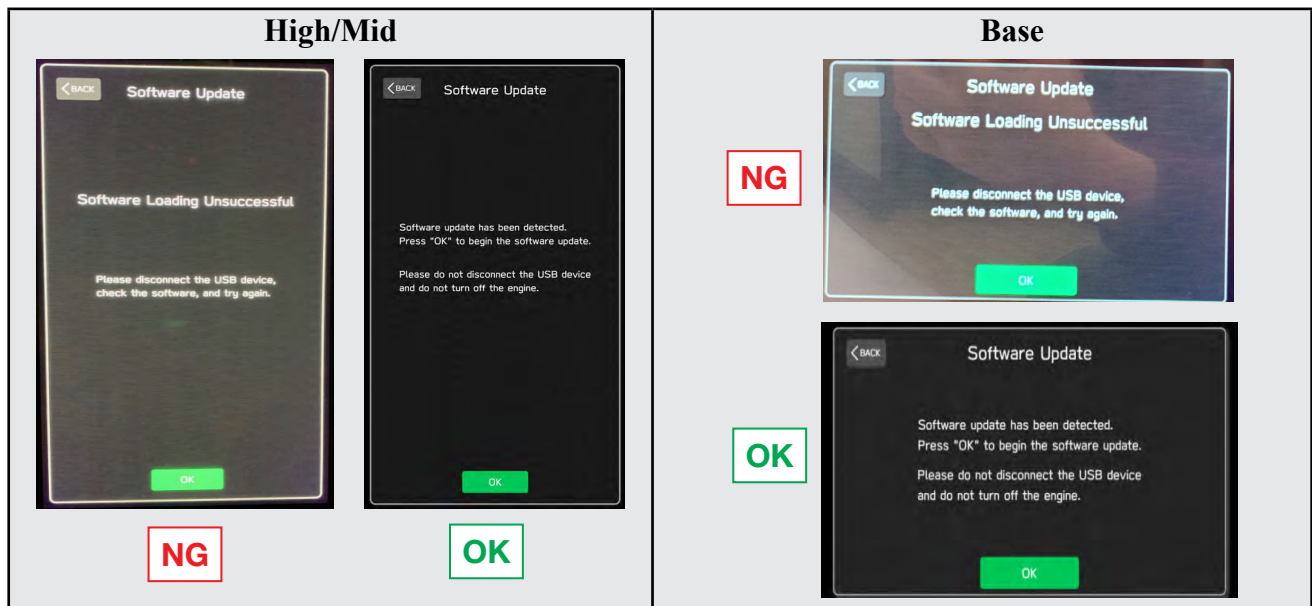
NOTE: If after plugging in the USB, the screen displays a **Software Loading Unsuccessful** message, confirm the USB device has been properly formatted and the the software on the device matches the system being reprogrammed (example: Base software is being used to update a Base system) and retry.

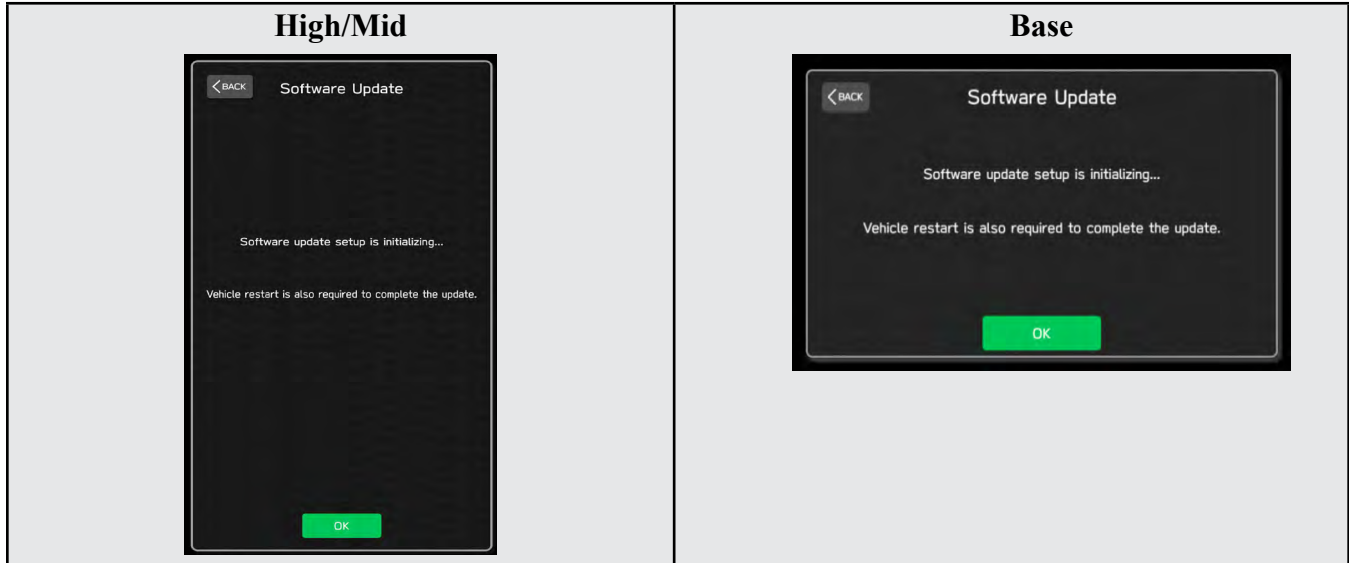
- If the screen shown below appears, **WAIT** for approximately 30 minutes or as long as necessary (waiting for longer than 60 minutes might indicate system malfunction). In that case please perform recovery according to the instructions in “Appendix B ” to allow the Software update setup initialization process to complete.

1. Turn the ignition OFF, open the driver’s door, close the driver’s door and **WAIT** for 3 or more minutes before proceeding further.
2. Open the driver’s door again and either turn the ignition ON (if a charger is connected) or start the engine.
3. Go to Dealership Mode menu again (PRESS and HOLD the RIGHT-side temperature control buttons (both up and down) and press the Tune / Scroll knob 6 times then release all to display the Dealership Mode) and select Software Update as in **STEP 4c** beginning on pg. 11.

IMPORTANT NOTE: If this procedure is required, contact Techline as additional action may be necessary.

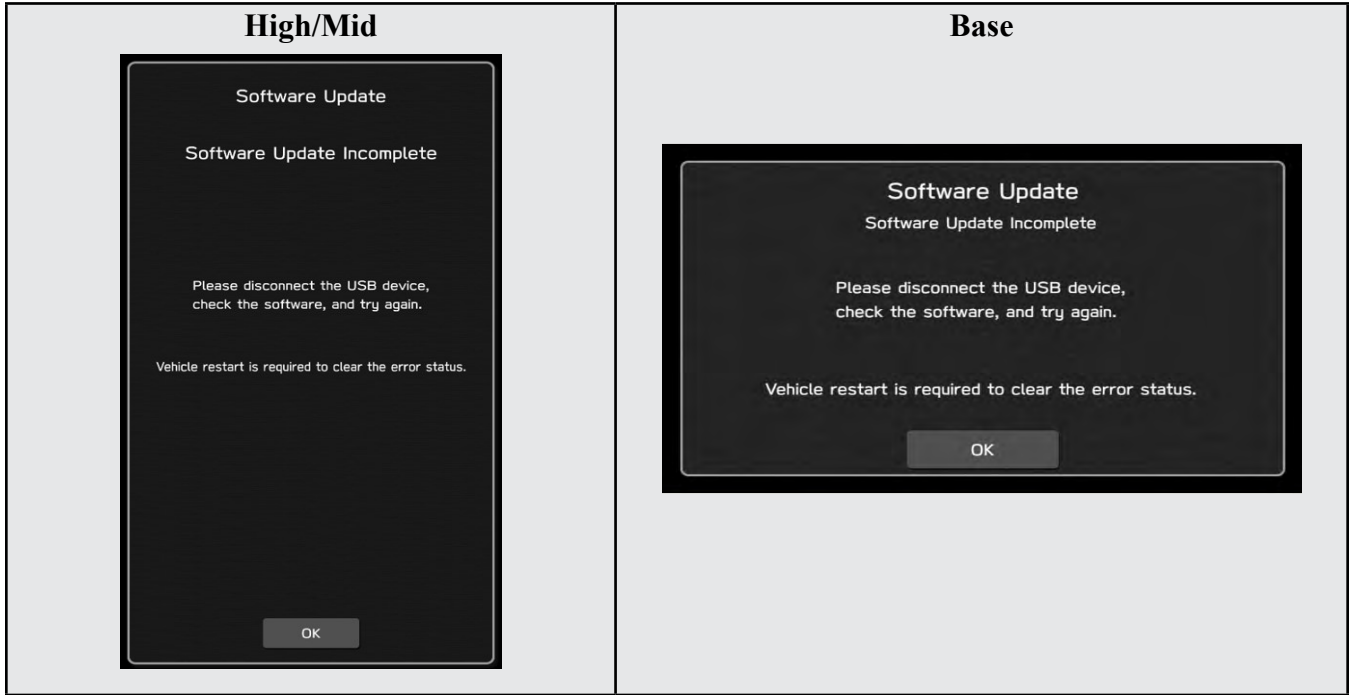
- If the first attempt of update fails with the message below, follow the steps described below 1-2 to 1-8 before retrying the software update.

1-1. Select OK in the screen below

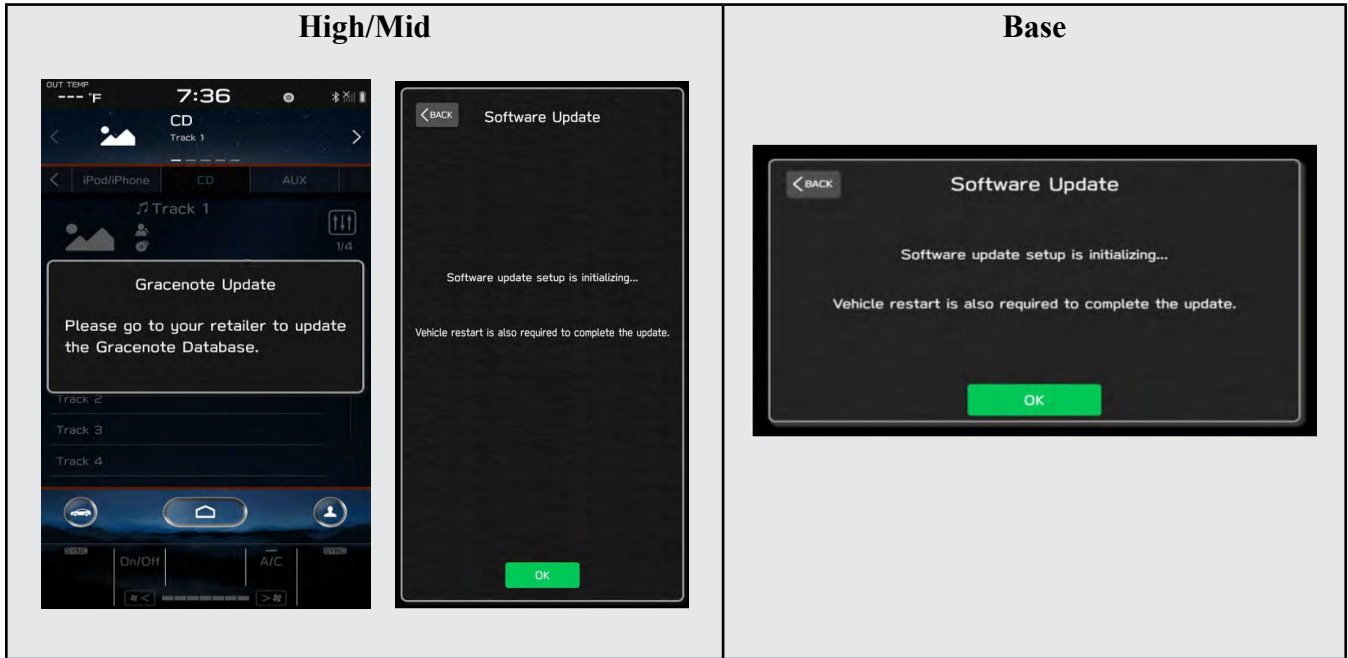
In case the Gracenote update popup screen appears or software initializing screen does not go away for more than 20 minutes, please perform steps 2-1 to 2-11.

2-1. Select “Settings” in the Dealership Mode diagnostics screen.

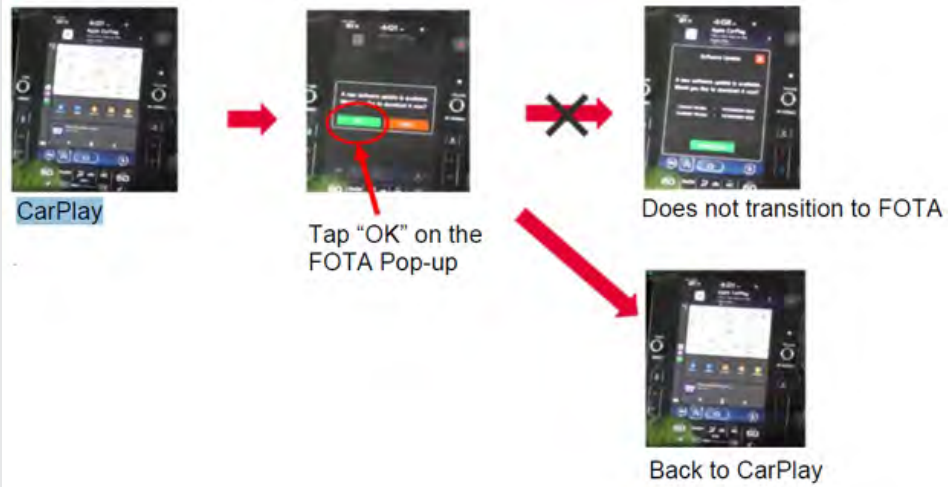
<p>Note* In case this USB update failure occurs, retry updating according to the instructions in “Appendix A”</p>
14	<p>When the FOTA pop-up (new software availability notification) is displayed while the CarPlay is being used, the display comes back to CarPlay screen even if the customer tries to get into the FOTA screen.</p>

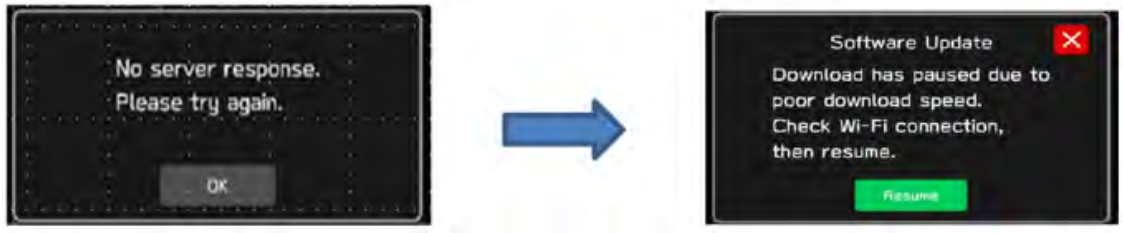
Number	New Functions and Enhancements
1	Icons of home screen change to those of the US specifications even though the original specification is not of the US.
2	Two ways of MOTA operations, i.e., by connect CCM to Wi-Fi or by transferring the downloaded map data to CCM via smart phone are executed simultaneously by error.
3	<p>"One of the Pop-up Error Messages displayed during the FOTA operation in case of weak Wi-Fi signal is not intuitive. Even if the customer tap "OK," it does not transit to another screen.</p>

<p>As the improvement for this inconvenience, the message is changed so that the customer finds the reason why the FOTA operation has been paused. Also a "Resume" button is prepared so that the customer can do the rest of operations after necessary action (moving the vehicle to another place with better Wi-Fi connection**, or tethering the CP1 to a mobile phone, etc.)</p> <p>Note** The FOTA operation can be paused when the Wi-Fi indicator at the upper right corner of the CID is not in "Good" or "Excellent" as shown below."</p>

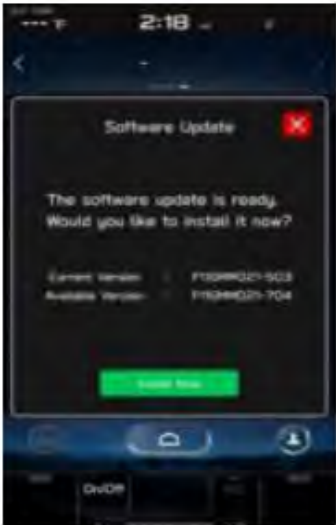
<p>Note* Even if this symptom occurs, after approximately 2 minutes, the system resumes, and the CID comes back to the below screen. Customer can then push the “Install Now” to proceed with the installation.</p>

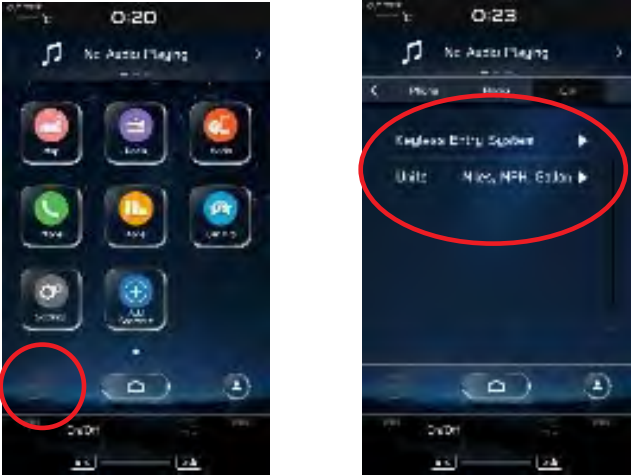
Number	Symptoms to be Improved:
4	<p>Vehicle Setting Icon in <Home> menu is grayed out. Menu list in the “Car” tab in the Setting Menu is not displayed.</p>

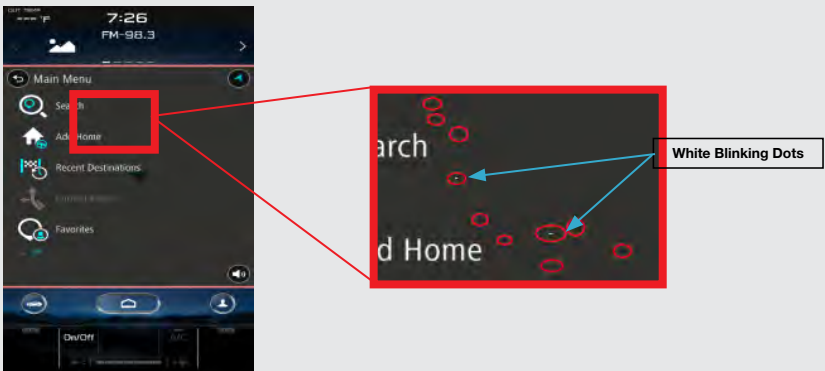
Symptom #	Description of Symptom:
1	Several minutes after Engine start, the Center Information Display (CID) reboots.
2	<p>After an extended period of usage, some white blinking dots appear on the display.</p>

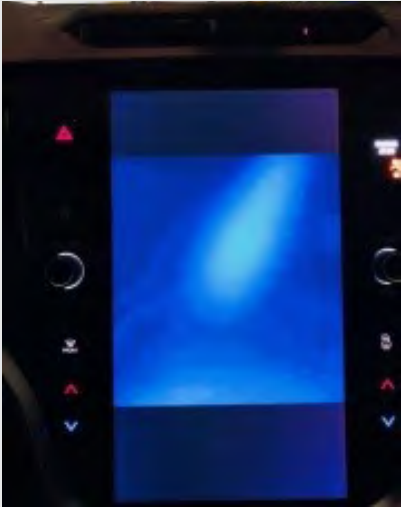
Symptom #	Description of Symptom:
13	<p>CarPlay connection cannot be established. When connecting an iPhone via USB, "CarPlay Unavailable" is displayed and CarPlay does work.</p>
14	<p>The HOME screen goes blank. When the screen is switched from Camera mode to HOME, no icons are displayed as shown below.</p>

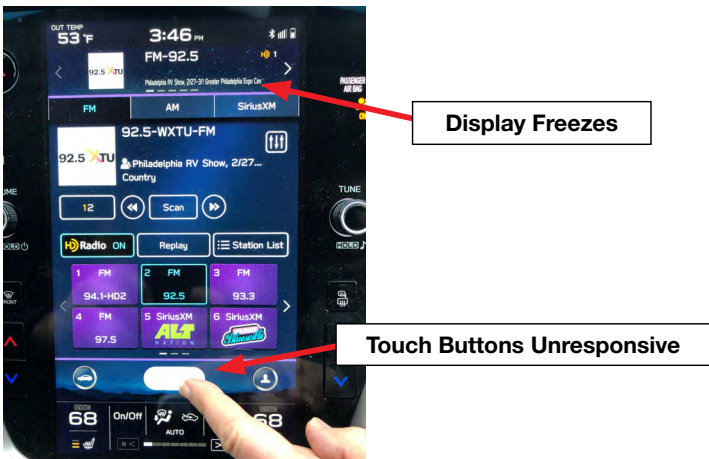
Symptom #	Description of Symptom:
1	<p>The CP1 display and/or center Combination Meter display freezes. No response from touch screen or voice guidance. After switching the ignition off and opening the driver’s door, the system does not recover**.</p>

<p>**NOTE: After switching the ignition off and leaving the driver’s door open more than 70 seconds, the system <i>may</i> recover after switching the ignition back on.</p>

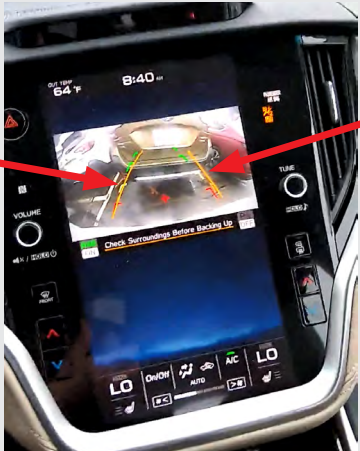
Symptom #	Description of Symptom:
2	<p>Delayed response of rear view camera guide lines. When the rear view camera is activated and the steering wheel is turned, there is a delay before the steering-responsive guide lines respond to the steering wheel input.</p>

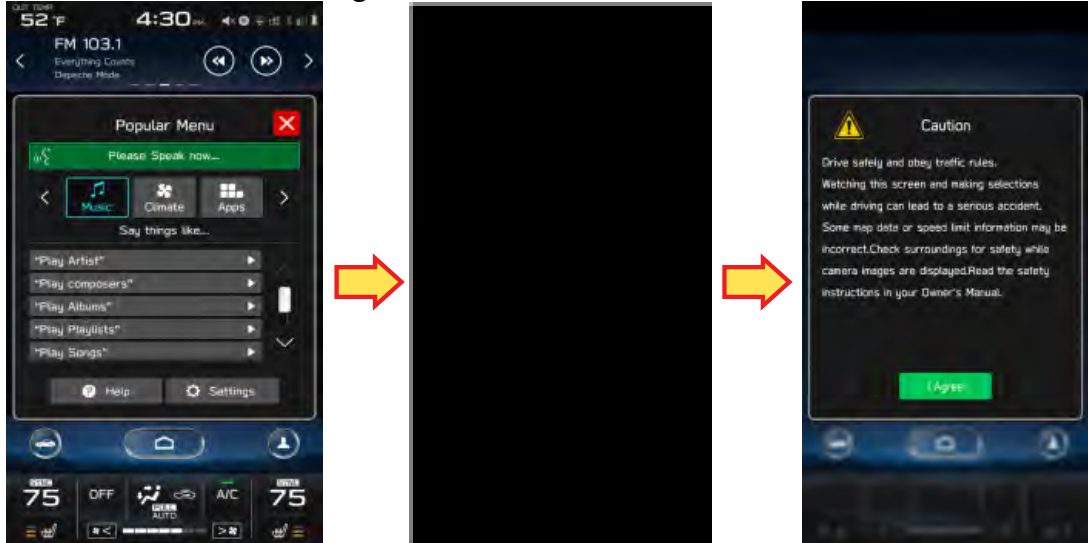
Symptom #	Description of Symptom:
5	<p>When using Voice Recognition to search for a 'Nearby POI' (Point of Interest) in Canada with FRENCH language selected, the CP1 display turns black and displays a Caution / disclaimer message.</p>
