# TECHNICAL SERVICE BULLETIN

## Second Row Seat Back Does Not Fold Down Or Recline

**23-2036**

<b>Ford</b> 2018-2023 Expedition
<b>Lincoln</b> 2018-2023 Navigator

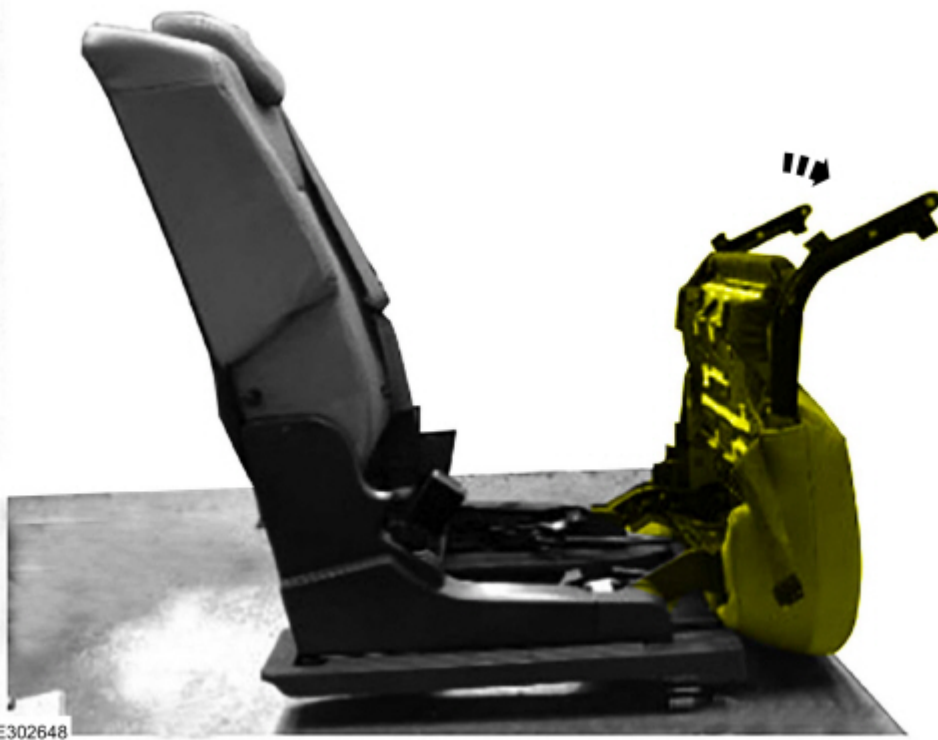
Figure 8

**NOTE: Avoid sliding the seat on the seat track front to back while the seat cushion is flipped forward or damage may result to the neighboring seat trim and material. (Figure 8)**

(2). Carefully, without damaging the neighboring seat material, flip the seat cushion forward.
