## SERVICE BULLETIN

**APPLICABILITY:** 2013-14MY Legacy and Outback Models with  
2.5L FB Engine  
2011-14MY Forester Models with 2.5L FB Engines  
2012-13MY Impreza and 2013MY XV Crosstrek  
Models with 2.0L FB Engine

**NUMBER:** 02-157-14R

**SUBJECT:** Surface Treatment Change To Oil Control Piston Rings

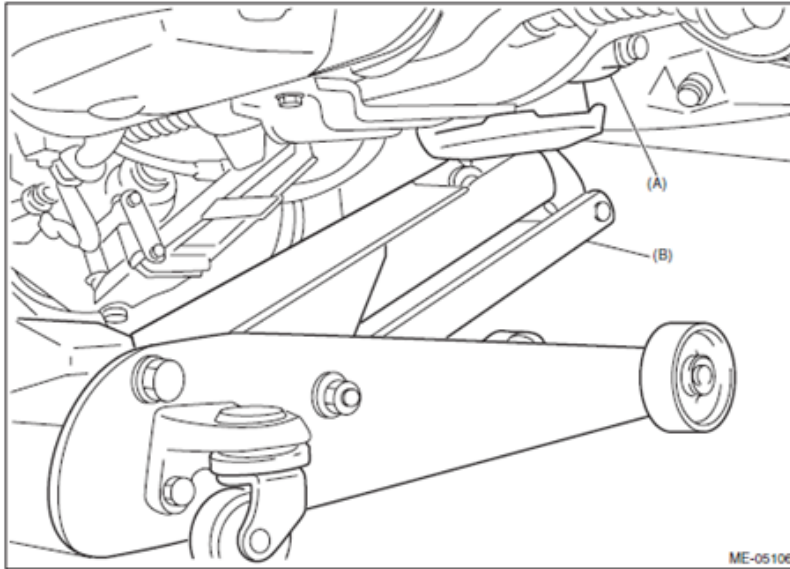
- When draining the engine oil, do not remove the engine oil filter. Leave the existing oil filter in place through engine disassembly, reassembly, installation and initial startup after engine reassembly.
- When removing the engine, there is no need to remove the transmission case cover (CVT only) or to disconnect / disturb any of the transmission harness connectors. While raising the transmission with the service jack placed under the front differential as shown in the illustration below, **only raise it enough to access and remove the engine mounting hardware**. Raising it too high can push the transmission up into the bulkhead / transmission tunnel and possibly cause damage.

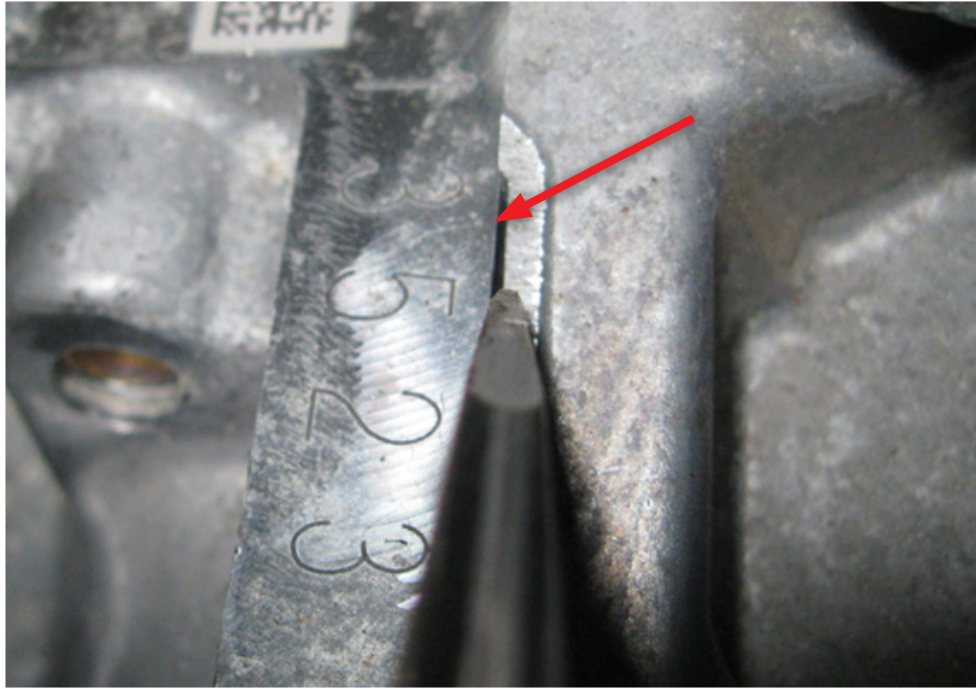
- To make separating the transmission (CVT) from the engine easier, there is a pry relief shown below in the machined mounting surface of the transmission case near the engine number. Use caution when applying any prying pressure and avoid twisting the tool to prevent case damage.

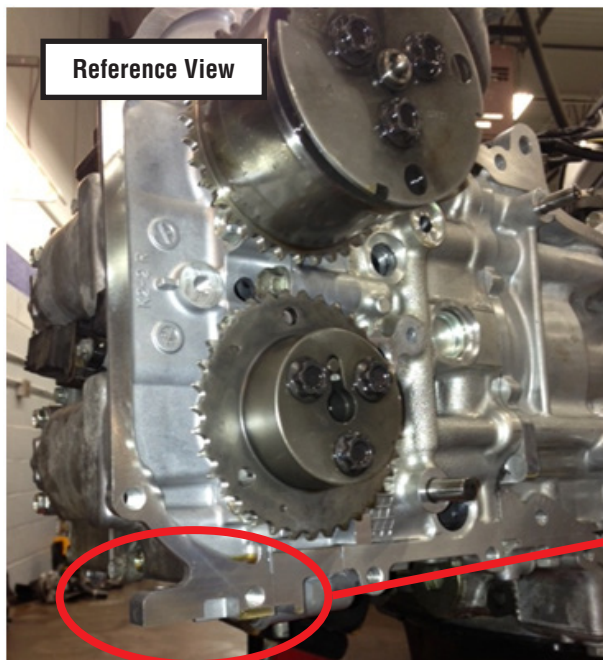
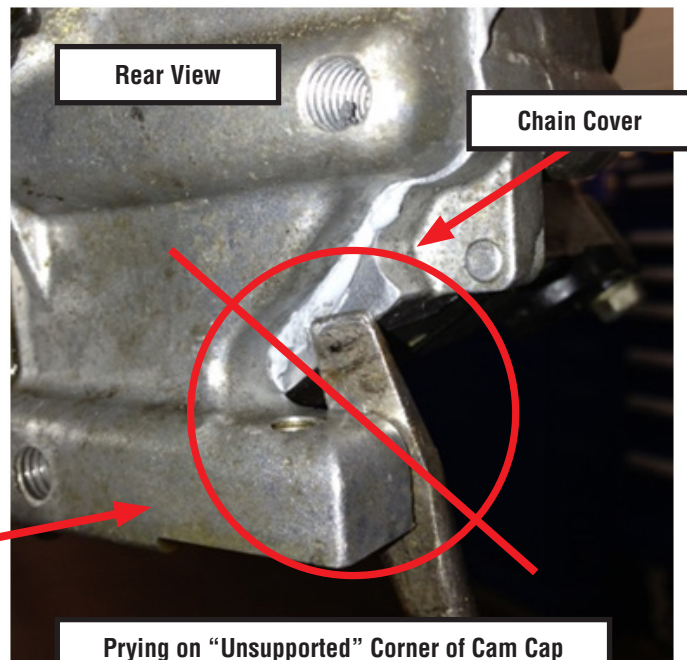
Prying on "Unsupported" Corner of Cam Cap

- There is no need to remove the oil dipstick tube or the original oil filter from the front chain cover. While the cover is removed, store it face (front side) down to minimize the chances of damaging the machined sealing surface on the block / head side. Also, don't use it as a tray to store other removed parts.
- **IMPORTANT:** After all 32 bolts securing the chain cover are removed, be **EXTREMELY** careful where you pry and what you pry on to break the silicone sealant's bond. The photos below show an example of where **NOT** to pry. In this case, the cam cap became cracked requiring a complete cam carrier replacement. *Patience is the key!*

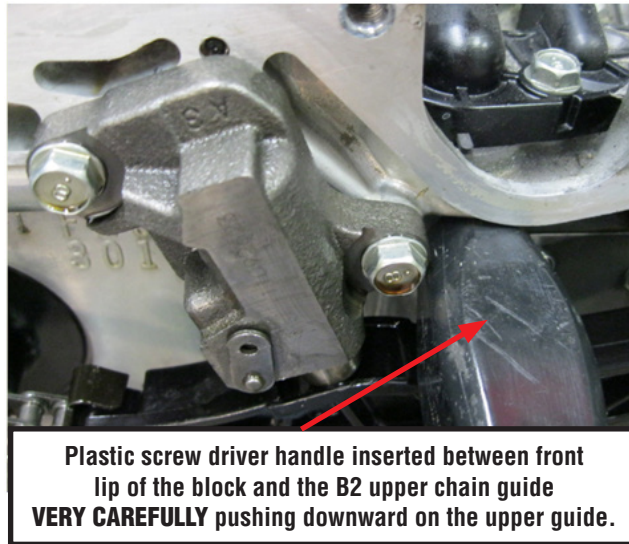
- If necessary, insert a plastic screwdriver handle between the lip of the block and the left side (B2) guide. Then, **VERY CAREFULLY** push down on the guide just enough to get the extra tensioner notch / “click”. When using this method, always make sure you are using plastic on plastic and NOT metal on plastic to avoid damaging the chain guides.

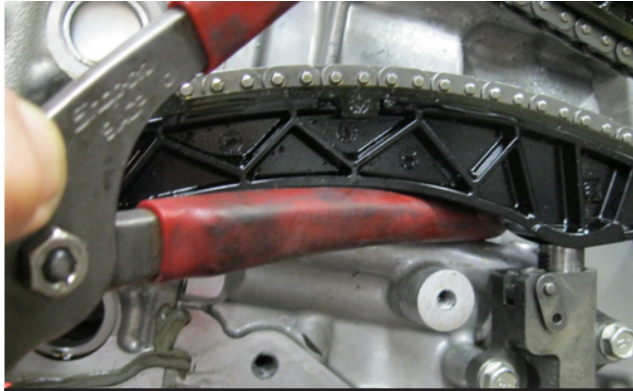
Rubber-coated plier handle inserted between a ledge area on the front of the block and the B1 lower chain guide **VERY CAREFULLY** lifting upward on the lower guide.

- Same as the left side, align the indicator links to the timing marks found on the cam sprocket assemblies. Install the chain guides and tensioner. Once proper positioning has been confirmed, pull the pin to release the tensioner. With your hand, grab and squeeze the upper and lower left side chain / guides together to allow the plunger in the tensioner to extend fully and click into its furthest notch as shown in the previous (right side) photo. If necessary, insert a rubber-coated plier handle between the ledge area on the front of the block and the right side (B1) lower chain guide. Then, **VERY CAREFULLY** lift up on the guide just enough to get the extra “click” on the tensioner as shown in the photo below.
