SERVICE BULLETIN

- APPLICABILITY:2012MY Forester, Impreza and WRX Models
Equipped with Fujitsu Ten Audio / Navigation
SystemsNUMBER:15-155-12R
DATE:08/14/12REVISED:11/09/12
 - **SUBJECT:** Fujitsu Ten (F10) Audio/Navigation Unit SD Card Exchange Information Including Diagnosis and Troubleshooting for Specific Software-Related Conditions Which May Be Corrected Through A Programming Update

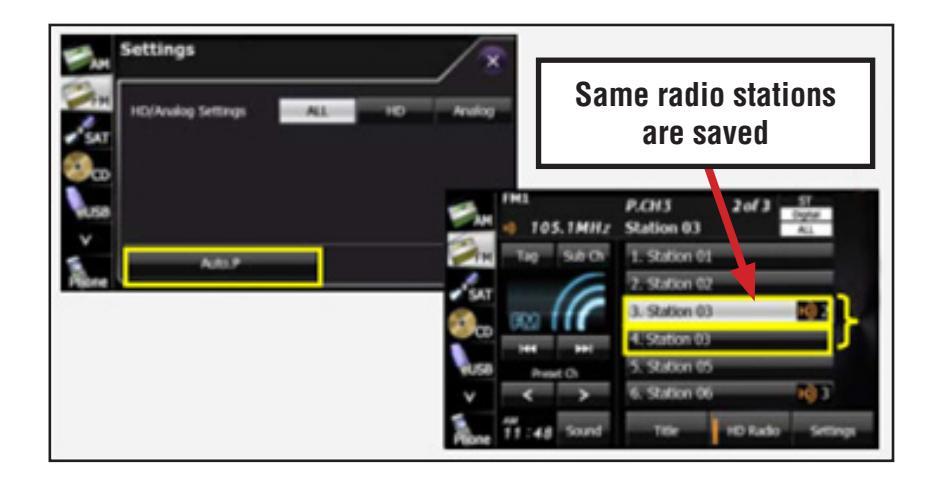
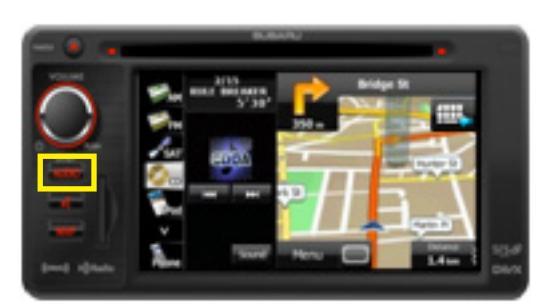
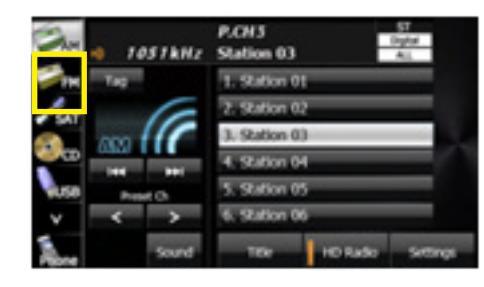
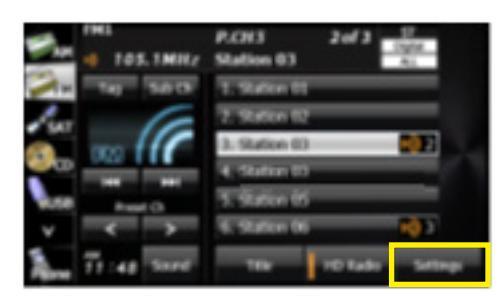
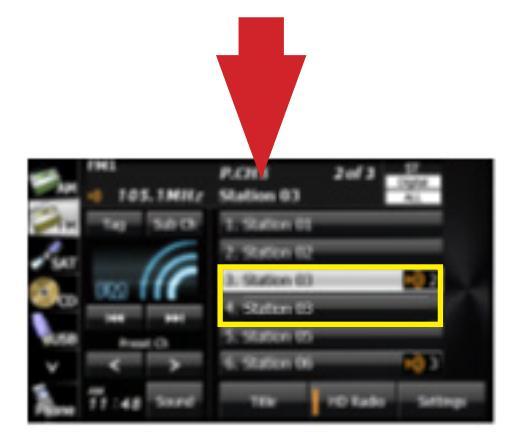
Condition 1:

When the "Auto. P" button is pressed on the "Settings" screen in AM or FM mode, a small "pop" noise is heard through the speakers. This condition may occur when the same radio station preset is saved twice in the "Preset" memory.

Speakers make a small "pop" noise

If the same FM preset is saved twice, change one to a different station

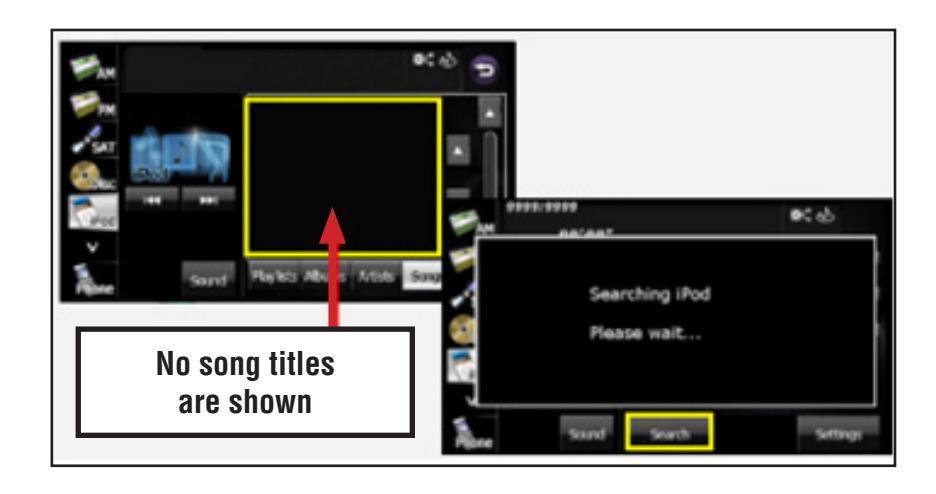
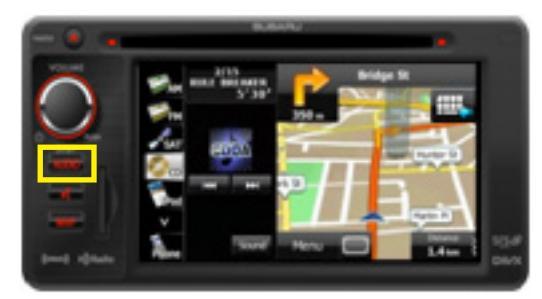
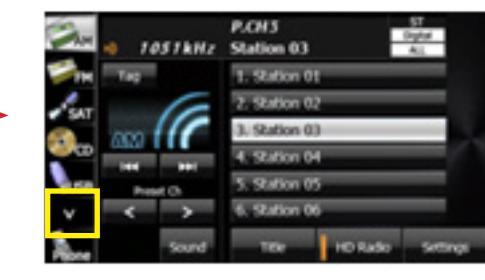
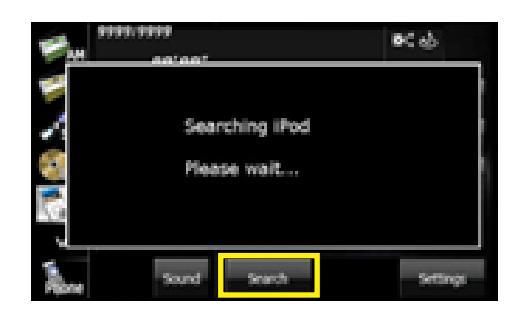
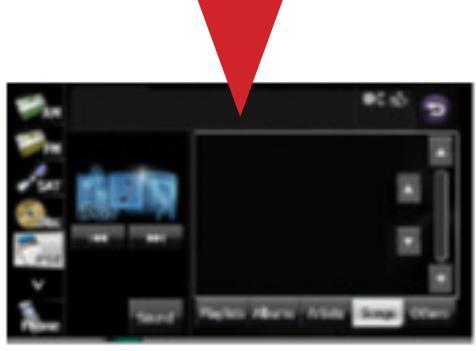
Condition 2:

Song titles are not shown in iPod mode. This condition may occur when the "Search" button on the "iPod Main" screen is pressed while the "Searching iPod Please wait..." message is displayed.

Searching iPod starts. Song lists will not be

displayed if "Search" button is pressed again

No song titles are shown

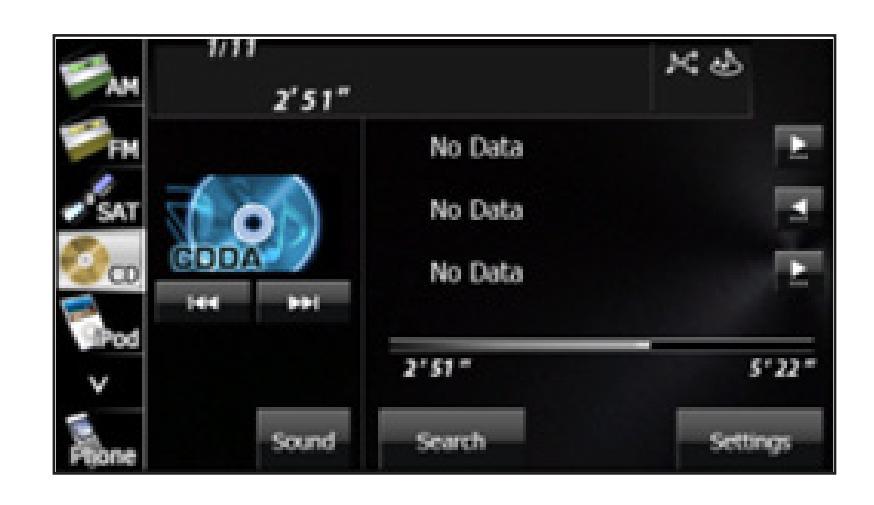
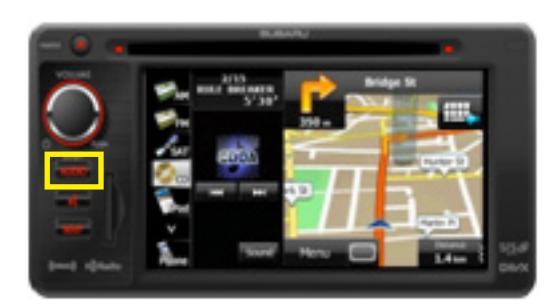
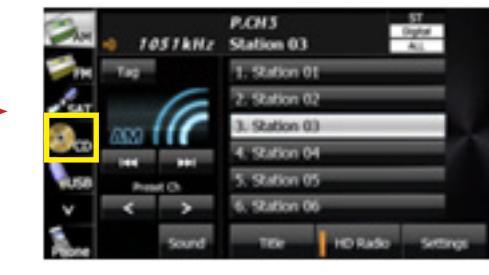
Condition 3:

CD playback is delayed for approximately 10 seconds after loading a CD or the CD mode is selected.

CD playback takes about 10 seconds to start

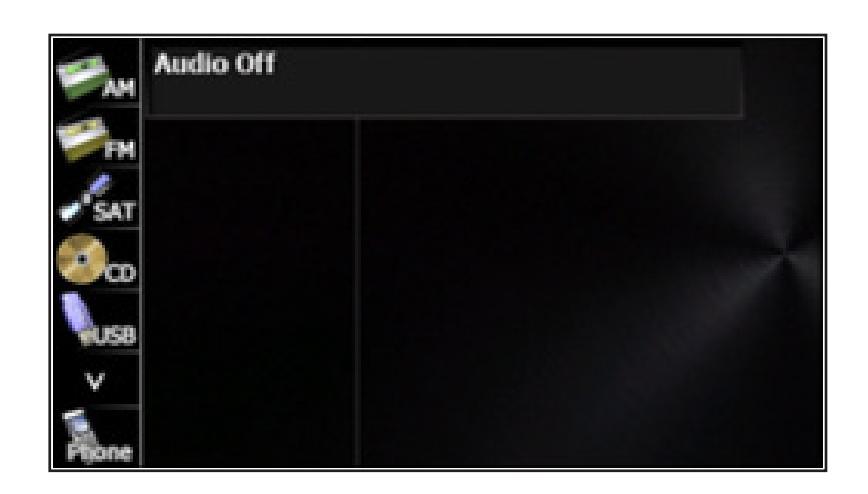
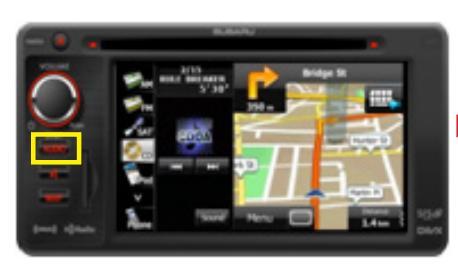
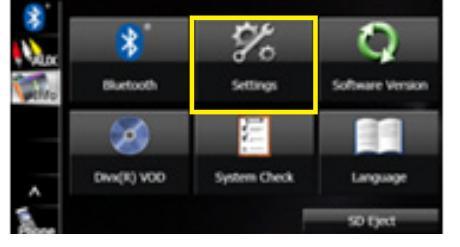
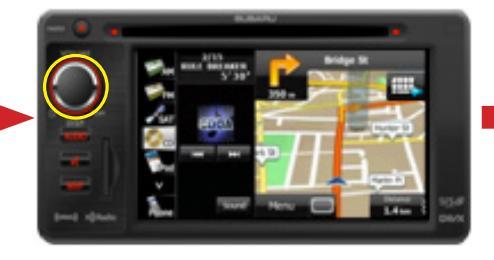
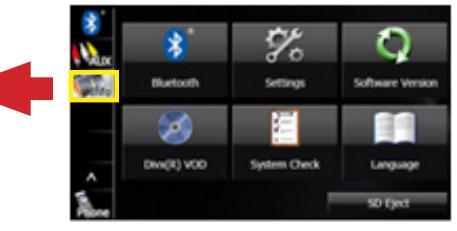
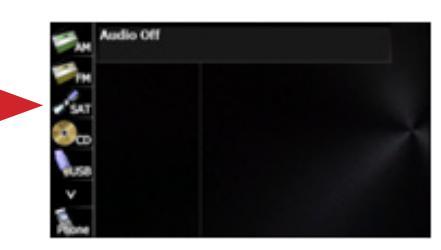
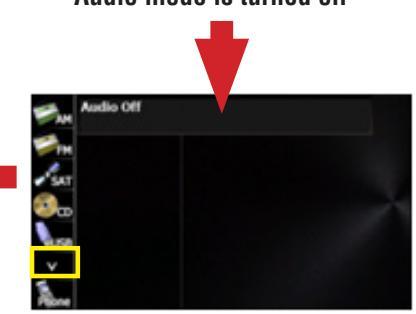
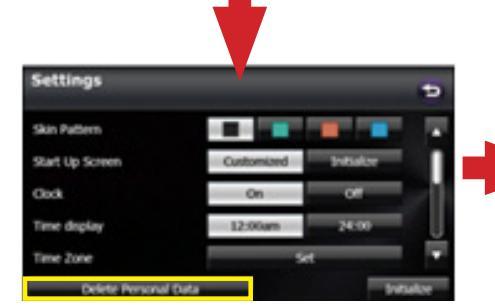
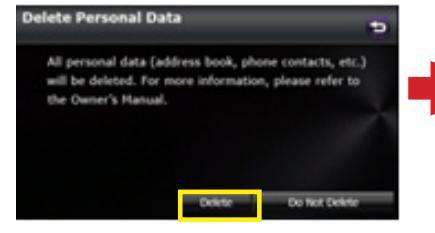
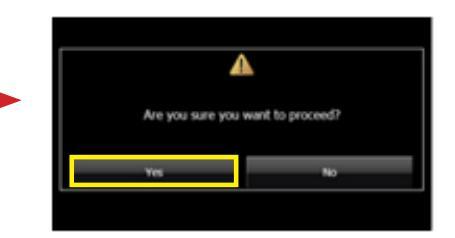
Condition 4:

FM radio can still be heard even if the audio unit is in "Audio Off" mode. This condition happens after "Delete Personal Data" button is pressed and cycling the ignition key off and back on again.

FM audio output continues in

"Audio Off" mode

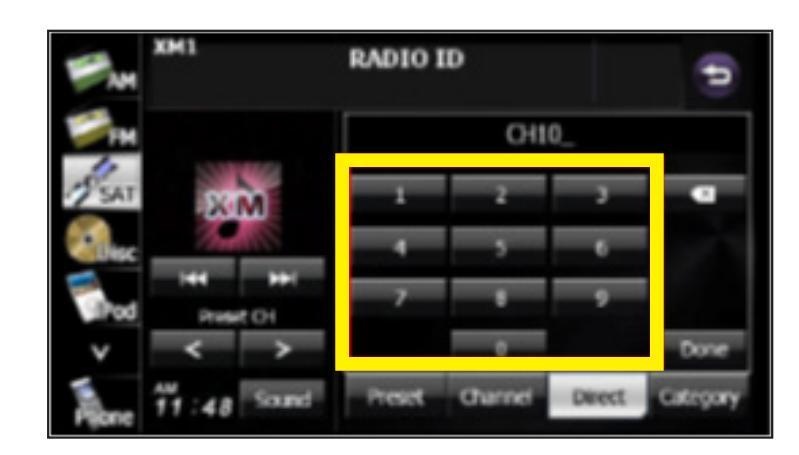
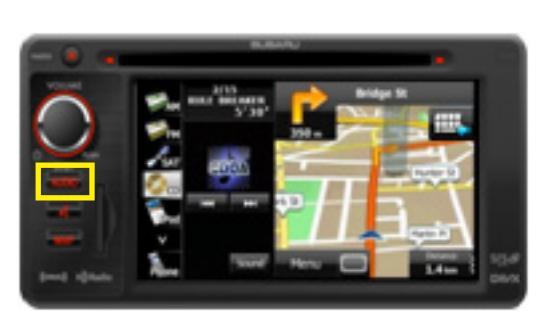
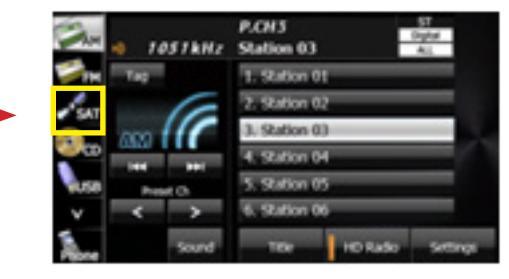
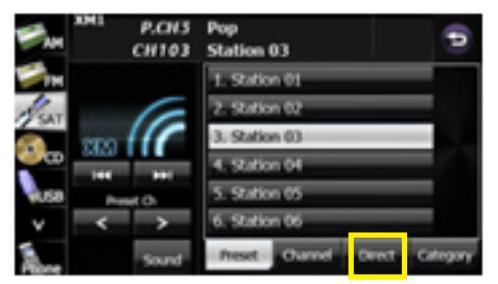
Condition 6:

In XM mode, the keypad appears normal but is inoperative while the vehicle is in motion. Once the vehicle is stopped, the keypad operates normally.

Although the keypad appears to be functional (not grayed-out), it does not operate unless the vehicle is stopped.
