## SERVICE BULLETIN

**APPLICABILITY:** All Models Equipped with Harman Audio / Navigation Head Units **NUMBER:** 15-221-18R  
**SUBJECT:** Harman Audio / Infotainment: Harman Generation 3.0 and 3.1 Operating Tips **DATE:** 04/11/18  
**REVISED:** 03/28/23

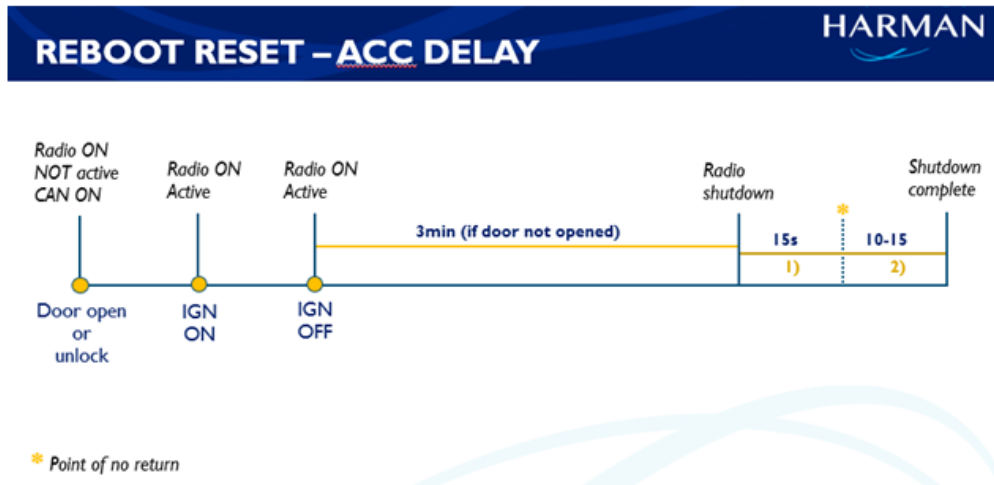
**CONDITION# 0.8** The shutdown process of the HU influenced by an ACC delay:

**Critical point:** If driver goes to reverse during this period, the shutdown process would stop (Reverse Camera delay) > if undo reverse the HU will continue the shutdown process and only show the reverse camera screen > during this time frame no other features will be available!

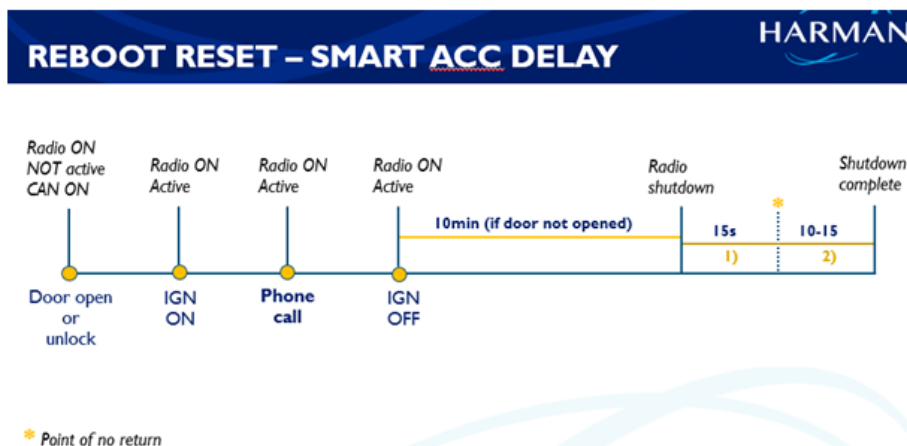
**CONDITION# 0.9** Shutdown process of the HU influenced by a Smart Accessory delay:

**Critical point:** If driver shifts into reverse during this period, the shutdown process will stop (Reverse Camera delay) > if shifted back out of reverse, the HU will continue the shutdown process and only show the reverse camera screen. During this time frame, no other features will be available.

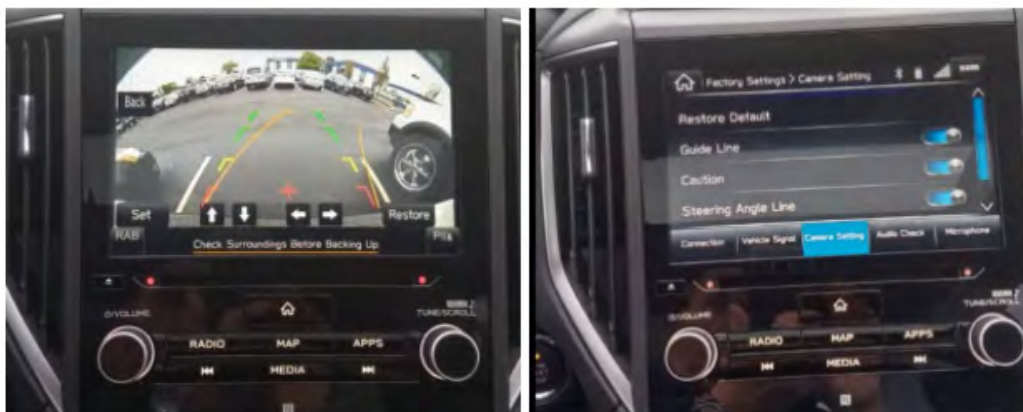
**CONDITION# 1.4** Orange park assist lines on the backup camera not moving or no longer present:

**CAUSE:** Park assist lines position is reflecting the steering angle. If the data is not supplied to the head unit from CAN bus or the data supplied is wrong, the lines position is not changing. Park assist lines display could be turned off via head unit setup.

**RECOMMENDATION:** Confirm the guide line settings and steering angle line data to determine the reason for concern.

Select camera setting option to verify the CONDITION# 1.4 and use Factory Settings/Camera Setting option to verify setup:

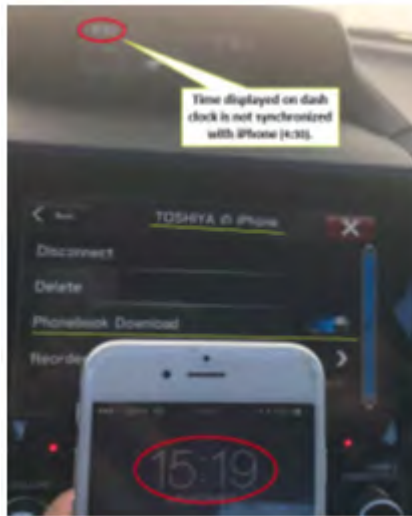
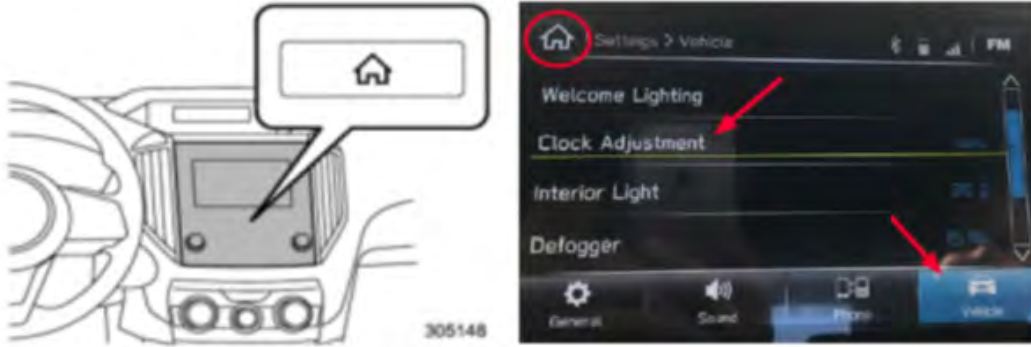
**CONDITION# 2.1 Display audio (non-navigation), clock not synchronized (2016 Dec TechTIPS):**

**CAUSE: NOTE:** This information is applicable to iPhone (IOS) users only. If a customer states the time displayed on their iPhone is not synchronized with the instrument panel clock display, the information below is an easy solution. Always ensure the latest software version is installed.

**RECOMMENDATION:** First, select the setting mode for the clock by following these steps:

- Press the “Home” button on the audio unit display.
- Press “Settings”
- Press “Vehicle”
- Select “Clock Adjustment”
- Select “Auto”

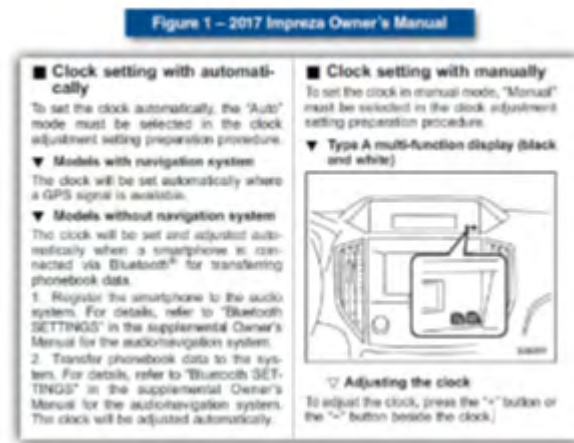
### **CONDITION# 2.2 Clock Setting Information** (December 2016 TechTIPS):

**CAUSE:** With the release of the 2017 Impreza Harman Gen 3 SUBARU STARLINK™ 6.5” Multimedia System and SUBARU STARLINK™ 8.0” Multimedia Navigation systems, there have been inquiries about the clock adjustment. There are two different modes of adjustment available: Automatic and Manual. **Figure 1** shown here is an excerpt from the 2017 Impreza Owner’s Manual describing both modes.

**RECOMMENDATION:** Automatic setting of the clock is accomplished differently between the navigation and non-navigation systems. As shown above, the navigation system will automatically set the time according to GPS location. Non-navigation systems utilize a paired smartphone connected via Bluetooth to accomplish the automatic setting. During the PDI process, it is recommended to manually set the clock on non-navigation models. This will ensure the correct time is displayed and allows the opportunity to show the customer the automatic feature should they choose to use it. Please review the Owner’s Manual for the applicable manual clock setting procedure.

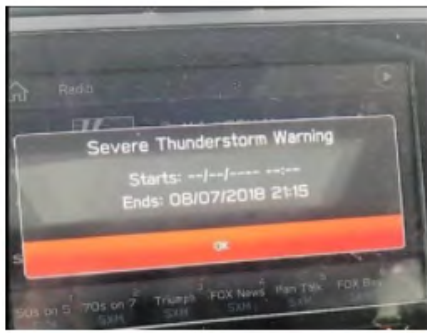
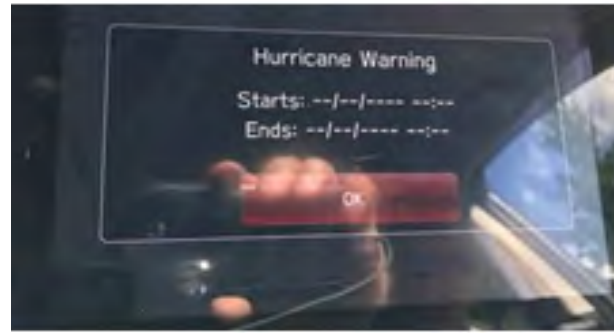
**CONDITION# 5.2 Hurricane or Severe Weather warning message is displayed:**

**CAUSE:** The head unit is designed to receive severe weather alert information from Sirius XM (SXM) and display a pop-up window with the alert message, whenever there is a signal from SXM. So far, we are only aware of HIGH grade units to have this feature available.

**RECOMMENDATION:** Please note when there is no date information supplied by SXM, the details (dates/ times) will be shown as "--/--/---- --/--" in the alert notification message. The head unit is operating as designed when this occurs.

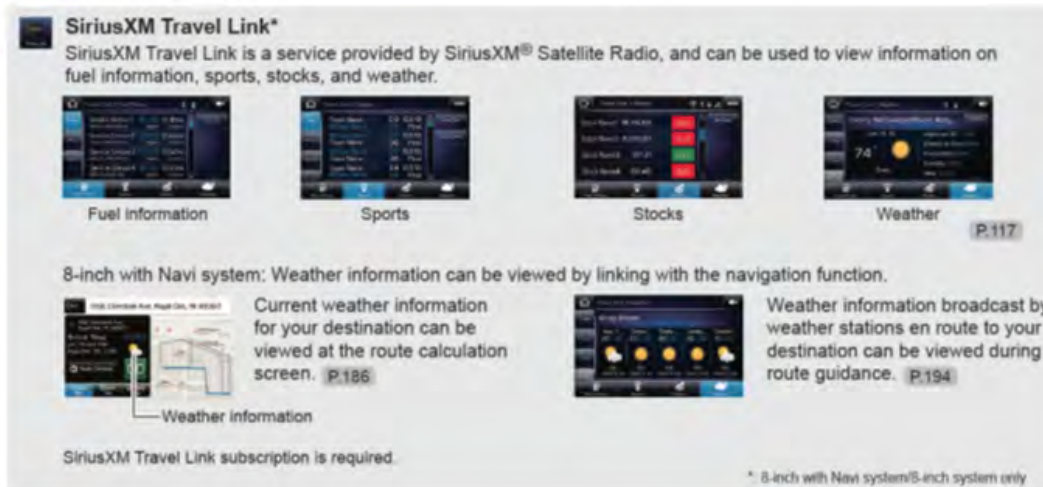
**CONDITION# 5.2 Weather, Fuel Information, Sports, Stocks information do not display in the Multi-Function Display (MFD):**

**CAUSE:** Weather forecasts, forecast temperature or highest/lowest temperature, and the chances of precipitation, etc. can be displayed in weather information. SiriusXM (sXM) services subscription is required.

**RECOMMENDATION:** Verify an active subscription for SiriusXM (SXM) services has been extended, after 1-year free trial period. Content using the SiriusXM® Satellite Radio Service is reset when personal information is initialized by selecting **Factory Data Reset** (Factory Data Reset) on the “GENERAL SETTINGS SCREEN”.

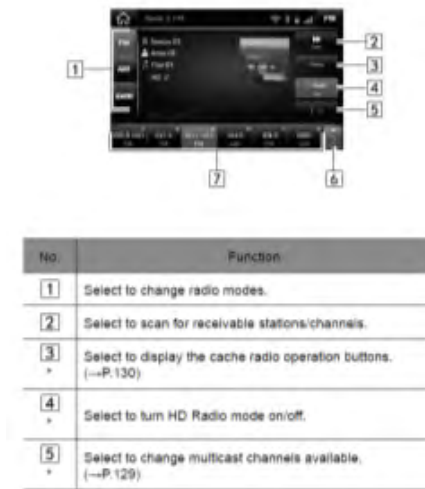
## CONDITION# 5.5 Volume fades Up and Down (FM/AM HD radio):

**CAUSE:** Assuming radio is in HD mode the vehicle is likely traveling outside of HD coverage area causing the head unit to switch between HD and Analog mode.

**RECOMMENDATION:** Turn HD off as shown in the picture below.

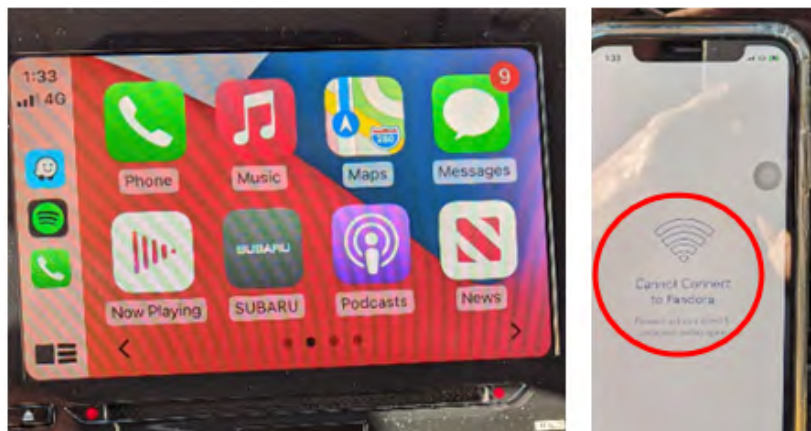
» Pandora streaming isn't working on the head unit (iPhone failed to connect to Pandora server):

**Note:** as you can see the head unit is projecting what iPhone is pushing to it and vehicle hardware replacement won't fix the concern with crashing phone application. In cases like that we suggested frequent iPhone reboot or restart (especially after recent iOS update) or updating or reinstalling the application on the phone. Check the comments in iTunes store as this may be a known concern with the app.

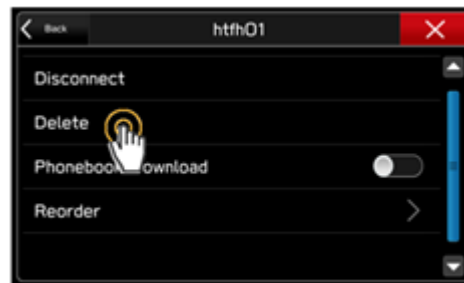
**CONDITION# 8.5:** New pairing not possible until Bluetooth on phone turned off and on again and phone deleted on HU side!

**CAUSE:** Phone does not disappear on HU side

**Unpair on HU side**

- > Does not disappear on phone side
- > New pairing not possible!

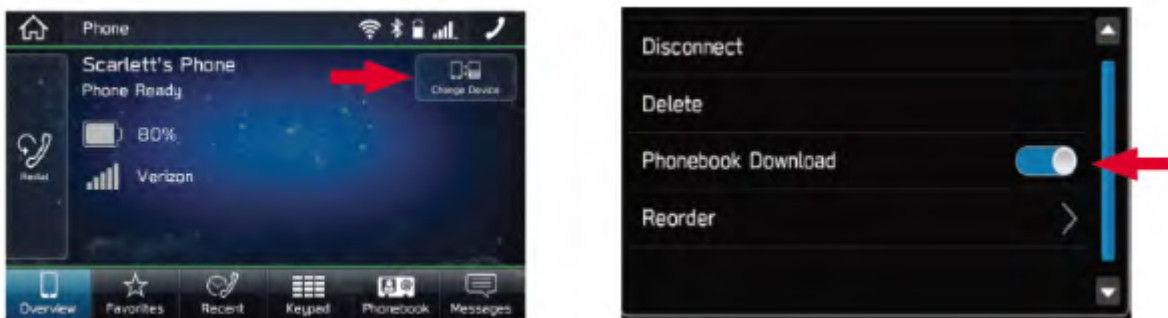
**CAUSE:** There have been reports received regarding phonebook downloading failure during Bluetooth Pairing. Customers report after repeated pairing attempts the condition continues.

**RECOMMENDATION:** We would like to refresh the steps involved in the process to prevent the issue occurrence due to the setup. If the phonebook or messages are not appearing as expected following Bluetooth Pairing, verify the Phonebook Download feature has been enabled in the head unit settings. Select the “Phone” button then press “Overview” on the head unit touch screen. Then select “Change Device” and ensure “Phonebook Download” is enabled.

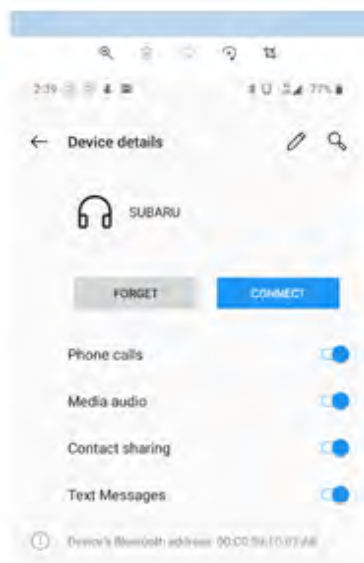
Select the gear icon next to your vehicle device name. Ensure all settings are enabled.

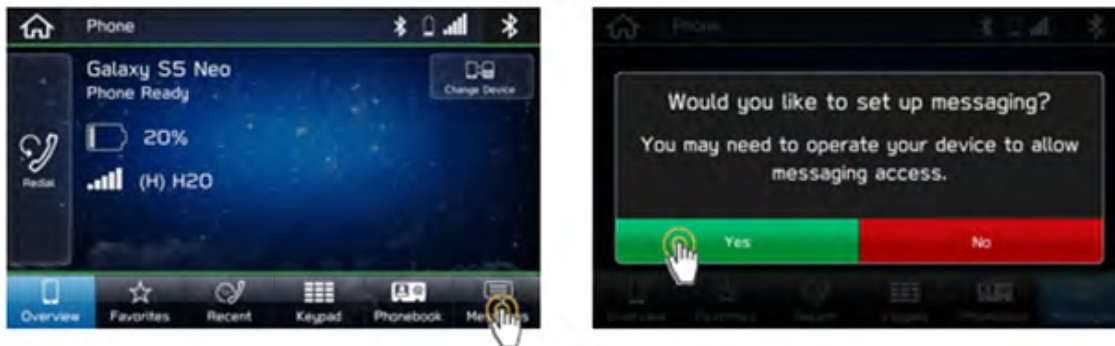
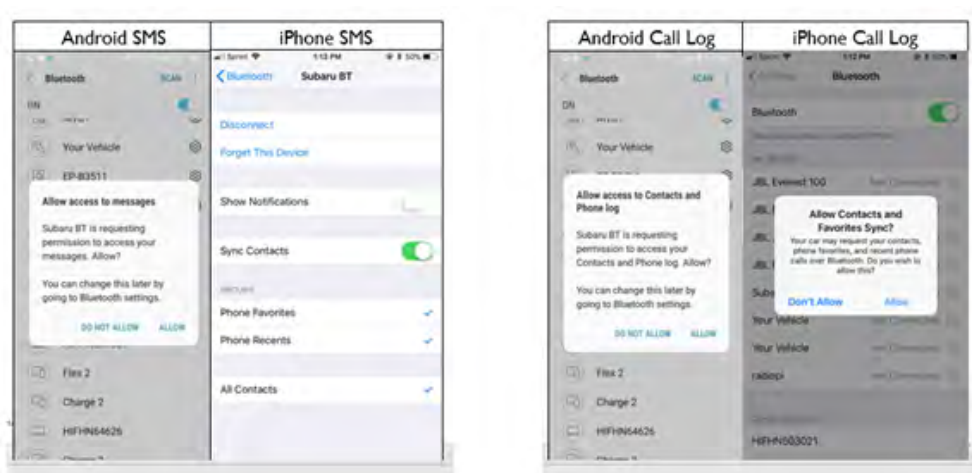
**Note:** Some phones will show SMS access request, some will show SMS and call history access request, some only call history access request. If there are access requests, you have to confirm them on phone side (refers to phone screenshot)

- If there is an access request, you have to confirm it on phone side.

- ignition cycle is required to enable SMS.

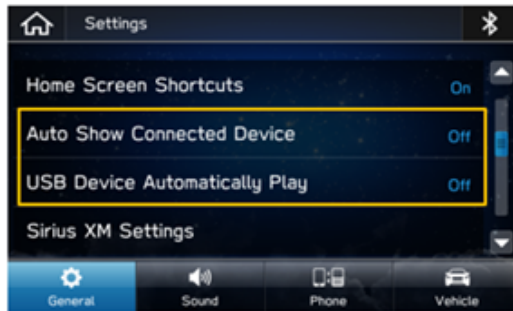
**CAUSE:** When pairing phone via Bluetooth connection will stop the radio playing and switch to media, if Auto Play is enabled.

Starting position: Settings > General

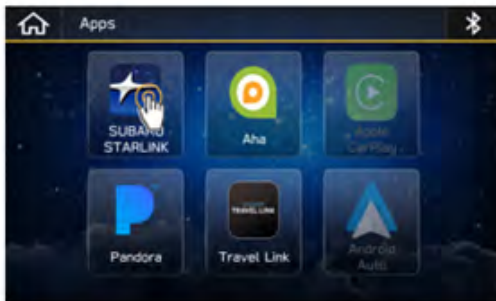
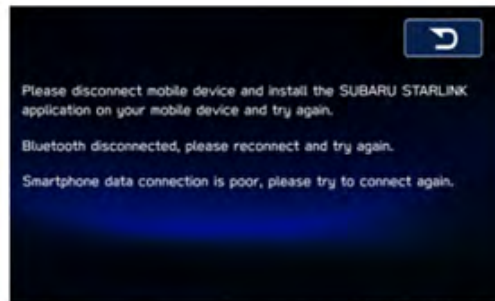
### CONDITION# 8.10: Starlink issues:

2. Error screen shown in case of issues.

The error can have multiple CAUSES which should be checked in the following order:

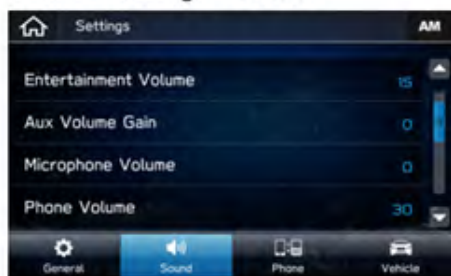
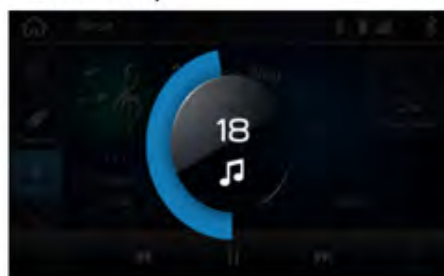
**CAUSE:** There are different volume focuses for different channels such as phone, navigation, microphone, etc.

A. Change value in the settings.

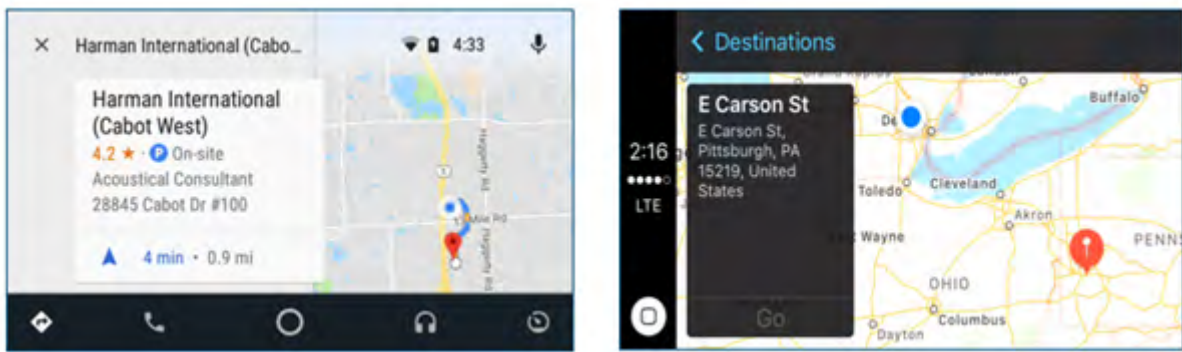
**CAUSE:** It is not possible to use multiple navigation applications at the same time.

- » Android Auto (AA) and CarPlay cannot be used at the same time. However active routes will be saved when application is closed.
- » Both AA and CarPlay close HU navigation and delete the active route.

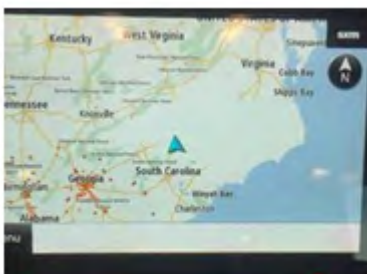
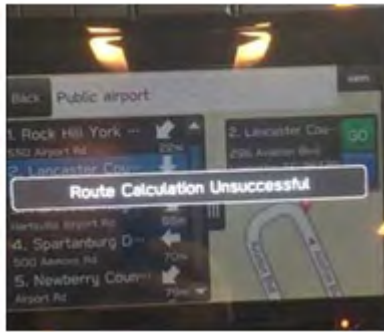
- Map display is either white (blank) or an incomplete screen (no roads) is displayed

- “Route Calculation Unsuccessful” message is displayed when trying to calculate a route

**CAUSE:** If a MOTA (Map Over The Air) update was performed or attempted previously, the state map data may have become corrupted. This can occur due a weak Wi Fi signal during MOTA update causing the update interrupt resulting in the data corruption.

**RECOMMENDATION:** Successfully updating the map data again using a strong and reliable Wi Fi signal or using USB Flash drive with the latest Map data downloaded from PC would restore missing map data.
