SERVICE BULLETIN

APPLICABILITY: 2012 and 13MY Impreza and XV Crosstrek™ **NUMBER:** 11-125-12
 Models Equipped With FB Engine **DATE:** 12/03/12

SUBJECT: DTCs P0365, P0366, P0390 and P0391
 Misfire DTCs P0301, P0302, P0303 and P0304

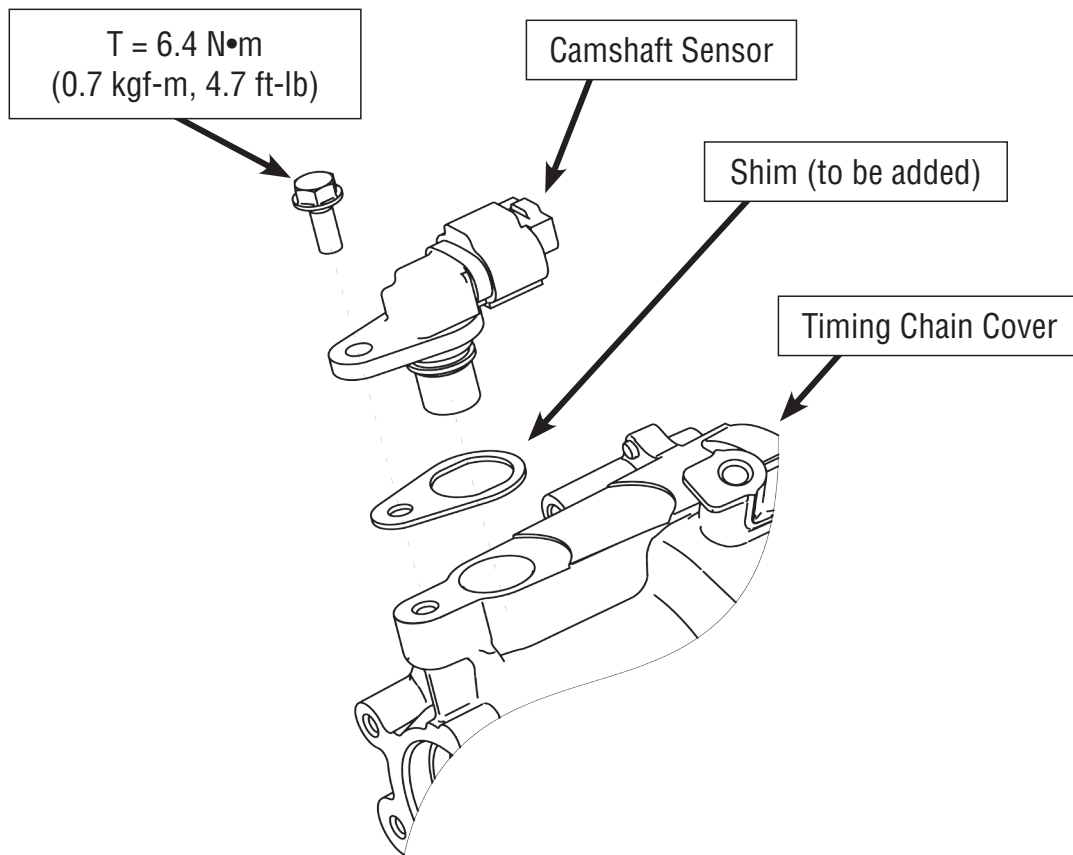
The specified clearance is 1.3 +/- .05mm (1.25 to 1.35mm or .049" to .053").

- Record radio station presets (and navigation system favorites if applicable).
- Disconnect the negative battery cable.
- Raise the vehicle on a lift and remove the engine under-guard.
- Remove the exhaust camshaft position sensor from the timing chain cover using the procedure in the applicable Service Manual.
