## SERVICE BULLETIN

**APPLICABILITY:** 2012 (AFTER VIN C\*411693)- 14 MY  
 Forester Models with 2.5L FB Engines

**NUMBER:** 02-144-13R

**SUBJECT:** Surface Treatment Change To Oil Control  
 Piston Rings

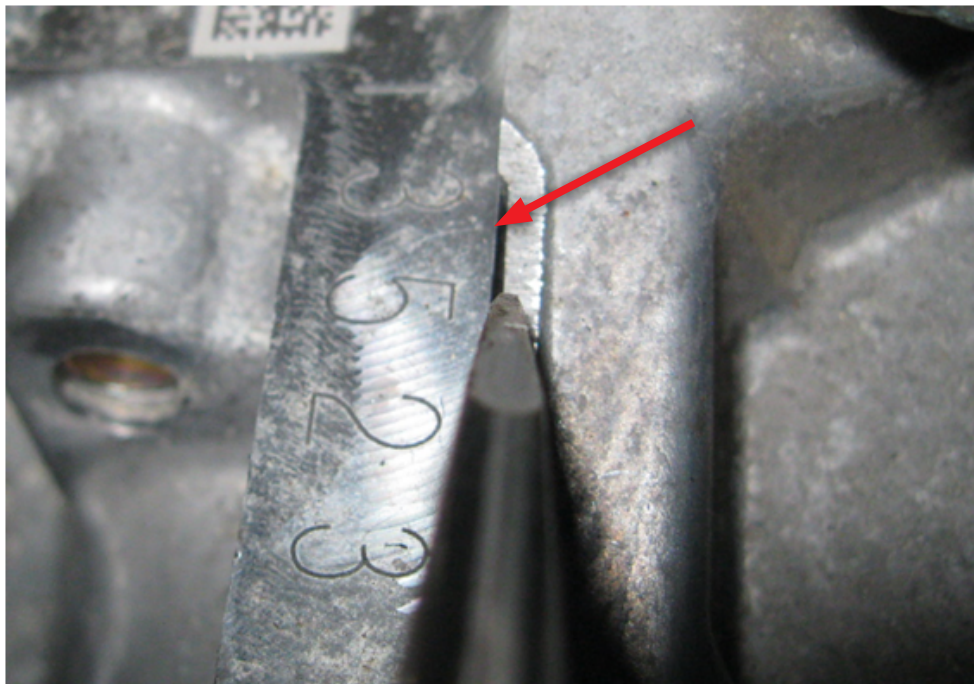
- To make separating the transmission (CVT) from the engine easier, there is a pry relief shown below in the machined mounting surface of the transmission case near the engine number. Use caution when applying any prying pressure and avoid twisting the tool to prevent case damage.

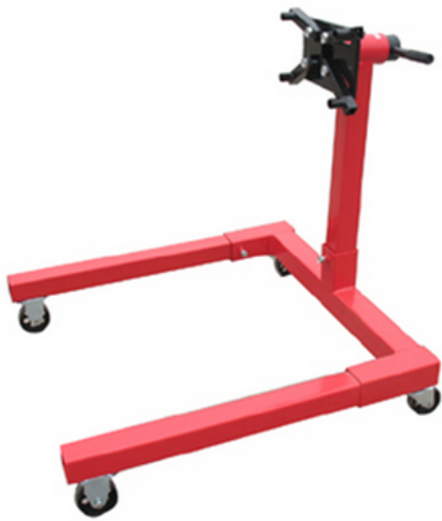
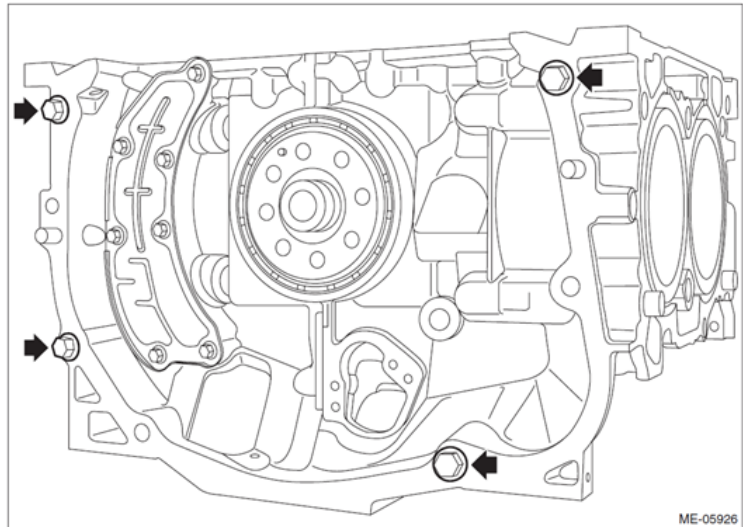
- Once the engine is removed, if you are using a generic engine stand (preferable since engine rotation is necessary), use the four mounting holes on the engine block shown below to mount it. Do not use the studs in the upper oil pan as the upper oil pan has to be removed to access the connecting rod bolts. **NOTE:** The connecting rod bolts are one-time-use and must be replaced.

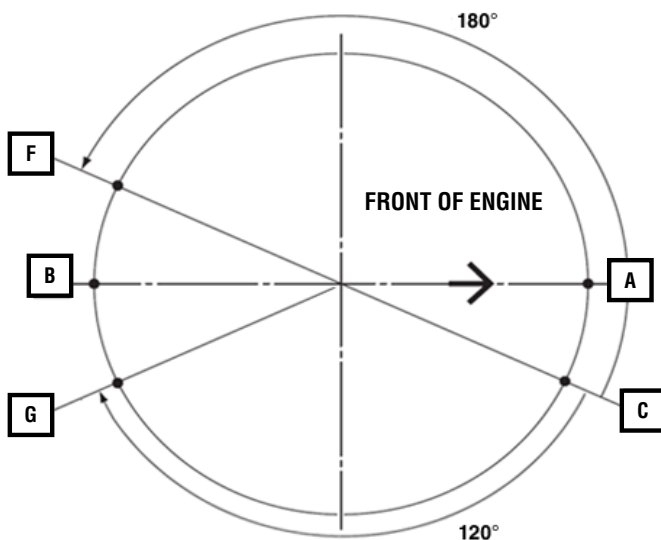
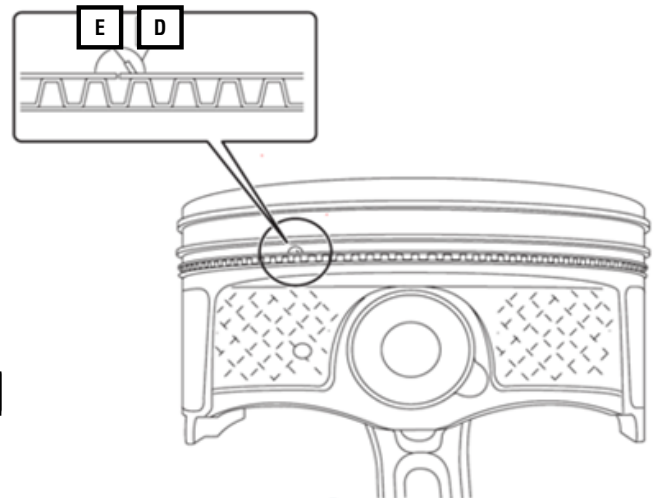
- “A”- Top compression ring end gap location
- “B”- Second compression ring end gap location (180 degrees away from “A”)
- “C”- Top oil control scraper ring end gap
- “D”- Recess in top of ring land to accept the “tang” of the upper oil control scraper ring - “E”
- “F”- Expander gap (180 degrees away from “C”)
- “G”- Bottom oil control scraper ring end gap (120 degrees away from “C”)

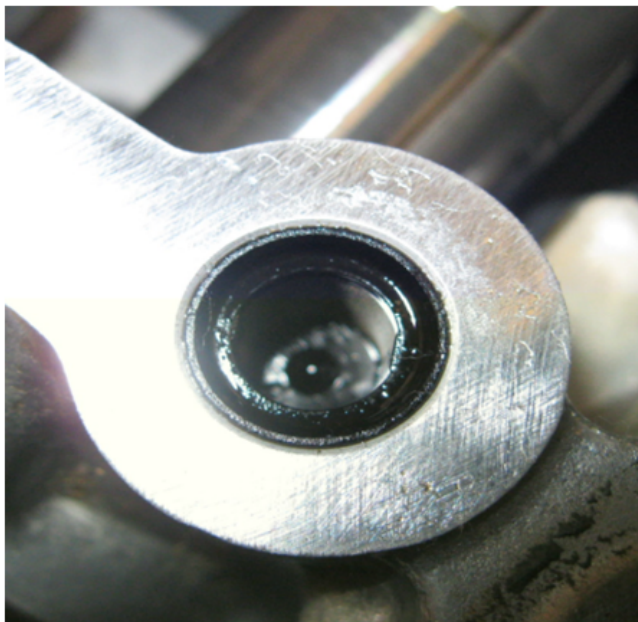
**Cam Carrier Filter Screen**

- ALWAYS install new connecting rod bolts as they are one-time use items.
- It is very important to take the time necessary to thoroughly clean the old silicone sealer from all the removed components before reassembly. It is a good idea to clean the surrounding areas then use tape to block off any oil passages in the front cover and cam carrier so any small bits of removed silicone debris are kept from entering the oil passages and possibly causing problems after reassembly. Once all the old sealer has been removed, remove any block-off tape, rinse out any oil passages thoroughly with brake cleaner and shop air.
- Don't forget to clean **(without removing)** the filter screens in the cam carriers (one filter in each carrier). In addition, always be sure to do a thorough inspection and cleaning of the oil pan, pick-up tube and screen as shown in the photos below before reassembly.
