## SERVICE BULLETIN

**APPLICABILITY:** 2013-14MY Legacy and Outback Models  
 with 2.5L FB Engines  
 2011-14MY Forester Models with 2.5L FB Engines  
 2015 MY Forester (Manual Transmissions Only)  
 with 2.5L FB Engines  
 2012-13 MY Impreza and XV Crosstrek Models  
 with 2.0 FB Engines  
 2014-15 MY Impreza and XV Crosstrek Models  
 (Manual Transmissions Only) with 2.0 FB Engines

**NUMBER:** 02-157-14R

**SUBJECT:** Surface Treatment Change To Oil Control  
 Piston Rings

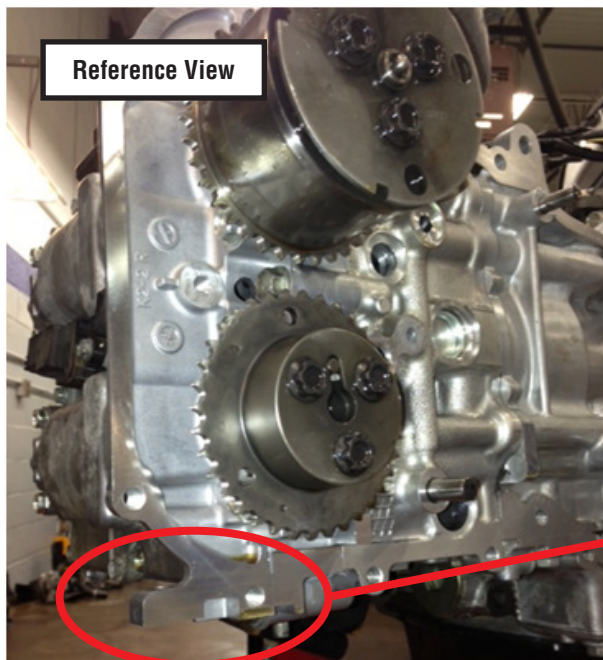
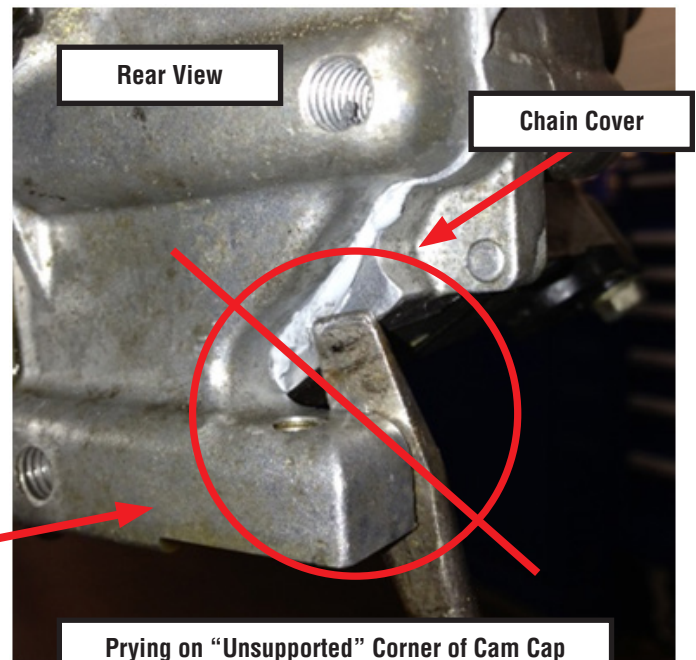
- There is no need to remove the oil dipstick tube or the original oil filter from the front chain cover. While the cover is removed, store it face (front side) down to minimize the chances of damaging the machined sealing surface on the block / head side. Also, don't use it as a tray to store other removed parts.
- **IMPORTANT:** After all 32 bolts securing the chain cover are removed, be **EXTREMELY** careful where you pry and what you pry on to break the silicone sealant's bond. The photos below show an example of where **NOT** to pry. In this case, the cam cap became cracked requiring a complete cam carrier replacement. *Patience is the key!*

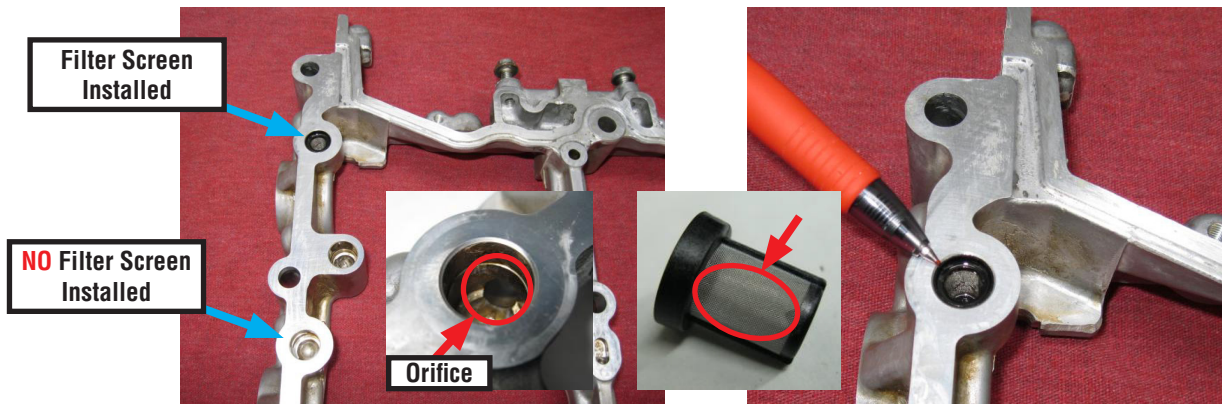
- **IMPORTANT:** If by chance the AVCS filter screens in the cam carriers have come loose, fallen out or become lost during disassembly, they are available separately (p.n. 14451AA050). **NOTE: The filter screens are directional and MUST be reinstalled in their original position, flush with the machined surface of the cam carrier.** There is an oil passage in the cam case which **MUST** align with the “screen” area on the outside surface of the filter (see insets below) otherwise, oil flow to the AVCS can become restricted or blocked resulting in engine damage. Engines with AVCS on both intake and exhaust will have 2 filters in each carrier (blue arrows) as opposed to just one (intake only AVCS) as shown in the photo below.

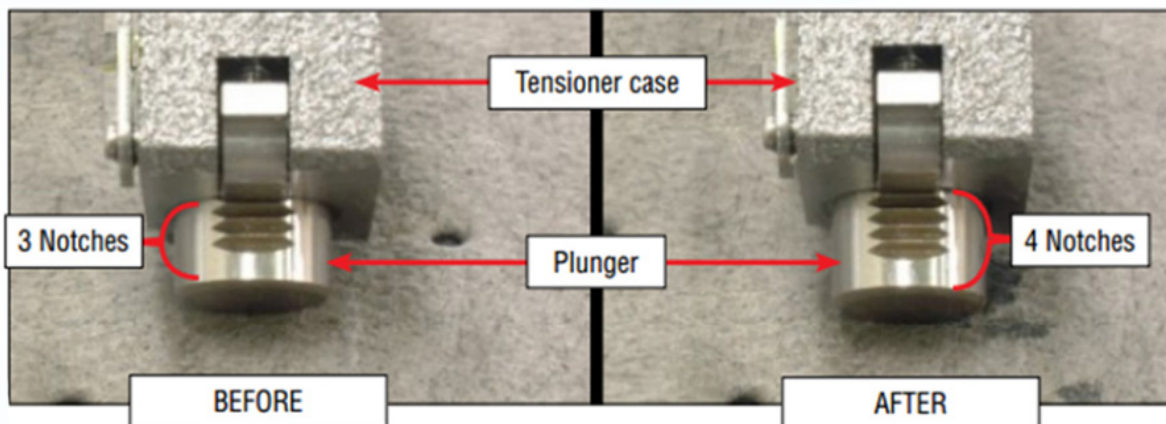
- If you have 3 notches showing, you want to get one more “click” so that 4 notches are visible as shown in the photos below. If you have 4 showing, you want to end up with 5. Whether you start with 3 or 4 will depend on the amount of wear present on the chains and guides. The number of clicks listed here is simply a guide. The point is to ensure proper initial chain tension is applied to avoid creating a brief rattle sound at engine start.

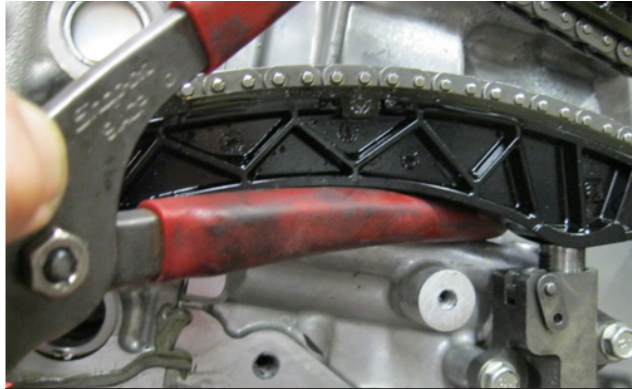
Rubber-coated plier handle inserted between a ledge area on the front of the block and the B1 lower chain guide **VERY CAREFULLY** lifting upward on the lower guide.

- Same as the left side, align the indicator links to the timing marks found on the cam sprocket assemblies. Install the chain guides and tensioner. Once proper positioning has been confirmed, pull the pin to release the tensioner. With your hand, grab and squeeze the upper and lower left side chain / guides together to allow the plunger in the tensioner to extend fully and click into its furthest notch as shown in the previous (right side) photo. If necessary, insert a rubber-coated plier handle between the ledge area on the front of the block and the right side (B1) lower chain guide. Then, **VERY CAREFULLY** lift up on the guide just enough to get the extra “click” on the tensioner as shown in the photo below.
