SERVICE INFORMATION BULLETIN

APPLICABILITY: 2019MY Legacy and Outback w/ 8-in. Navi System **NUMBER:** 15-255-19R
 2019-**23**MY Impreza and Crosstrek w/ 8-in. Navi System **DATE:** 11/08/19
 2019-**23**MY Crosstrek Hybrid w/ 8-in. Navi System **REVISED:** 05/15/23
 2019-**24**MY Forester w/ 8-in. Navi System
 2019-**21**MY WRX WRX STI w/ 7-in. Navi System
 2019-22MY Ascent w/ 8-in. Navi System
 2019-**21**MY BRZ with 7-in. Navi System

SUBJECT: Map Data Update Procedure for Harman Gen 3.1 Navigation Equipped Head Units (H/U)

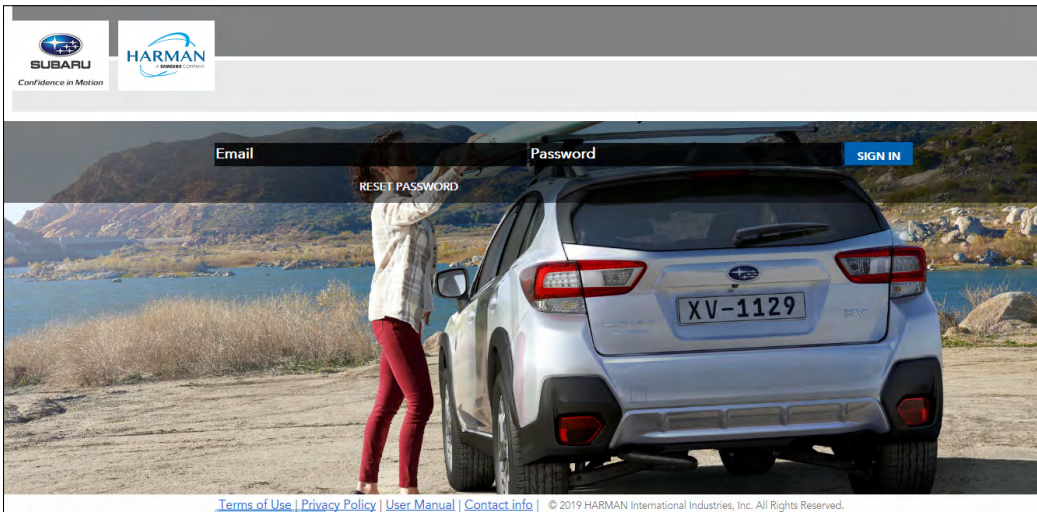
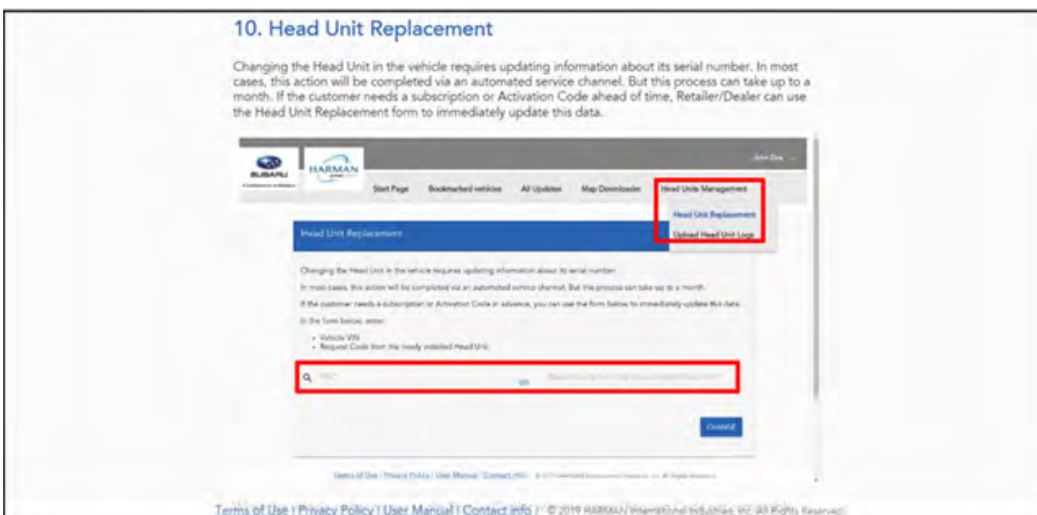
Please input VIN and Head Unit Request Code on “10.Head Unit Replacement” in the URL below, referring to “User Manual”.

After LogIn ➡ Head Unit Management ➡ Head Unit Replacement ➡ input VIN & Request Code.
