SERVICE BULLETIN

APPLICABILITY: 22-**23MY** WRX Models **NUMBER:** 15-301-22R
SUBJECT: Reprogramming File Availability for Optimization of Gen 4 Denso CP1 Infotainment Systems **DATE:** 09/09/22
REVISED: 05/22/23

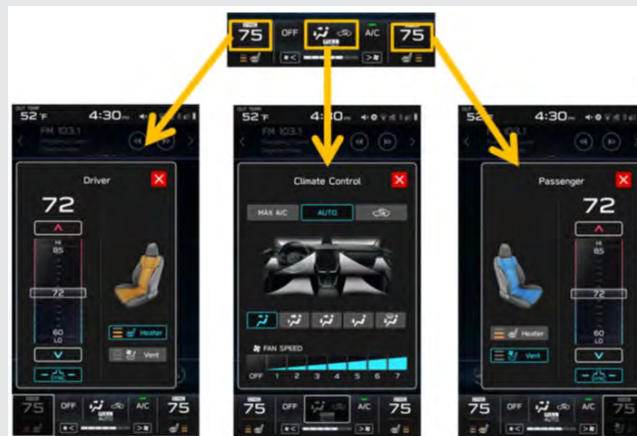
Current (-22MY) screen transition:

Air conditioner control interface is changed to that of 23MY.

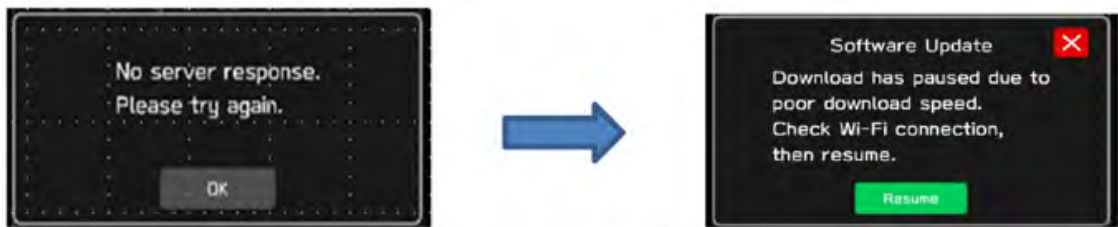
1	Icons of home screen change to those of the US specifications even though the original specification is not of the US.
2	Two ways of MOTA operations, i.e., by connect CCM to Wi-Fi or by transferring the downloaded map data to CCM via smart phone are executed simultaneously by error.
3	<p>One of the Pop-up Error Messages displayed during the FOTA operation in case of weak Wi-Fi signal is not intuitive. Even if the customer tap “OK,” it does not transit to another screen.</p> <div style="text-align: center;">

</div> <p>As the improvement for this inconvenience, the message is changed so that the customer finds the reason why the FOTA operation has been paused. Also a “Resume” button is prepared so that the customer can do the rest of operations after necessary action (moving the vehicle to another place with better Wi-Fi connection**, or tethering the CP1 to a mobile phone, etc.)</p> <p>Note** The FOTA operation can be paused when the Wi-Fi indicator at the upper right corner of the CID is not in “Good” or “Excellent” as shown below.</p> <div style="text-align: center;">
