SERVICE BULLETIN

APPLICABILITY: 2019-23MY Impreza
 2019-23MY Crosstrek (Including Hybrid Model)
 2019-24MY Forester
 2019MY Legacy/ Outback
 2019-21MY WRX
 2019-21MY WRX STI
 2019-21MY BRZ- Navigation -equipped ONLY
 2019-22MY Ascent

NUMBER: 15-236-18R
DATE: 12/04/18
REVISED: 12/08/23

SUBJECT: Reprogramming File Availability for Optimization of Harman Gen 3.1 and Gen 3.1α Audio and Navigation Head Units

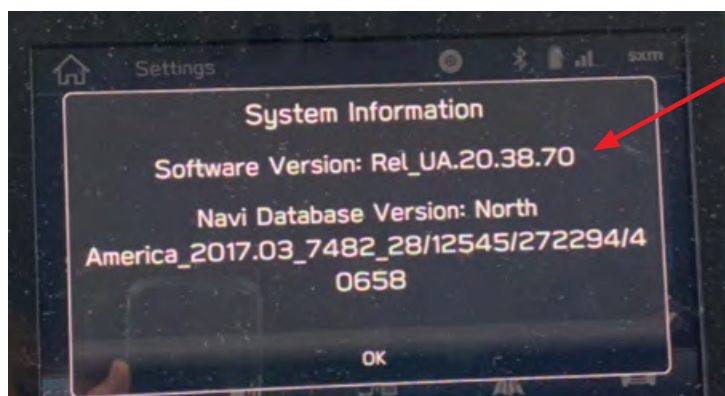
- The currently installed software version will be displayed. If the Software Version is **not Rel_UK.23.16.70**, proceed to **Step 2**.

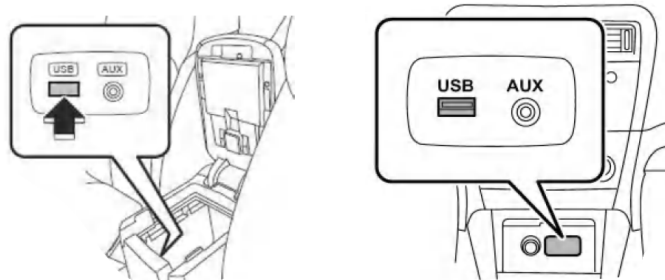
IMPORTANT NOTE: If the head unit does not recognize the USB flash drive during the reprogramming process, this may be due to an incompatible Controller IC in the USB flash drive or it is otherwise incompatible with the head unit. If this occurs, delete all files from the flash drive and re-format it to “FAT32”, instead of “NTFS” and reload the appropriate “update” folder to the USB flash drive. If the USB flash drive is still not recognized, please discontinue the use of that drive and instead use a USB flash drive from a different manufacturer.

- With the engine idling (or GR8 connected), plug the flash drive into the USB Port.

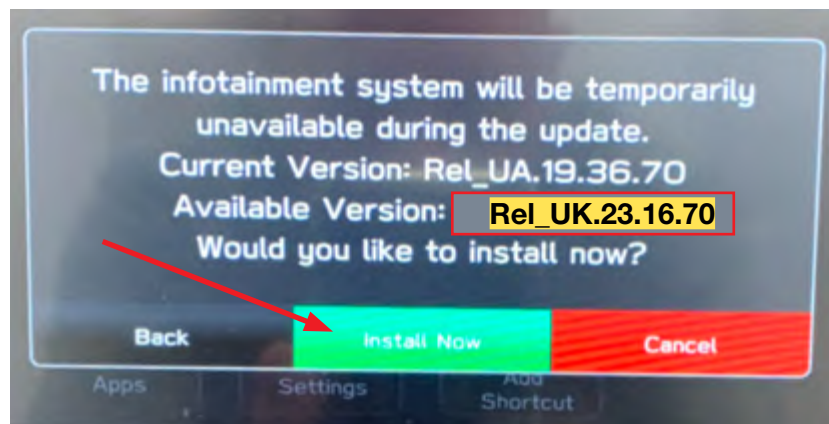
- The current and available software version information will be displayed. The Available Version I.D should be **Rel_UK.23.16.70**.

- After confirming the Available Version, press “Install Now” to start the reprogramming process. The screen will go blank (black) for a brief period after installation begins.
- Each of the updates (Base, Mid and High) should take less than 10 minutes to install.

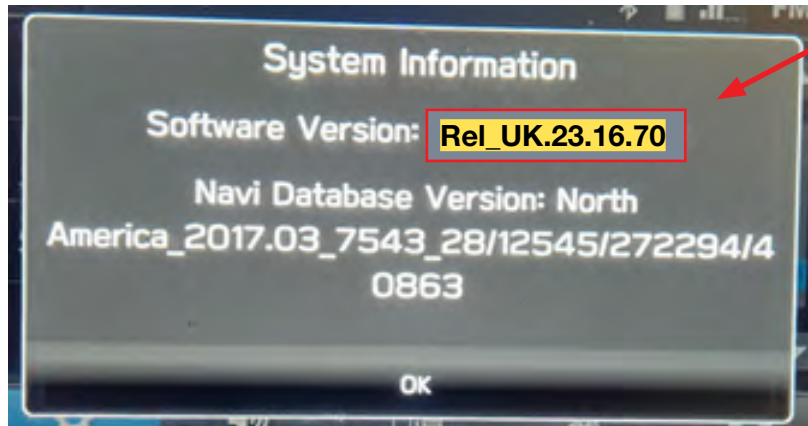
- Confirm Software Version is now “**Rel_UK.23.16.70**”.

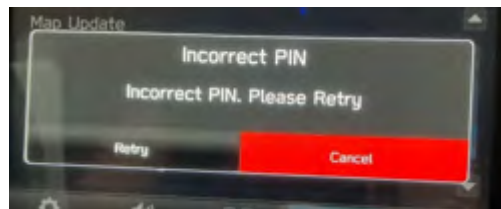
- 8) Repair Facility POI icons are now shown on the NAVI map display. See **NOTE 4** below.
- 9) Activation Code Not Accepted by Navigation System when updating Map Data

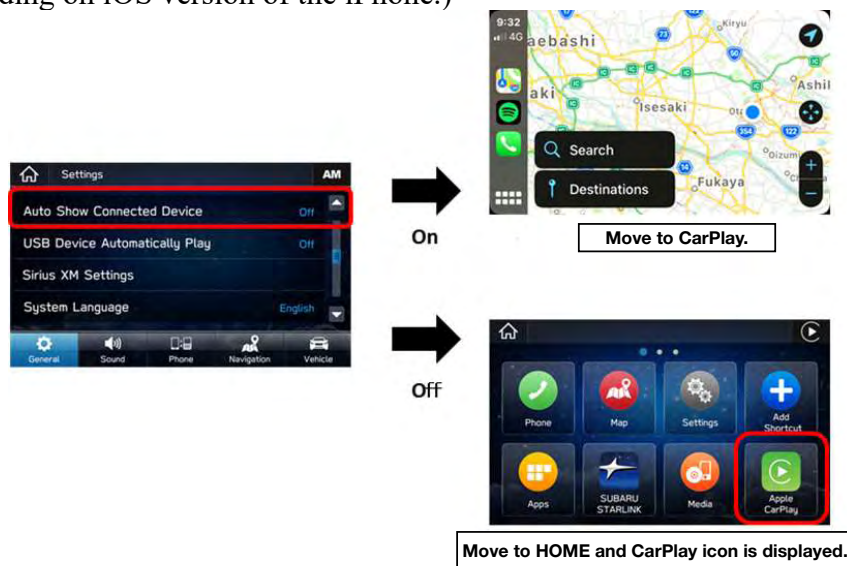
In a case where the iPhone was disconnected while playing music then reconnected while it is playing music, the system moves to CarPlay screen no matter what is set in <Auto Show Connected Device> in Setting (depending on iOS version of the iPhone.)
