**SERVICE BULLETIN**

**APPLICABILITY:** 2013MY Legacy and Outback 2.5L Models  
 2012-13MY Impreza 2.0L Models  
 2013MY XV Crosstrek  
 2011-2014MY Forester  
 2013MY BRZ

**NUMBER:** 11-130-13R

**SUBJECT:** Difficulty Starting, Rough Idle, Cam Position or Misfire DTCs  
 P0340, P0341, P0345, P0346, P0365, P0366, P0390, P0391,  
 P0301, P0302, P0303 or P0304

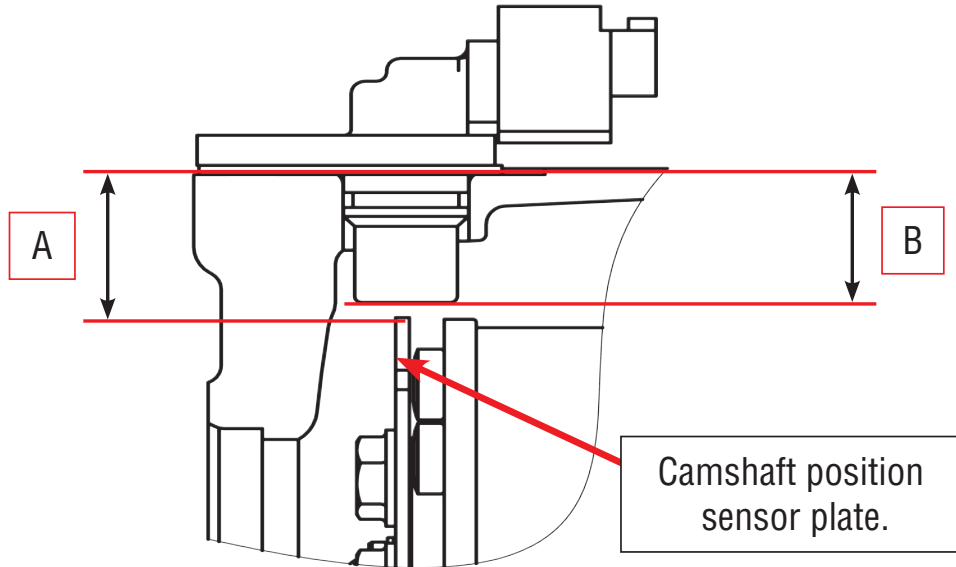
A = Top of timing chain cover to camshaft position sensor plate

B = Camshaft position sensor mating surface to the bottom of the sensor

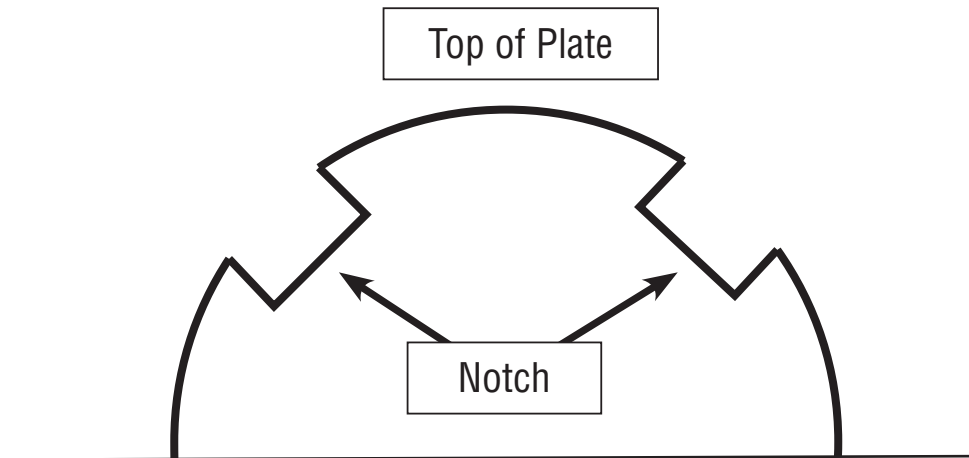
**NOTE:** When measuring “A”, make sure you are measuring to the outside diameter or “top” of the sensor plate and not to the bottom of a notch as shown below. Be sure to record all measurements.

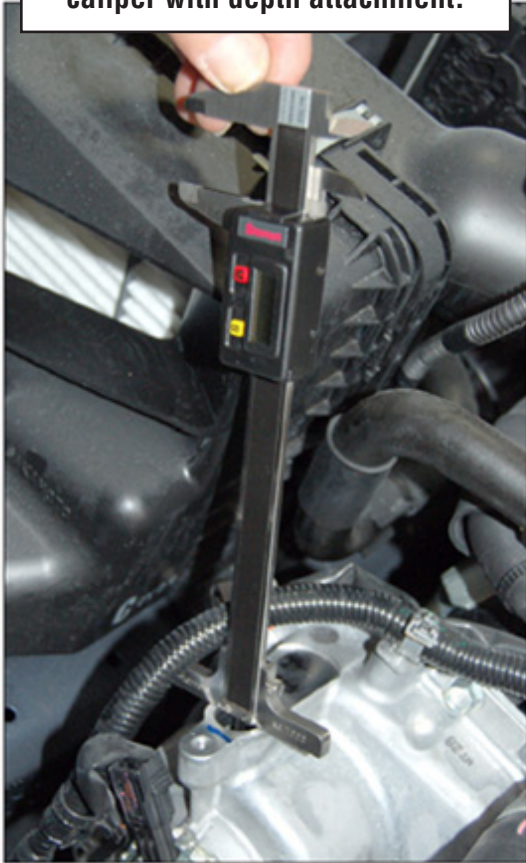
Measurement taken using digital caliper with depth attachment.

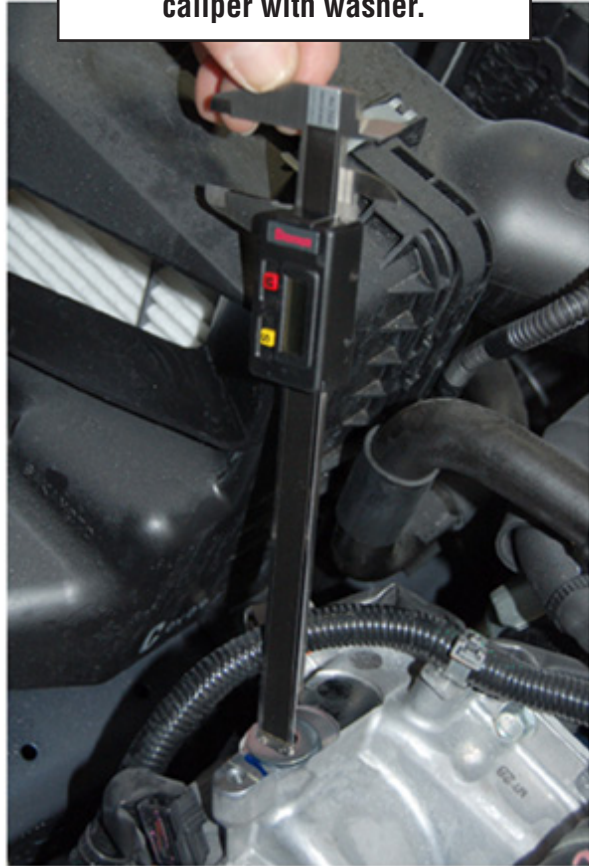
Measurement taken using digital caliper with washer.

**IMPORTANT:** When using the flat washer, make sure the washer is fully seated on the machined surfaces of the timing cover or your measurements will not be accurate.

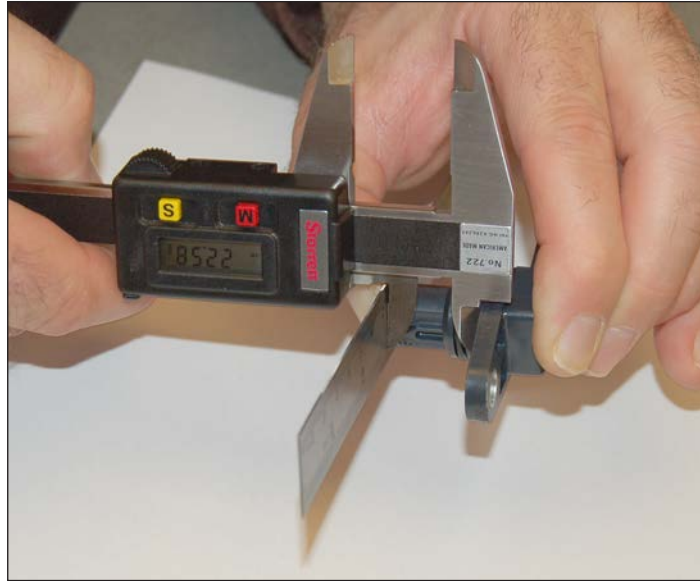
When taking measurement “B”, use a flat steel ruler or equivalent along with the digital caliper.

7. Measure the distance between the camshaft position sensor mounting surface and the bottom of the sensor as shown above.
