From Customer Service Department Subject Starter Ventilation Enhancement

Starter ventilation enhancement.

All Lamborghini Aventador LP 700 Coupe and Roadster MY 12,13 and 14 from VIN CLA0091 to VIN ELA02238.

Campaign Code: L83X-A.04.13

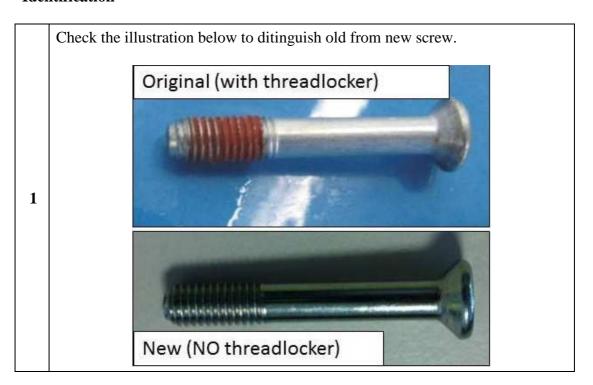
Identification

As a result of continuous product monitoring, Automobili Lamborghini Spa has found that on some vehicles, the starter motor may not crank immediately upon start request.

Replace lower starter motor screw without threadlocker, allowing for better temperature control.
