Service Bulletin

SPECIAL COVERAGE

SUBJECT: Special Coverage Adjustment – Transmission Clutch Wave Plate

MODELS: 2007-2009 Buick Enclave
2008-2009 Chevrolet Equinox, Malibu
2009 Chevrolet Traverse
2007-2009 GMC Acadia
2007-2009 Pontiac G6
2008-2009 Pontiac Torrent
2007-2009 Saturn AURA, OUTLOOK

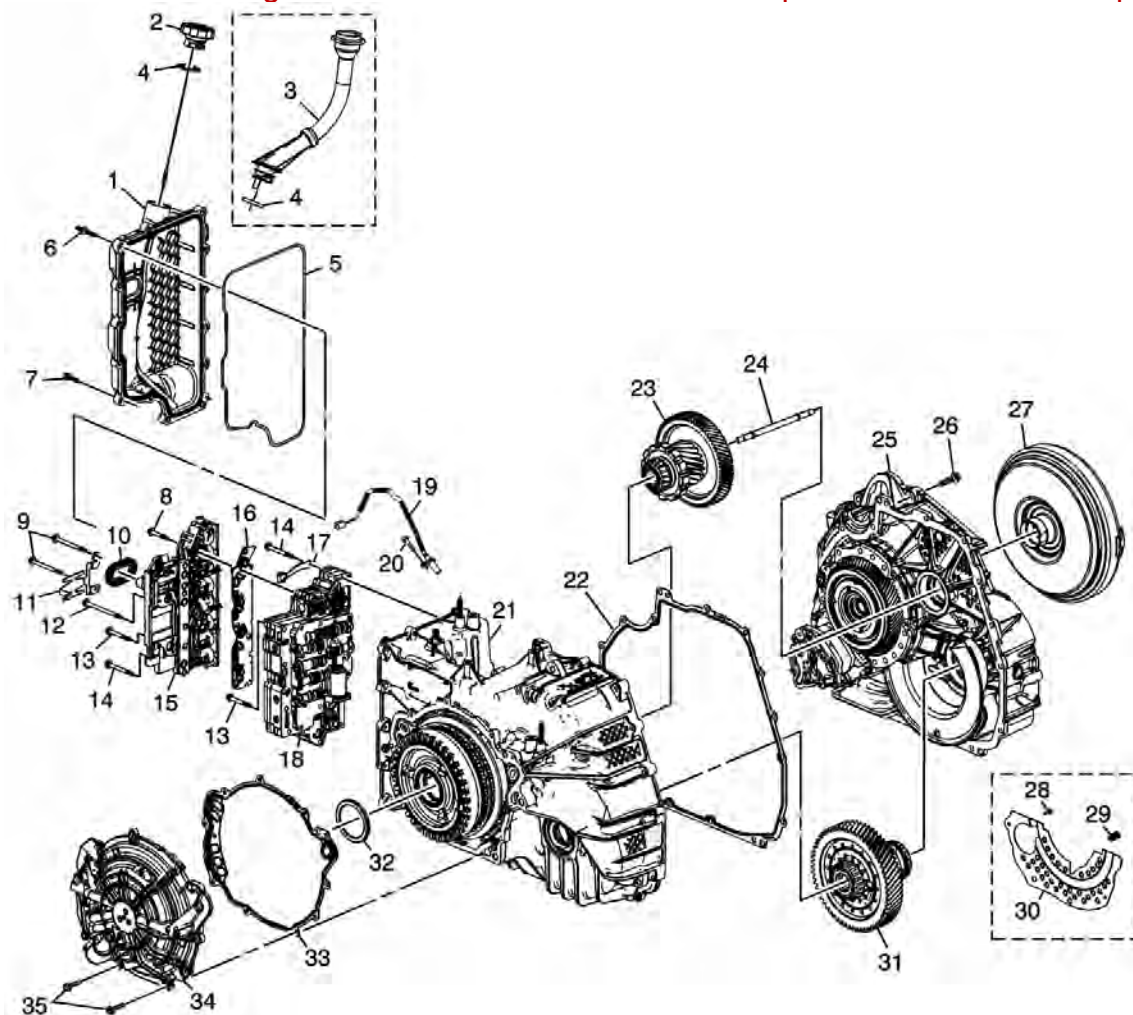
1725874

Note: The control solenoid (w/body and TCM) valve assembly should not be washed in a parts cleaner. The control solenoid (w/body and TCM) valve assembly should not be replaced for any DTC unless SI diagnostics for the DTC have been completed and instruct to replace the part.

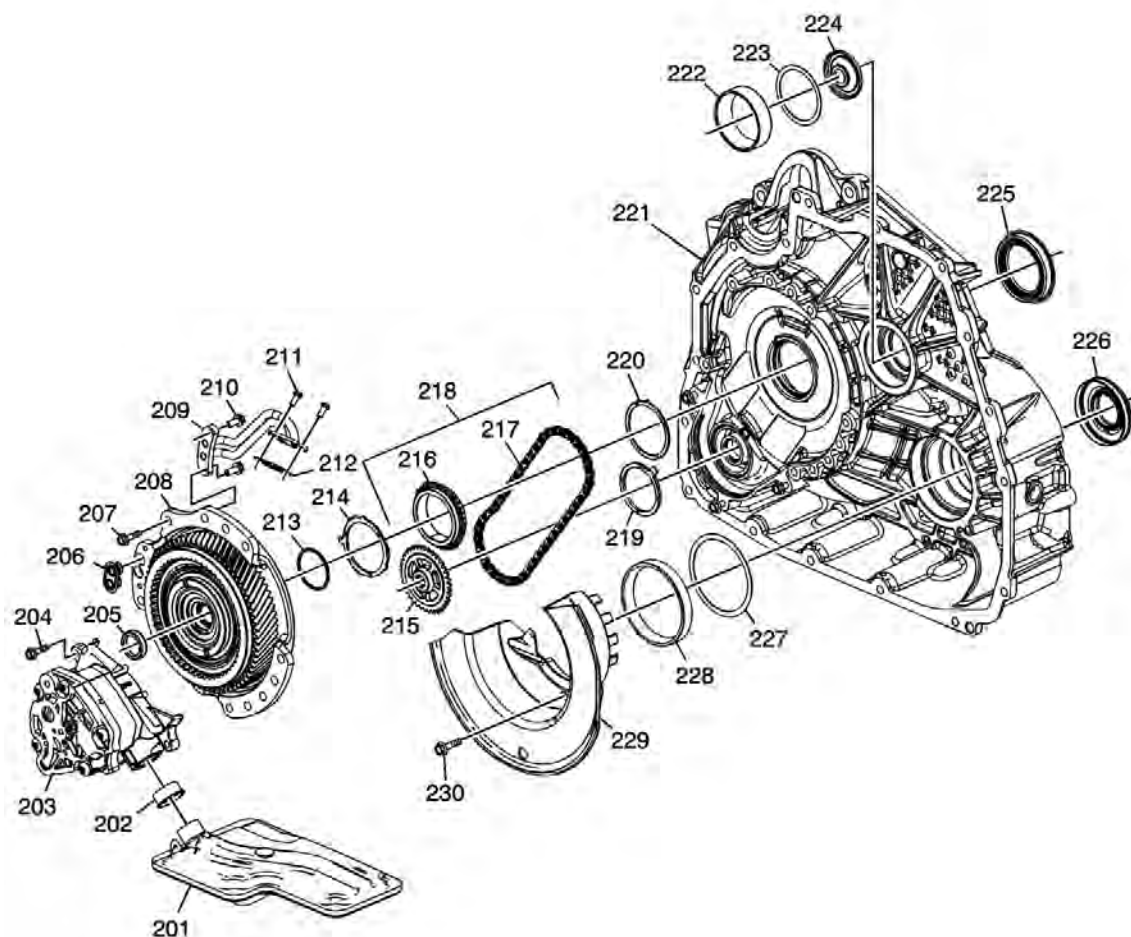
1725882

Note: Debris generated by the condition must be cleaned from the entire transmission and the pump fluid filter (201) and the control solenoid filter plate (16) must be replaced. Failure to separate the case halves, disassemble the transmission, clean the debris and replace the pump fluid filter (201) and the control solenoid filter plate (16) could lead to repeat transmission damage and repairs.

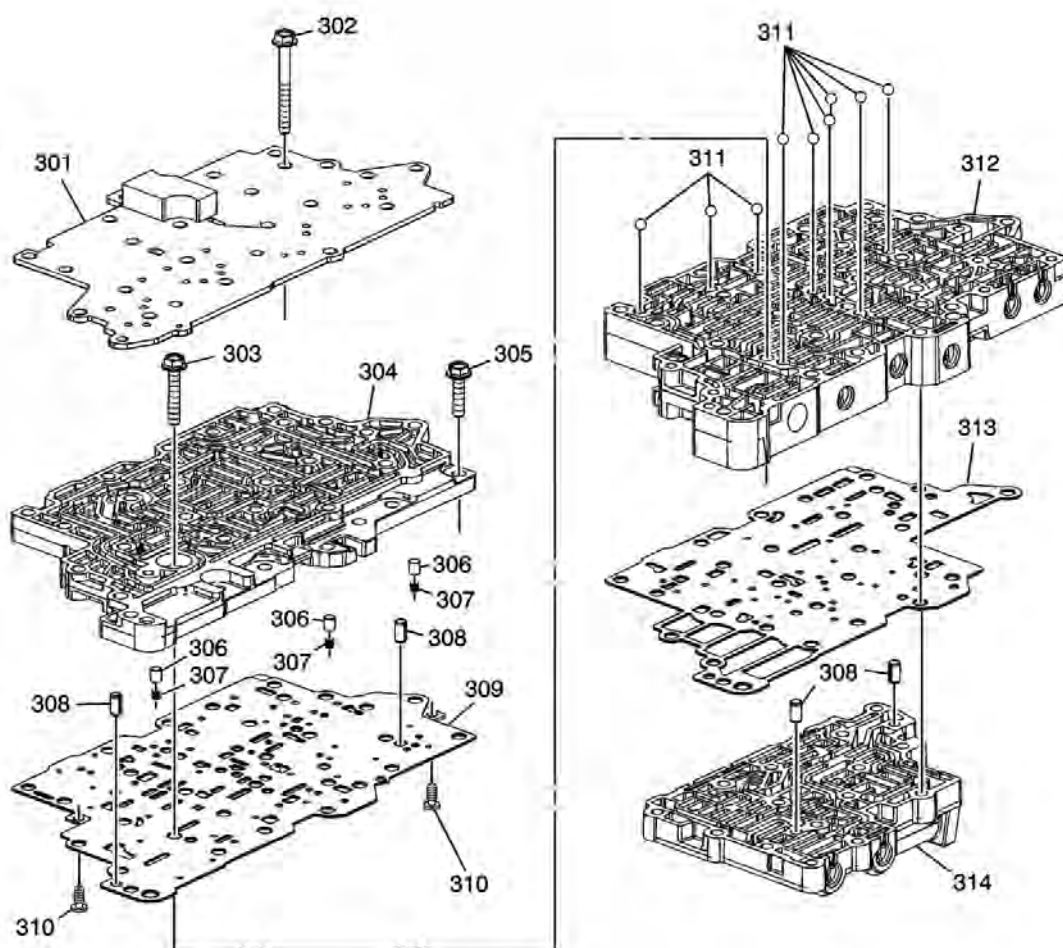
1725885

Note: 2007-2008 applications – when assembling these transmissions, inspect the control valve channel upper plate (301) to make sure that it contains the slot as indicated above. Plates installed that do not include this slot may result in DTCs.
