Service Bulletin

Bulletin No.: PIT5374

Subject: Headlight Performance (BCM Calibration and Bulbs)

Models: 2015 GMC Sierra
2014 GMC Sierra 1500

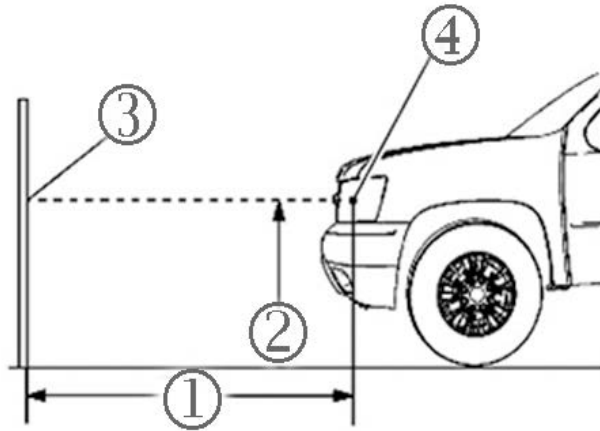
4092121

Note: Floor must be level.

1. Position the vehicle directly in front of the screen or wall at a distance of 25 feet.
2. Remove any snow, ice or mud from the vehicle.
3. The vehicle should be fully assembled and all other work stopped while the headlamp aiming is being done.
4. The vehicle should contain cargo or be loaded to represent normal vehicle use
5. Tires should be properly inflated.
6. Rock the vehicle to stabilize the suspension.
7. Measure from the floor to either headlamp reference mark.
8. At the screen, measure from the floor and place the horizontal tape at the measured height. This establishes the Horizontal Aiming Line.
