Service Bulletin

Bulletin No.: PIT5318

Subject: Wind Buffeting Droan Type Noise And/Or Body Pressure Booming

Models: 2015 Cadillac Escalade Models
2015 Chevrolet Suburban, Tahoe
2015 GMC Yukon Models

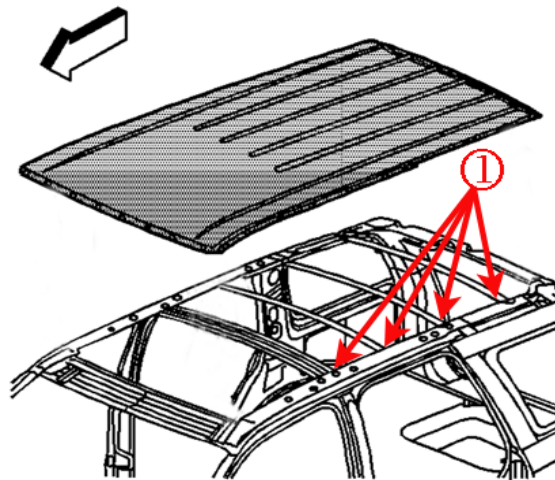
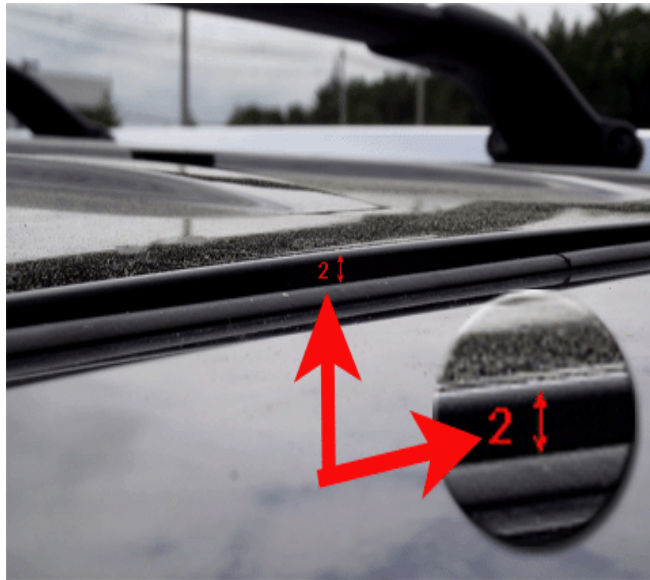
3973293

Some owners may comment of a wind buffeting/droan noise or body/pressure booming (the feeling of pressure in the ears) while driving. The body booming issue may be more noticeable when the engine is in V4 mode. In some cases, they may also notice a water leak from the headliner area, if equipped with a sunroof. These concerns could be caused by the roof sheet metal no longer being attached to the roof bows (1). On trucks with a sunroof, it may be noticed that the rear edge of the sunroof glass is considerably lower than the roof (2). This is due to the roof sheet metal being detached from the roof bow directly behind the sunroof opening (3).

To correct this concern, apply panel vibration control material between the roof bow and roof sheet metal, along with foam shim material when necessary.
