Service Bulletin

Subject: Groan, Squeak or Rubbing Type Noise When Turning Steering Wheel

Models: 2010-2016 Buick LaCrosse
2012-2016 Buick Regal, Verano
2012-2015 Chevrolet Cruze, Volt
2013-2016 Chevrolet Malibu Limited (VIN 1)
2014-2016 Chevrolet Impala

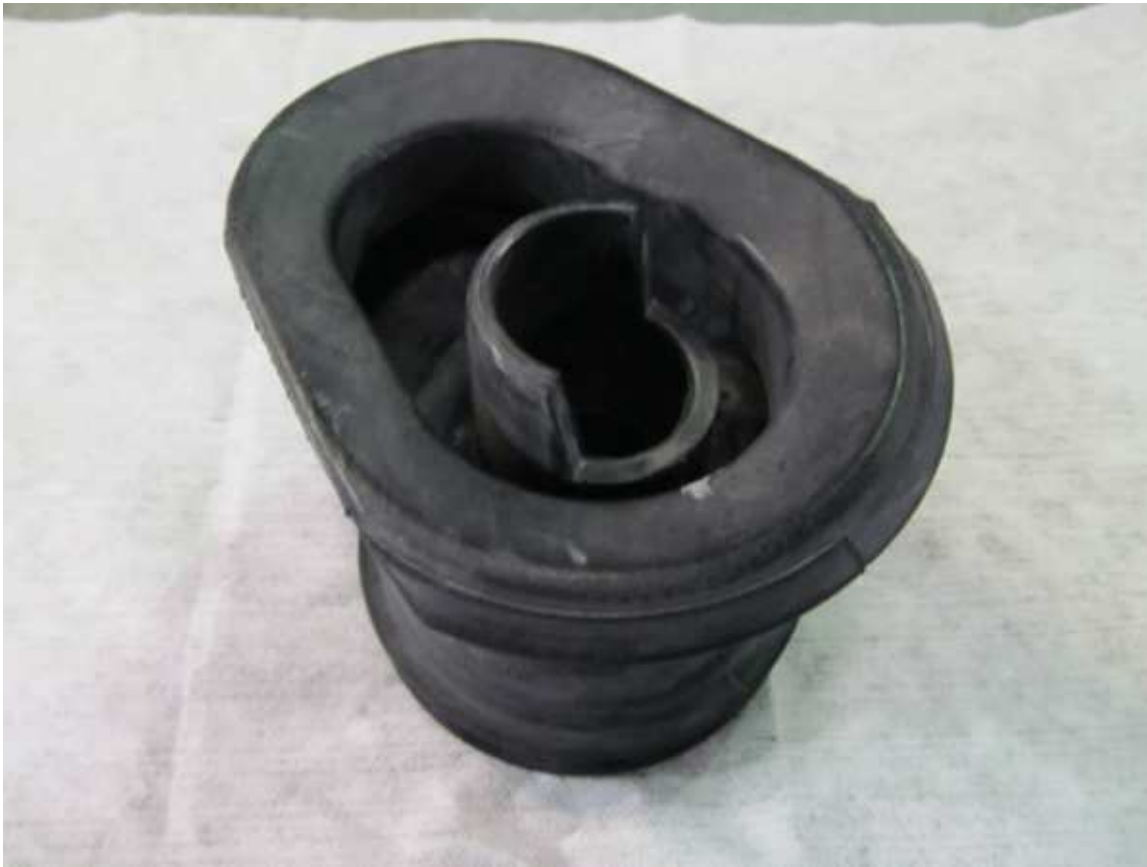
Technicians should inspect the steering column seal for proper installation by repositioning the inner intermediate steering shaft boot assembly to gain access. Inspect the seal at the front of the dash where the intermediate steering shaft passes through from the steering gear. Ensure that the seal is centered in the opening and around the intermediate steering shaft as shown above. If the seal is out of position, replace the steering column seal following the steps below.

1. Remove the intermediate steering shaft lower bolt. Refer to *Intermediate Steering Shaft Replacement* in SI.
2. Remove the inner intermediate steering shaft boot assembly.
