SERVICE BULLETIN

APPLICABILITY: 2015-16MY Legacy and Outback Models

NUMBER: 15-177-14R

SUBJECT: New “Gen 2” Fujitsu Ten (F10) SD Card Audio / Navigation (AVN) System Operating Tips

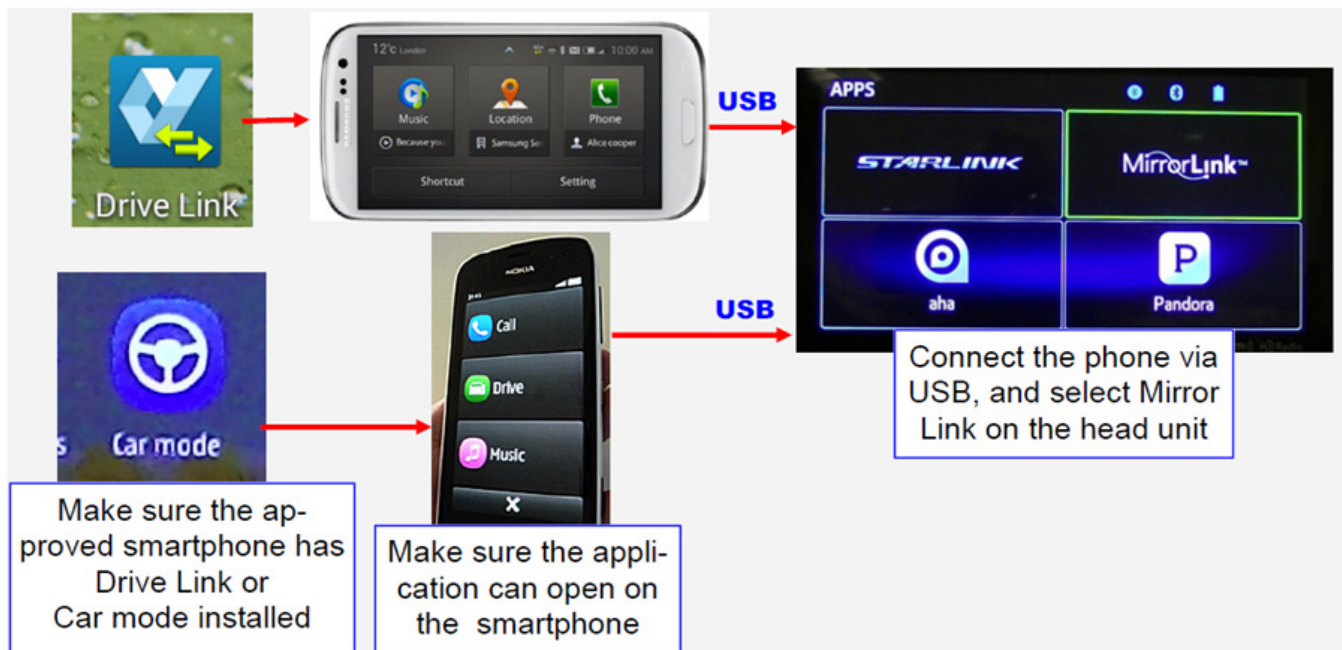
CONDITION #9: MirrorLink does not work with my Samsung or Nokia Smartphone.

- The Smartphone is not compatible with MirrorLink.
- The Drive Link application is not installed on the approved Samsung Smartphone.
- The Car mode application is not installed on the approved Nokia Smartphone.
- The application is not launched or open on the Smartphone.
- The Smartphone is not connected to the head unit with a USB interconnect cable.

- Make sure the Smartphone is compatible with MirrorLink (see Owner Manual Pg. 141.)
- Make sure the “Drive Link” application is installed on the approved Samsung Smartphone (See Owner Manual Pg. 141).
- Make sure the “Car mode” application is installed on the approved Nokia Smartphone (See Owner Manual Pg. 141).
- Once applicability has been confirmed and the application properly installed on the Smartphone, follow the steps below:
 1. Open/Launch the application on the Smartphone.
 2. Connect the Smartphone to the vehicle with a USB interconnect cable.
 3. Press the “APPS” button on the head unit.
 4. Select MirrorLink on the head unit.

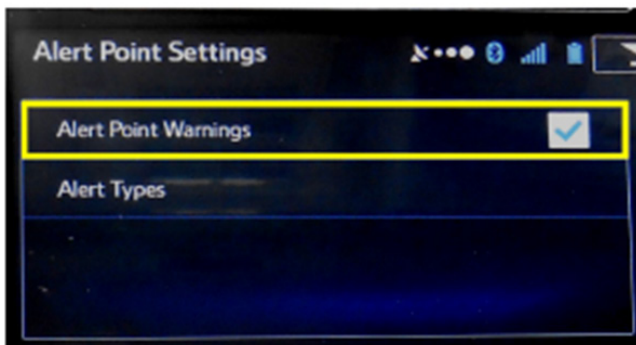
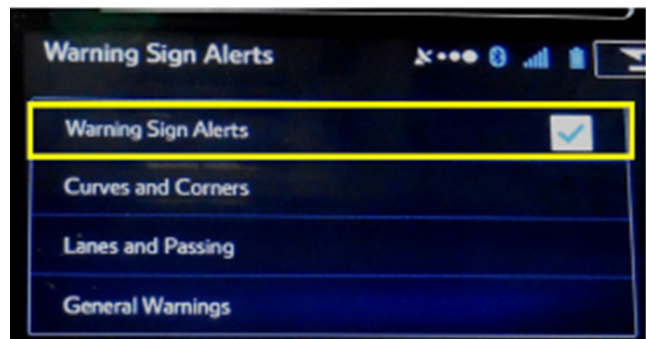
CONDITION #14: A chime is heard while driving.

- If the chime is unnecessary when approaching alert points, disable (uncheck) “Alert Point Warnings” or “Warning Sign Alerts” settings by following the steps below:
 1. Select “Menu” on Map screen.
 2. Select “More”.
 3. Select “Settings”.
 4. Select “Sound and Warnings”.

5. Select “Alert Point Settings” or “Warning Sign Alerts” (see picture below).
6. Disable (uncheck) the settings (press the check mark to “toggle” on / off).

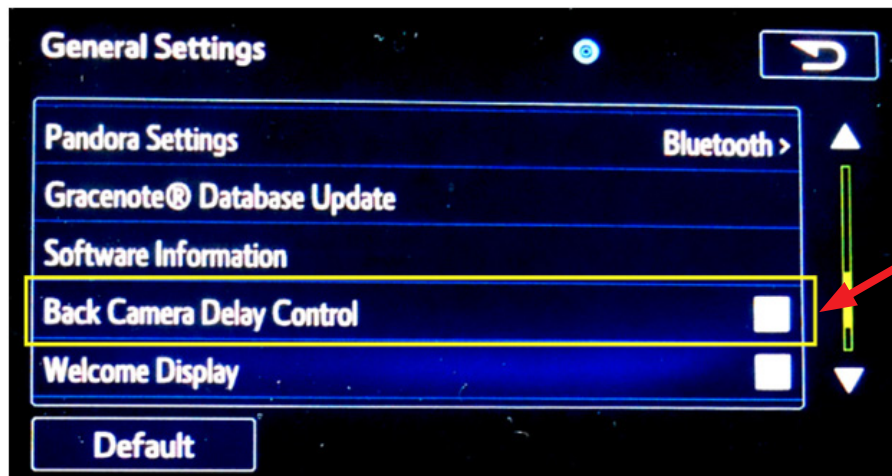
CONDITION #17: Back-up camera image remains displayed after shifting out of Reverse

Disable “Back Camera Delay Control” setting by following the steps below:

1. Touch “HOME” button.
2. Touch “SETTINGS” button.
3. Touch “General”.
4. Unselect the “Back Camera Delay Control”.

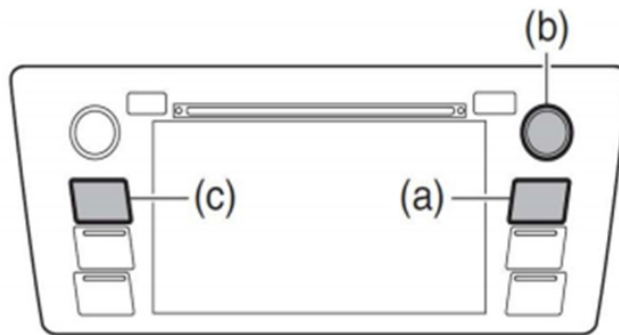
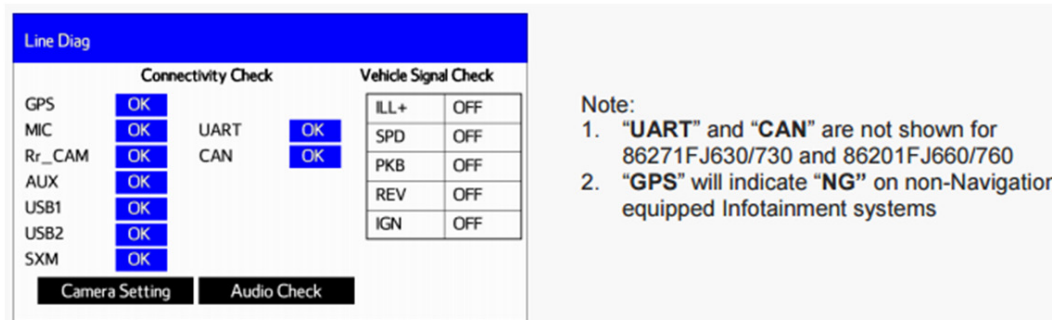
CONDITION #18: When in Diagnostic Mode, AUX, USB1 and USB2 all show as being NG

- Turn the ignition switch to ACC (or press the Engine Start Stop button).
- While pressing and holding the “a” button, press the button “b” twice.

The “Line Diag” screen will be displayed where the connection status of each device is verified.

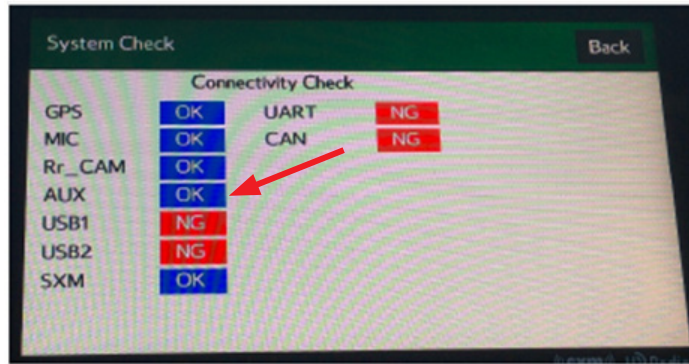
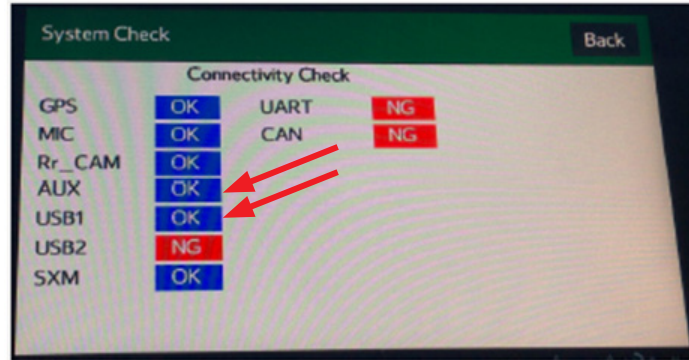
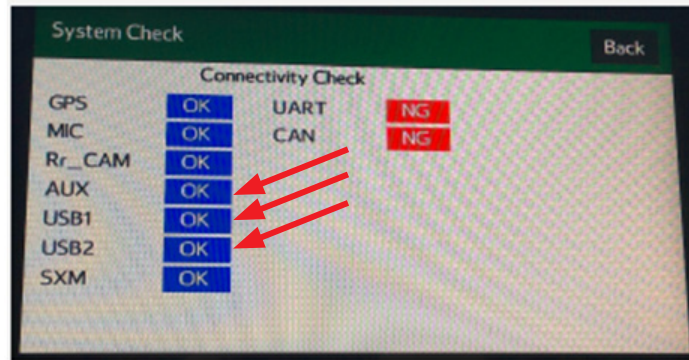
AUX cable & device connected

AUX cable, device & USB device connected

AUX cable, device & 2 USB devices connected

To change the display for AUX from “NG” to “OK” insert an AUX cable connected to a compatible device (e.g. MP3 player) into the AUX port.

To change the display for USB1 and/or USB2 from “NG” to “OK” insert a compatible USB device into the USB port. **NOTE:** you will need to insert 2 USB devices to test both USB ports at the same time.

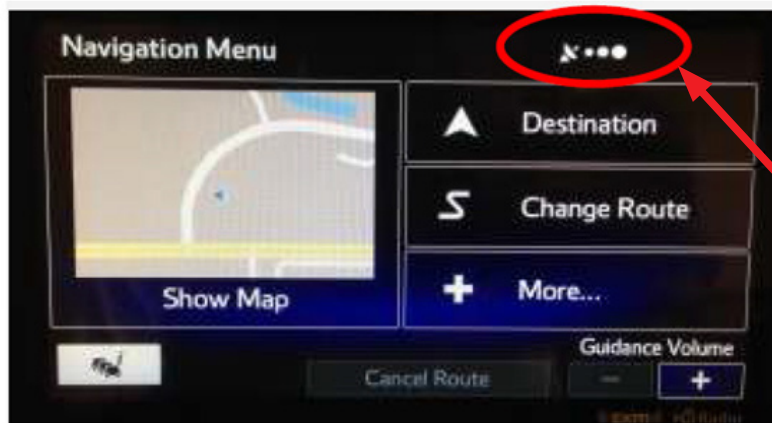
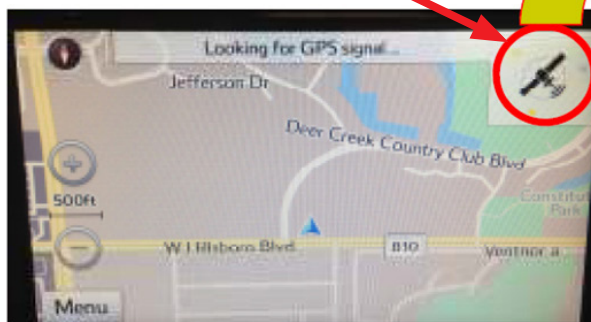
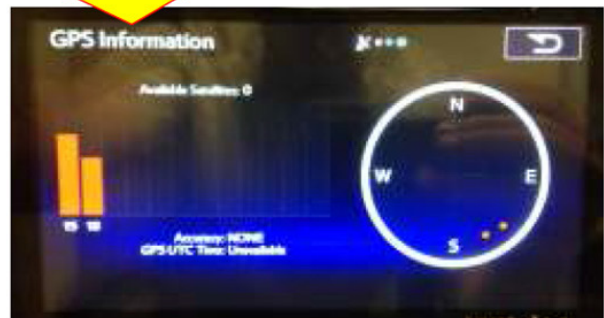
CONDITION #19: Unable to Locate the GPS Information Screen

On the “Navigation Menu” screen, the GPS signal strength indicator is always available at the top right of the screen as shown below. In addition, if the GPS signal strength becomes weak, a Satellite icon will show when the MAP screen is displayed. If this Satellite icon (also a soft key) is pressed, the GPS information screen will be displayed which indicates how many satellites are currently being received along with the accuracy of the GPS signal.

The GPS Signal strength indicator is always available for reference in the upper right of the “Navigation Menu” screen.

If the GPS signal becomes weak, a Satellite icon will appear in the upper right corner of the MAP screen. Touch the icon to show the GPS information.

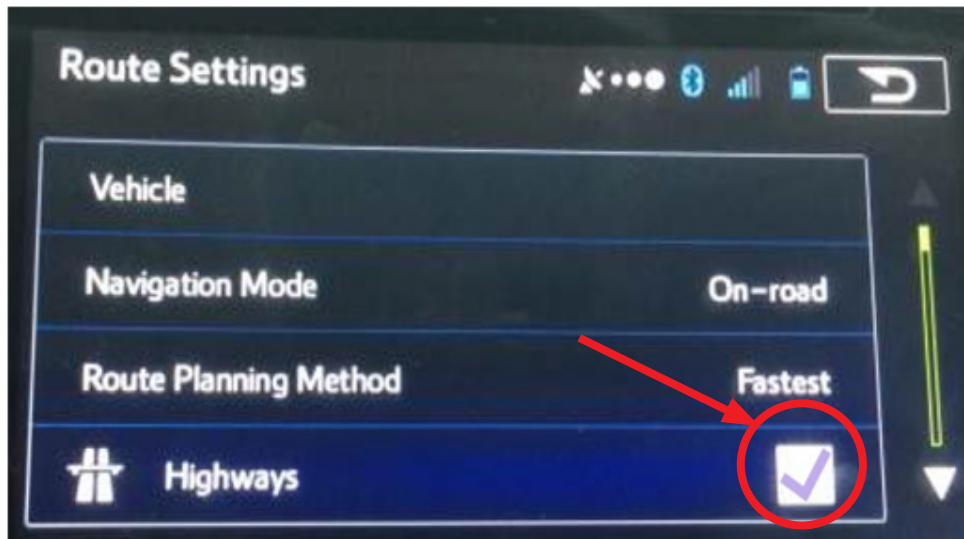
CONDITION #20: The Navigation system often routes the user off the highway, and onto rough surface (dirt / gravel) roads.

- Select “**Menu**” on the Map Screen
- Select “**More**”
- Select “**Settings**”
- Select “**Route Settings**”
- When “**Highways**” is checked the navigation system will always consider using highways first when planning routes.

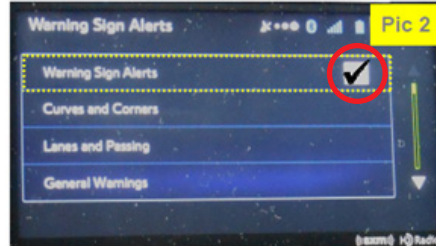
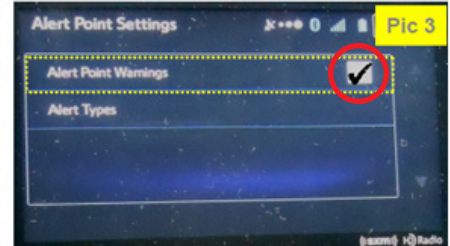
CONDITION #21: When the Speed Limit is displayed, “Alert Signs” are not displayed, even when “Warning Sign Alerts” and Alert Point Settings” are enabled.

Display of the Speed Limit takes priority over Warning Sign Alerts and Alert Point Warnings. If the Speed Limit is being displayed as shown in Pic 1 below, the other warnings will not be displayed.

Speed Limit Displayed

Warning Sign Alerts and Alert Point Warnings are enabled

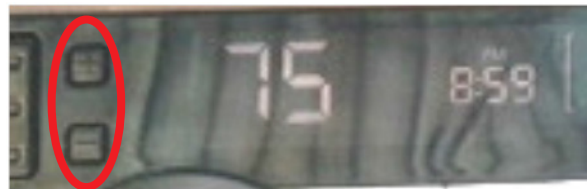
CONDITION #23: The clock display on HVAC panel is incorrect even when “Auto Adjust by GPS” is selected on the Clock settings menu.

1. If the user wants to operate the AVN unit without the map SD card installed and still have the correct time shown on the HVAC panel, access the Clock settings menu, uncheck “Auto Adjust GPS” then manually reset the correct time using “+” and “-” buttons to the left of the clock display as shown below.

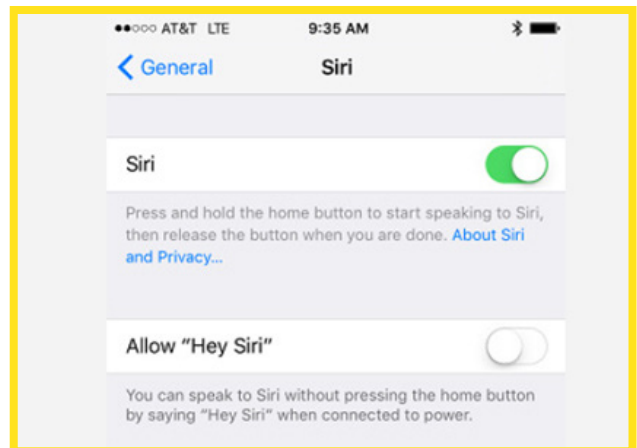
Pic 5

CONDITION #24: Messages are displayed on the screen after pressing / holding the Talk switch on the steering wheel to activate Siri (2016 MY vehicles equipped with Gen 2.1 Navigation / Display Audio system).

1. Go to “Settings”
2. Select “General”
3. Select “Siri”
4. Enable “Siri” (Pic 5)

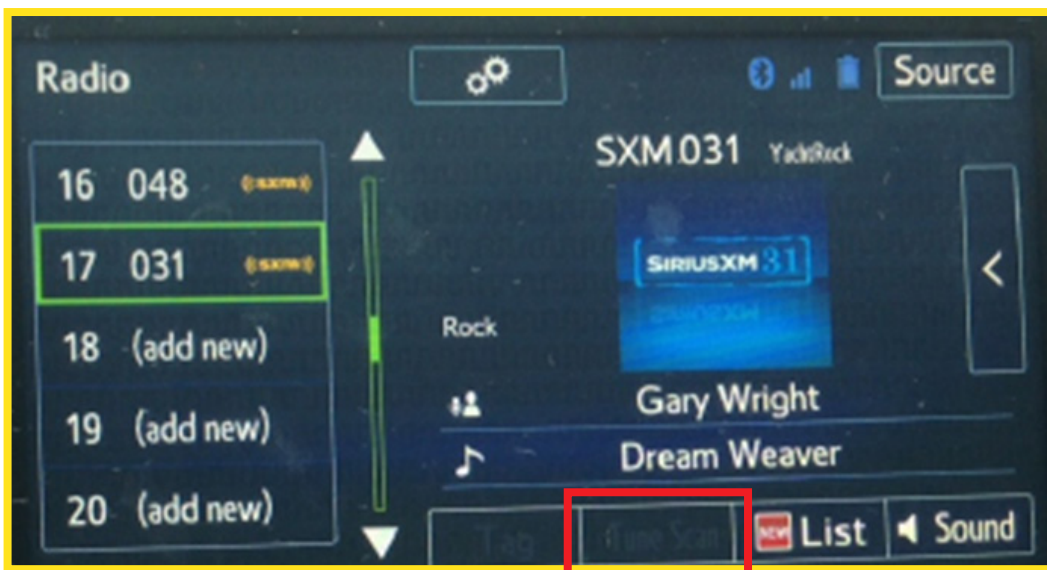
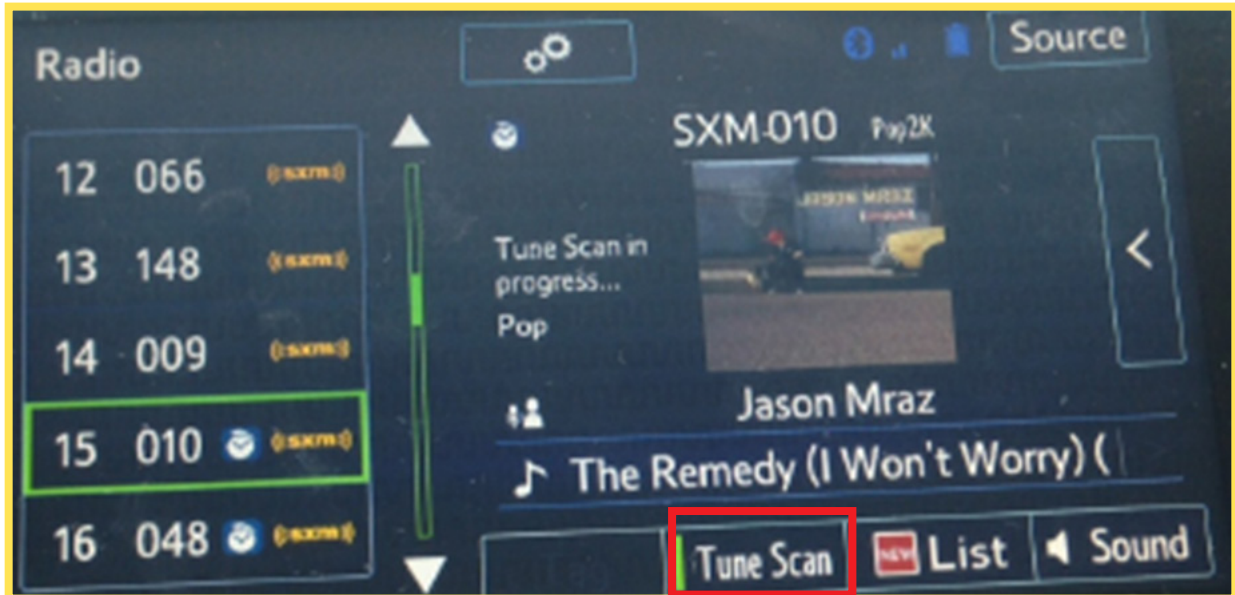
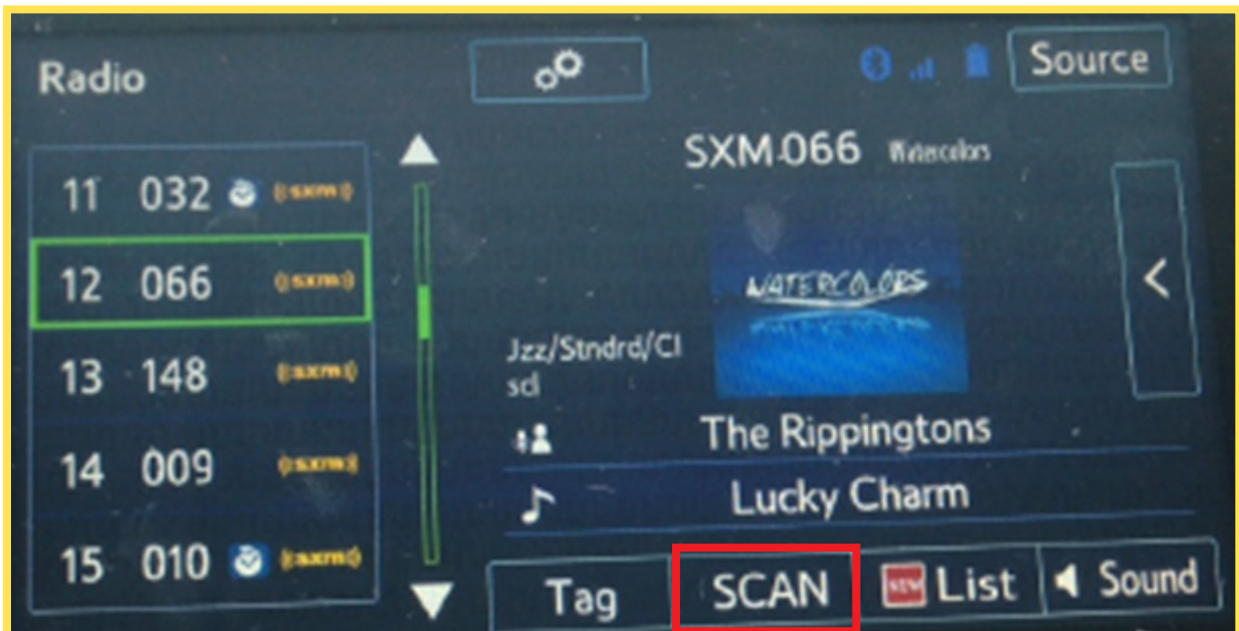
CONDITION #25: The “Tune Scan” feature is unavailable (2016 MY vehicles equipped with Gen 2.1 Navigation / Display Audio system).

1. Make sure the user has set some of the SXM preset channels as “Smart Favorites”. See CONDITION #22 of this TSB for more information on setting up Smart Favorites
2. Wait for content to be cached to the unit (this may several minutes).
3. After the unit has been able to cache the start of a song from one channel, the “Tune Scan” button will activate on the display.

YES: Pressing the button will activate “Tune Scan”

NO: Check to see if the user has any SXM presets setup as “Smart Favorites” (See Owner’s Manual pg. 75 for more about “Smart Favorites”)

Are SXM preset channels stored as “Smart Favorites”?

YES: Wait for several minutes after the unit has received SXM signal for the “Tune Scan” button to become available.

NO: Store SXM preset channels as “Smart Favorites” then wait for several minutes after the unit has received SXM signal for the “Tune Scan” button to become available.

If the “SCAN” is in place of the “Tune Scan” button, press the button to turn on the “Tune Scan” option.

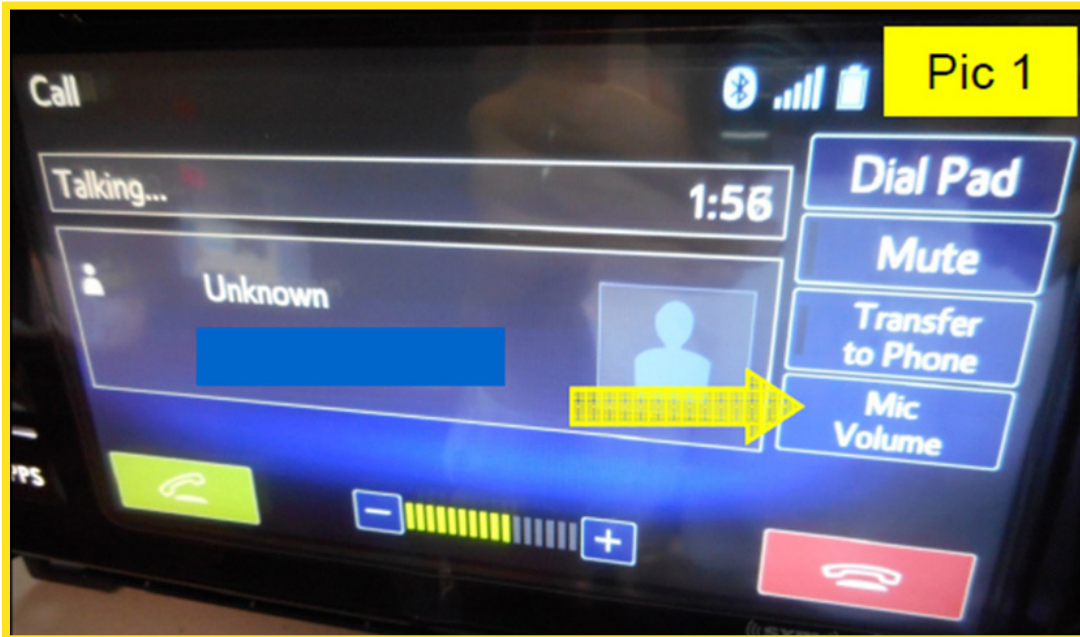
CONDITION #26: Bluetooth hands-free outgoing voice quality is poor. Call recipient cannot understand the caller in the car clearly.

1. Access “Mic Volume” function by touching the soft key during a hands-free call (**Pic1**).
