Subject: RATTLE NOISE FROM FRONT DOOR GLASS	Bulletin No: 09-016/15
	Last Issued: 05/18/2015

2013-2016 CX-5

2014-2016 Mazda6

2014-2016 Mazda3

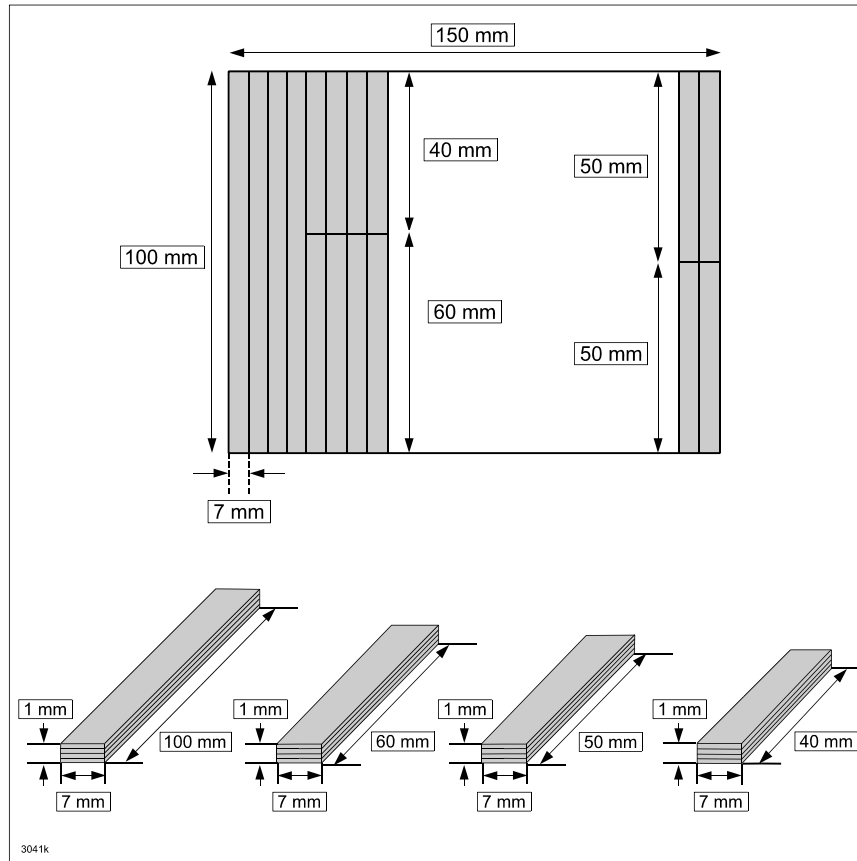
A: Attach the specified size of non-woven pad.

X: A non-woven pad or a resin foam has already been attached to this position so it is not necessary to attach.

2. Cut non-woven pads to size for position(s) according to vehicle type listed below (mass production change level).
 - a. Obtain the 0.25 mm thick pad from the Noise Parts Set.
 - b. Using a straight-edge and sharp knife, cut the pad into the sizes necessary for the vehicle repair, then stack the 4 pieces on top of one another to create a pad 1 mm thick.
