### TECHNICAL SERVICE BULLETIN

SUBJECT:			No: <b>TSB-07-13-003REV</b>
<b>WHISTLE NOISE FROM ENGINE COMPARTMENT</b>			DATE: <b>April, 2007</b>
			MODEL: <b>2007 Raider 3.7L</b>
CIRCULATE TO:	<input type="checkbox"/> GENERAL MANAGER	<input checked="" type="checkbox"/> PARTS MANAGER	<input checked="" type="checkbox"/> TECHNICIAN
<input checked="" type="checkbox"/> SERVICE ADVISOR	<input checked="" type="checkbox"/> SERVICE MANAGER	<input checked="" type="checkbox"/> WARRANTY PROCESSOR	<input type="checkbox"/> SALES MANAGER

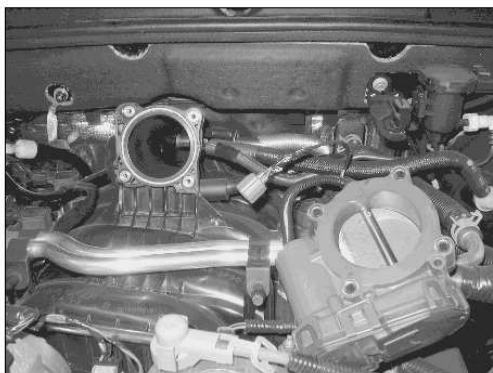
► A slight **high frequency (pitch)** whistle-like sound may be heard while driving at any ambient temperature or engine temperature. The noise is most noticeable under load, with light throttle between 1,200 to 2,000 RPM.

4. Remove the four throttle body mounting bolts. Then remove the throttle body from the intake manifold and place to the side.
5. Check the condition of the throttle body-to-intake manifold o-ring and replace if necessary.
6. Clean mating surfaces of throttle body and intake manifold.

7. Apply a **small diameter bead (about 1 mm)** of RTV to the intake manifold-to-throttle body joint, **inboard of the o-ring**. The RTV is to be applied to the lower section of the joint between the lower two throttle body bolt attachment holes as shown.

8. Reinstall the throttle body. Tighten the four attachment bolts to 60 in lbs (7 Nm).
9. Wipe off all excessive RTV from the inside of the joint.
10. Reinstall the air intake tube at the throttle body.
