Techline News

Contents

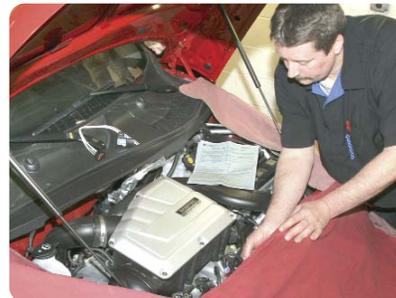
The MAP sensor in the intake manifold and the TMAP sensor in the duct between the intercooler and intake manifold are replaced with two new TMAP sensors. The fitting on the kit TMAP sensor is different from the OEM sensor and requires a different O-ring.

TIP: The O-rings in the kit are identical to the blue O-rings used on fuel injector tips.

TIP: On the HHR SS, it is necessary to modify the TMAP sensor before installing into the intercooler duct, following details in the instruction sheet.
