Fuel Contamination in Returnless Fuel Systems

GM TECH *Link*

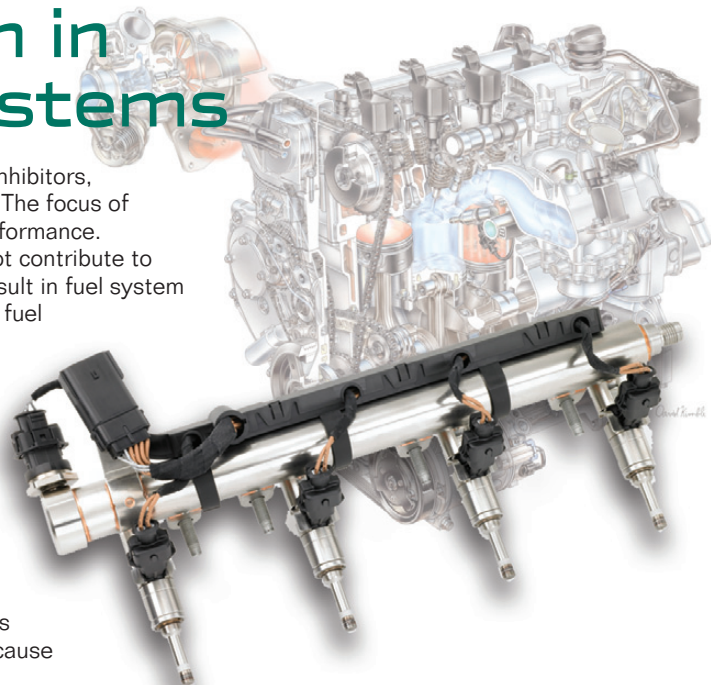
Modern returnless fuel systems also were developed to lower emissions. By not returning hot fuel from the engine to the fuel tank, the internal temperature of the fuel tank is reduced, lowering evaporative emissions. But since the returnless fuel system does not have a fuel return line that returns fuel back to the fuel tank, it is easier for fuel contaminants to become trapped in the fuel rail and cause engine misfires and other performance conditions.

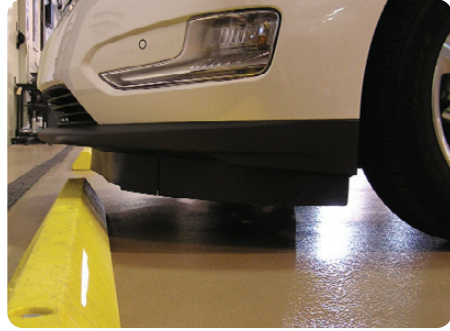
The 2011 Volt features a low front bumper fascia air deflector that is designed to direct airflow around the vehicle, improving fuel economy. Some owners may be concerned about the low ground clearance of the front air deflector and that it contacts the ground on short inclines.

A shorter front bumper fascia air deflector (part number 20993998) with a higher ground clearance is now available for service. The shorter air deflector brings the ground clearance up to 125 mm (4.9 in) from the original clearance of 95 mm (3.7 in).

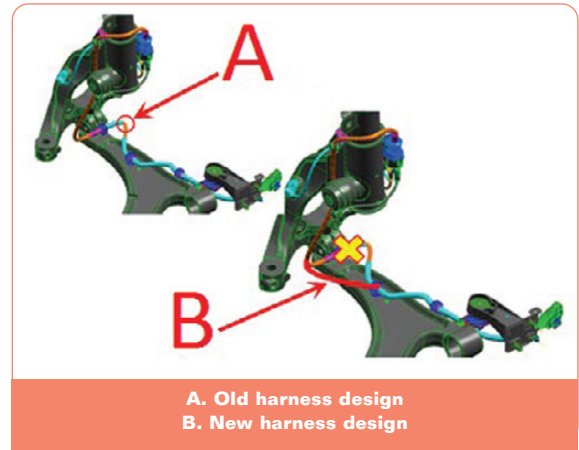
Check the harness to either the left front or right front acceleration sensor and/or damper actuator, which may be wearing on the drive axle or any of the front suspension components. Circuits may also become open due to flexing of the harness at the knuckle attaching clip.

If this condition is present, replace the front wheel speed sensor harness at X113 for the left side and at X114 for the right side. Make sure the new harness is routed properly to prevent further contact from occurring. The new harness is shorter and does not attach to the steering knuckle.
