ARTICLES CONTAINED IN THIS ISSUE

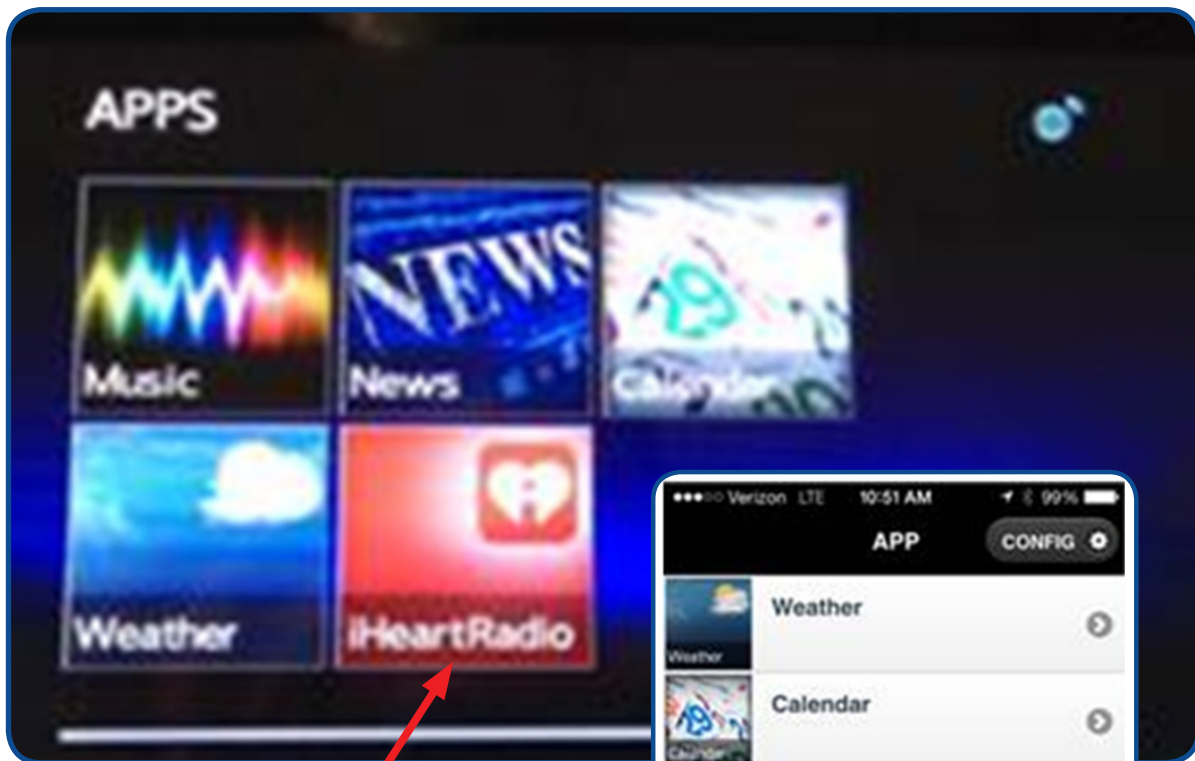
Should you receive a customer inquiry about not being able to see the iHeartRadio app on their phone as a selectable choice after downloading STARLINK, here's the reason why. If the customer goes into the Settings menu of their phone **before** pairing it to the vehicle, although the iHeartRadio icon will be displayed on the audio unit, it will not be displayed on their phone until **after** pairing is complete. Once pairing has been completed, all five applications displayed on the audio unit will be selectable from the phone's Settings menu. Although chances of this situation happening are slim, should it arise (after confirming the Starlink app has been downloaded to the phone), simply pair the phone, open the Starlink app and all five applications should be selectable from that point forward

Audio Unit Display Showing
iHeart Radio Icon

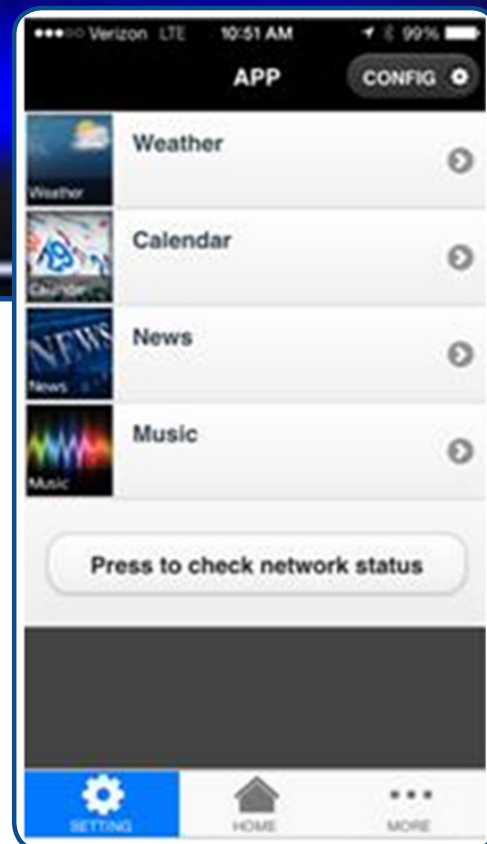
Phone Display Prior to Pairing
