## ARTICLES CONTAINED IN THIS ISSUE

CODE	ARTICLE.....	PAGE
(00)	March STIS New Releases .....	9
(01)	QMR of the Month.....	1
(01)	QMR of the Month Award Presentations.....	2
(01)	Calling the Techline Revisited ..	3
(02)	FA and FB Engine Crank Sprocket Timing Mark - Important Reminder .....	4
(07)	Identifying Electrical Harness Connectors .....	5
(07)	Electrical Diagnosis and Aftermarket Equipment .....	7
(12)	Fuel Door Freeze-Up .....	8

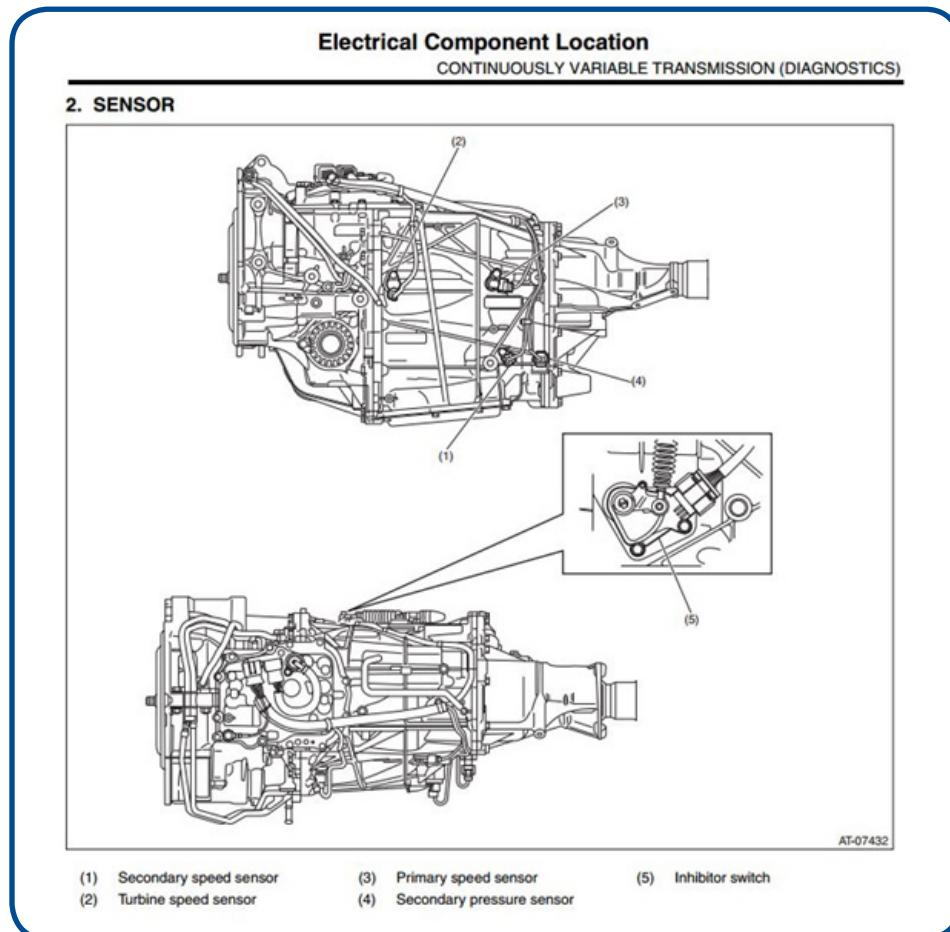
The Electrical Component Location (term is also searchable) chart also comes in handy with identifying the location of the specific component you are diagnosing. (This illustration ties in with the DTC P0716 referenced in this article's example).

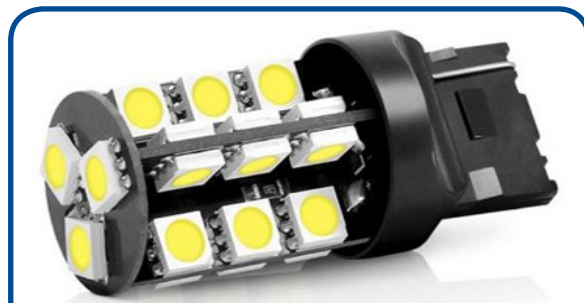
Replacement LED Bulb (7440, Red) (7440CR) by Lumen®, Bulb. 27-LEDs bulb, 360 degree light output. Increase the output of your vehicle lights for safety and style with replacement LED bulbs that are fitted to install easily in the original light sockets without modification. **CAN Bus compatibility** ensures no flickering, bulb out warnings, check engine lights or other data loop errors on modern vehicles so equipped. 1-year manufacturer warranty. Replaces the following bulb types: 992.

**“CAN BUS compatible” versions typically \$20 or more.**

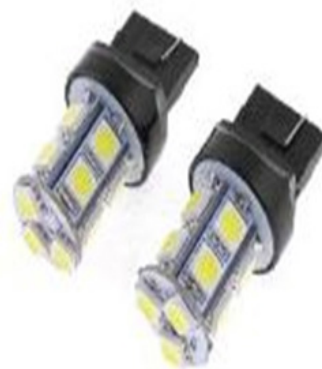
Typical LED bulbs without a resistor, Non-CAN BUS compatible, sell for \$4

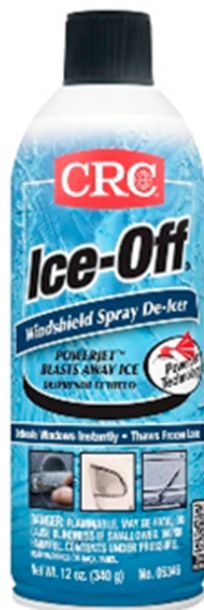
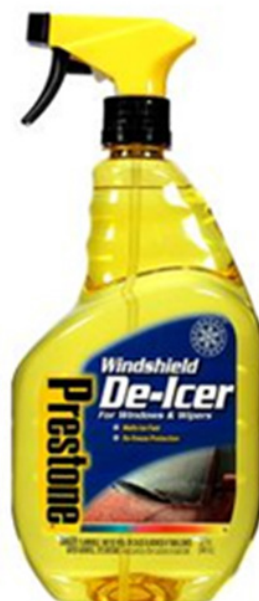
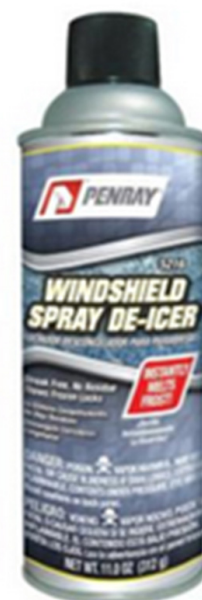
We have received a limited number of reports regarding fuel doors freezing shut and / or inoperative inside release mechanisms, especially in cold weather. The cause is water droplets accumulating at the bottom of the saucer portion and freezing to the filler door flap as shown in the photos below.

Either a CAREFUL “tap” with the side of your closed hand to break the ice or application of a spray de-icer product directly onto the indicated area of fuel door has provided good results in restoring normal operation. Spray de-icer products like those shown in the example photos below are readily available at major retail outlets and are all specifically described as being safe for application directly onto the vehicle finish.
