### ARTICLES CONTAINED IN THIS ISSUE

CODE	ARTICLE.....	PAGE
(00)	STIS New Releases .....	11
(01)	QMR of the Month .....	1
(01)	QMR of the Month Award Presentation .....	2
(01)	QMR of the Month Program Update .....	2
(01)	Subaru University .....	3
(05)	Abnormal Noise Diagnosis .....	4
(07)	Bluetooth Pre-Call Worksheet .	5
(11)	DTC P0171 Diagnostics .....	5
(12)	Interior Rear View Mirror Separation Reminder .....	6
(15)	Auto Dimming and Home Link Accessory Mirror Wiring Harness Troubleshooting – A Reminder .	7
(15)	Microphone Not Working? Check the Telematics System .	11

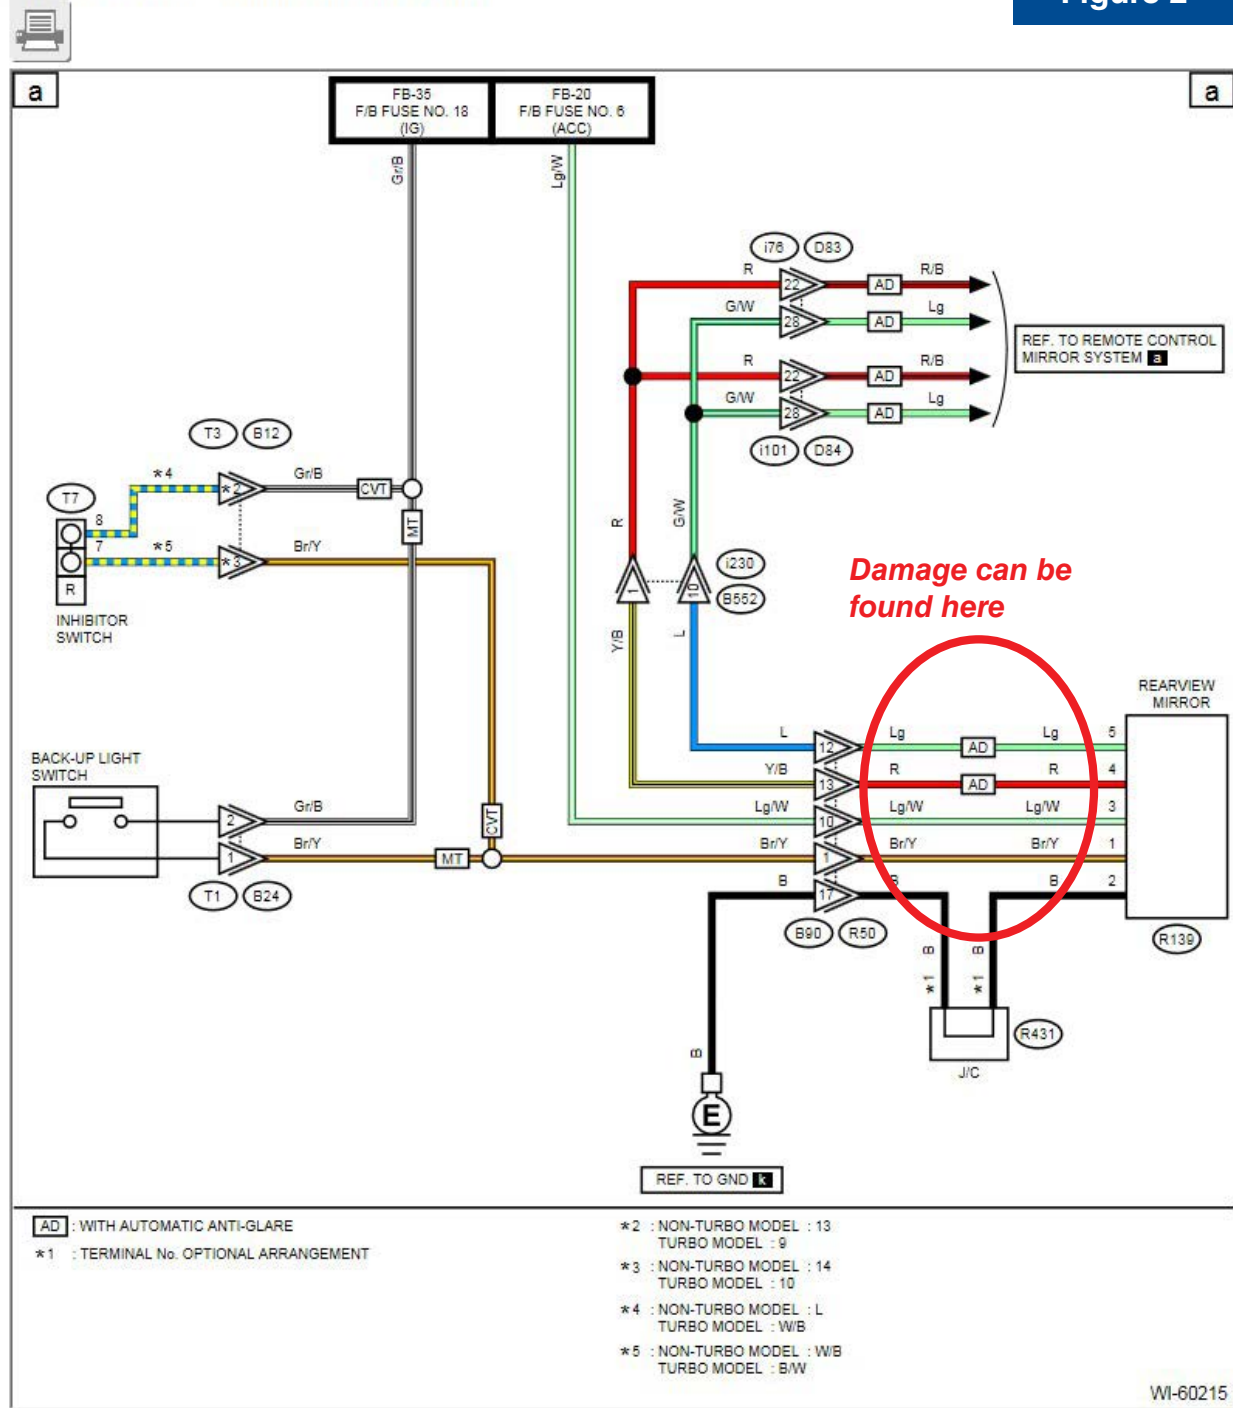
Figure 2

If you are diagnosing an electrical fault on a vehicle, do not forget to check all of the associated systems involved with the circuit in question. One example would be inoperative back-up lights and back-up camera on a 2016 Forester with a short to ground in power supply circuit **FB-35**. Check if the vehicle is equipped with the Auto Dimming and Home Link accessory mirror. If equipped, there is a possibility when the map light or Eye Sight® panel was reinstalled, the wiring harness may have been pinched if not routed correctly. **Figure 1** shows a damaged wiring harness in this case.

Multiple components could be affected on this 2016 Forester if the roof harness or Auto Dimming and Home Link accessory mirror harness is damaged. Reviewing **Figure 3** shows that any component on the reverse light circuit could be affected. Another symptom of this damage, shown in **Figure 5**, can be found in TSB 15-173-14 which is applicable to the 2014-2015 Forester models. Information found in this bulletin highlights damaged exterior auto dimming mirrors with approach lighting caused by a short to ground in the interior auto dimming mirror harness.
