## ARTICLES CONTAINED IN THIS ISSUE

## 12 2015MY LEGACY / OUTBACK SEAT HEATER OPERATION OVERVIEW

## 13 PAINT CONDITION ON HOOD – MOISTURE STAIN

## 15 2019 FORESTER REMOTE ENGINE START CHANGES AND PRECAUTIONS

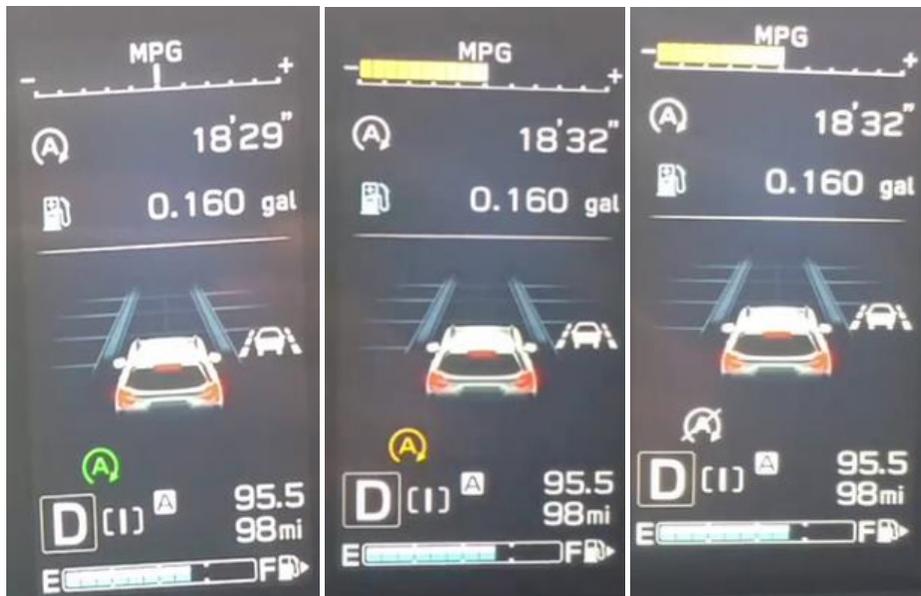
When the Automatic Start-Stop System is engaged, the system icon in the instrument cluster illuminates in green. When the Automatic Start-Stop System is turned off, the icon illuminates in amber. When a malfunction is detected, the amber icon blinks. When Automatic Start-Stop System enable conditions are not met, the white icon with crossed line illuminates.

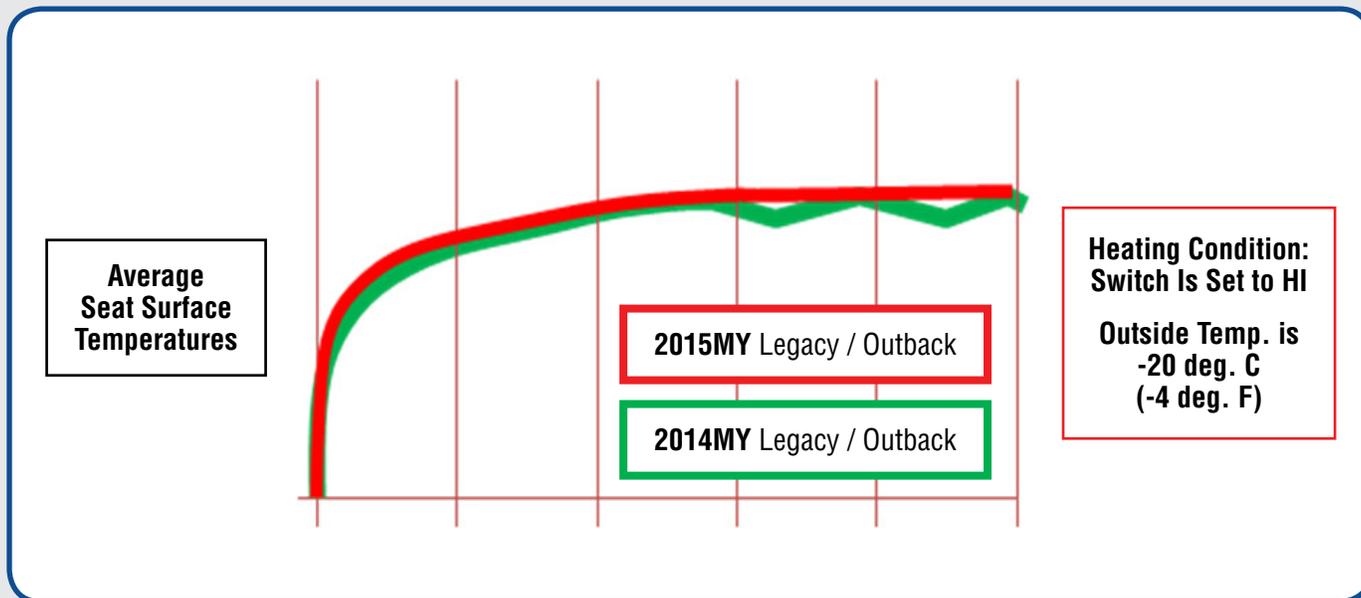
In comparison, the thermistor sensor used in the new system also cycles on and off but, the operating range (temperature difference) is much smaller with a slightly lower upper limit temperature. The new system turns on the element until the thermistor sensor determines approximately 38 degrees C (roughly 100 degrees F) then cycles the element off until the temperature (at the thermistor) reaches approximately 37 degrees C (roughly 98 degrees F) before the element cycles on again, yielding only an approximate 2-degree range. As you can see, the upper and lower temperature range on the new system is significantly reduced. However, this is an apples and oranges comparison as the actual seat temperature felt is very similar. As you can see on the chart below, the average surface temperature of the front seat for each system ends up being very close. The RED line on the graph shows the temperature on front seat surface of the new 2015MY Legacy / Outback while the GREEN line represents the previous model year. You can see the fluctuations of the previous system have been virtually eliminated and the temperature stability enhancement the new system provides.

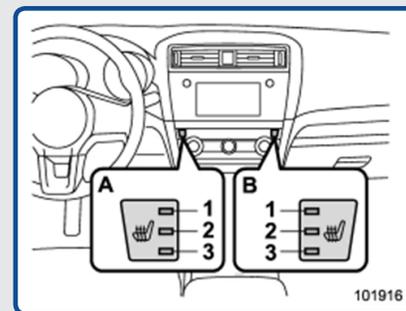
There are three levels of front seat heating available for 2015MY Legacy and Outback, HIGH (1), MID (2) and LOW (3). The difference among these modes is an upper limit temperature change of about 2 to 4 degrees C. Similar to the older system the speed at which the seat actually heats up varies with the level settings. The high setting will heat the seat the quickest, mid will increase the temperature more gradually and low will increase it at the slowest rate.
