SPECIAL EDITION

10 2020 OUTBACK/LEGACY COCKPIT GEN1 INFOTAINMENT SYSTEM: HELPFUL OPERATING TIPS

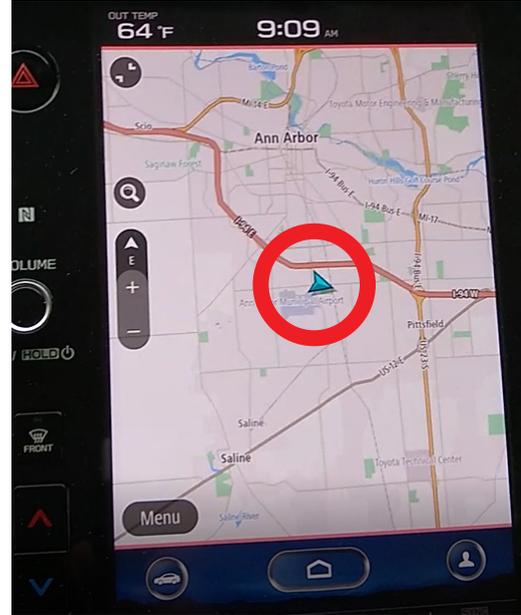
Normal Operation
(map icon is blue/green)

After the PDI Fuse is moved, the GPS starts receiving a signal to update the map to the current location. As soon as the GPS receives the current location, the map icon will turn cyan (blue/green) and the clock resets.

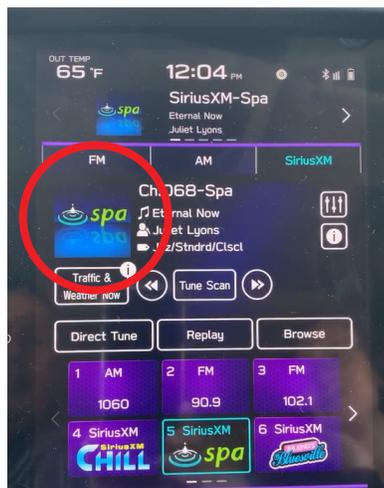
Artwork is displayed when stopped or parked

It is a normal characteristic for the SXM station artwork to disappear from the Cockpit Gen1 (CP1) Gen4 infotainment system CID when the vehicle is in motion.

Please explain to customers this is a normal operating characteristic intended to reduce distraction. Replacing the head unit will not change this characteristic.

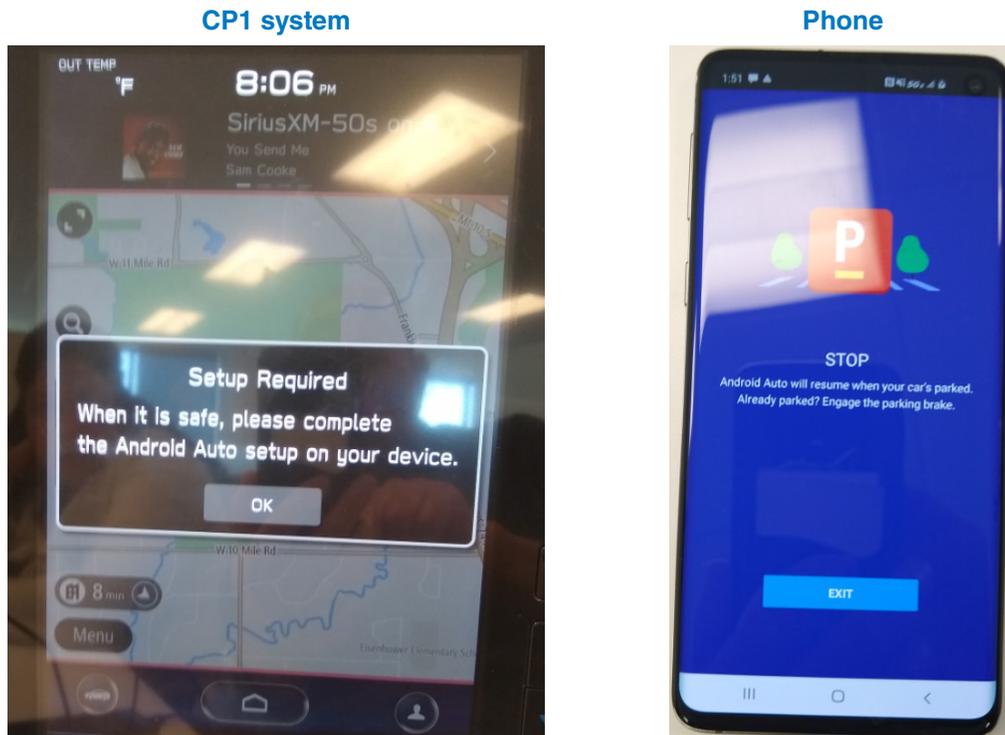
Android Auto launch

NOTE: The vehicle has to be parked and the parking brake (EPB) has to be on, in order to complete initial pairing process between the Cockpit Gen1 (CP1) Gen 4 infotainment system and a phone running Android Auto application. When connecting a phone to the USB port, please follow the messages displayed on CP1 CID and the phone. See below an example.

It is a good practice to confirm an undamaged genuine cable to connect the phone as well as the phone is properly set up to accept connection with a new vehicle.
