SPECIAL EDITION

TROUBLESHOOTING AND IDENTIFYING USB TYPES WITH TECHLINE RECOMMENDATIONS

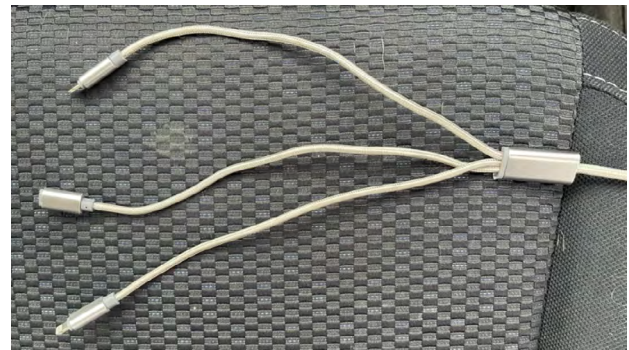
- E. Techline, Android and Apple do not recommend any cable with multiple tails, typically labeled “3 in 1” charging cords. These should not be used in projection apps and may not charge the phone if the total draw exceeds the rating on the USB hub.

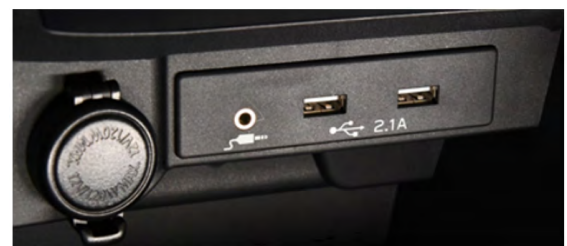
At this time most Subaru model have the maximum power output labeled on the USB port. TSB [15-226-18](#) can be referenced on certain models.
