### Articles Contained in this Issue

## 01 UNDERSTANDING POWER SUPPLY

## 15 All Vehicles Equipped With CP 1.5, Auxiliary Port Noise

## 15 Repairing STARLINK Telematics DTCs

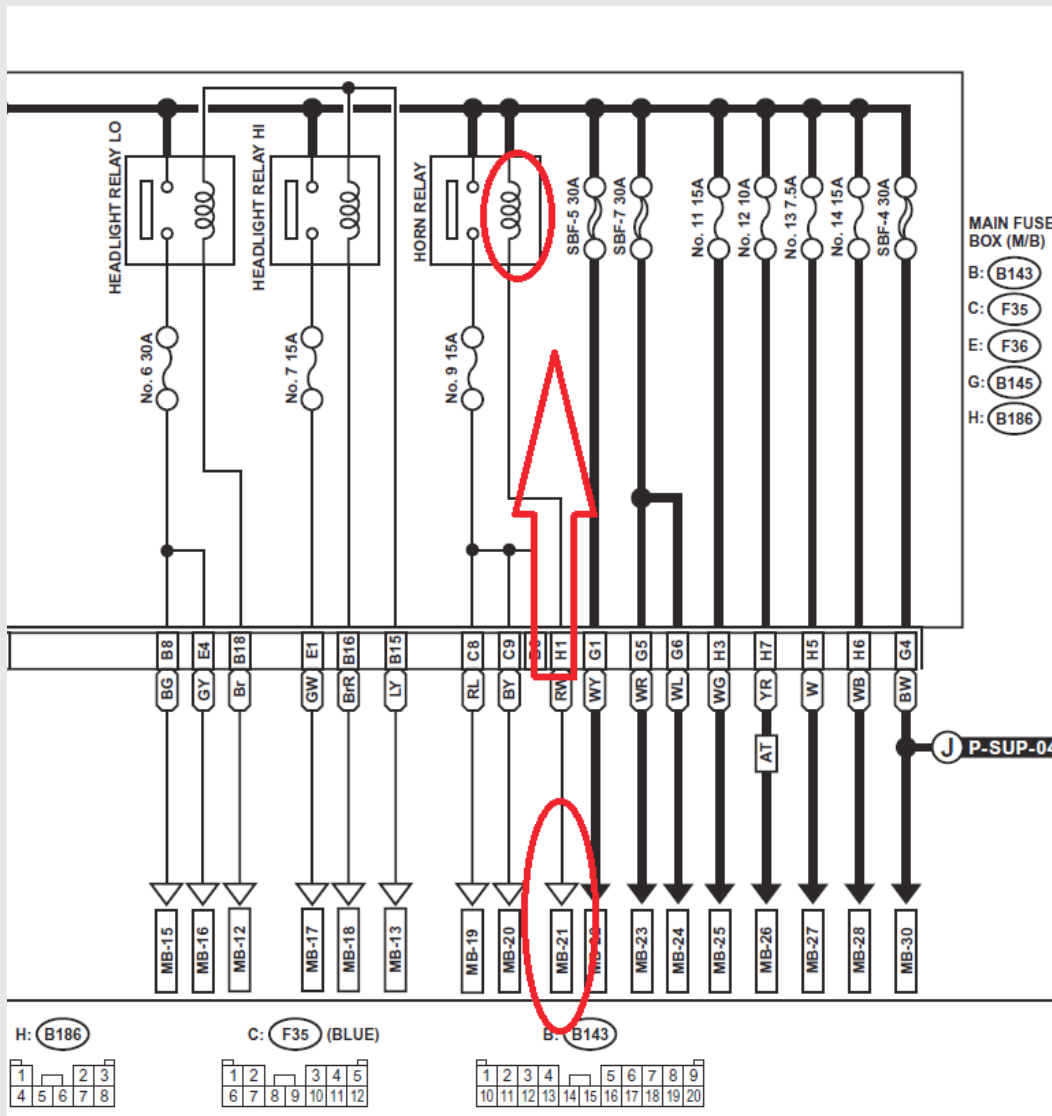
A quick review of the Power supply reveals all three affected circuits are on MB-21. MB-21 is supplied power by the horn relay. A continuity check on the coil side of the horn relay yielded a faulty horn relay.

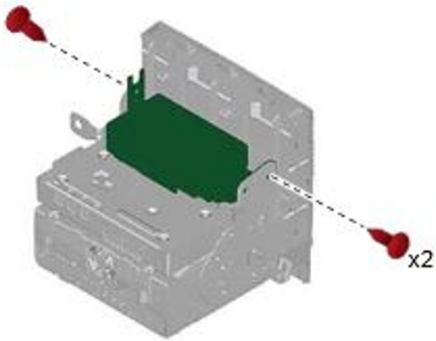
Techline has received calls about identifying a newly implemented device for the door lock system. The battery Backup Unit was implemented into vehicles outlined in the chart below. The Backup Unit provides power to the door locks in the event of a collision that disables the standard 12v power source. When the vehicle receives a strong impact, all the doors and the rear gate are automatically unlocked, to prevent passengers from being trapped. The device is mounted above or near the Audio Unit in most cases. Please refer to STIS for specific model removal/installation, and inspection.

**NOTE:** When the ignition is turned on, the capacitor in the device is charged for 90 seconds.
