Applies To: **2004–07 TL** – ALL
2008 TL – From VIN 19UUA....8A000001 thru 19UUA....8A009070

September 6, 2007

Driver's Side Vent Rattles While Driving

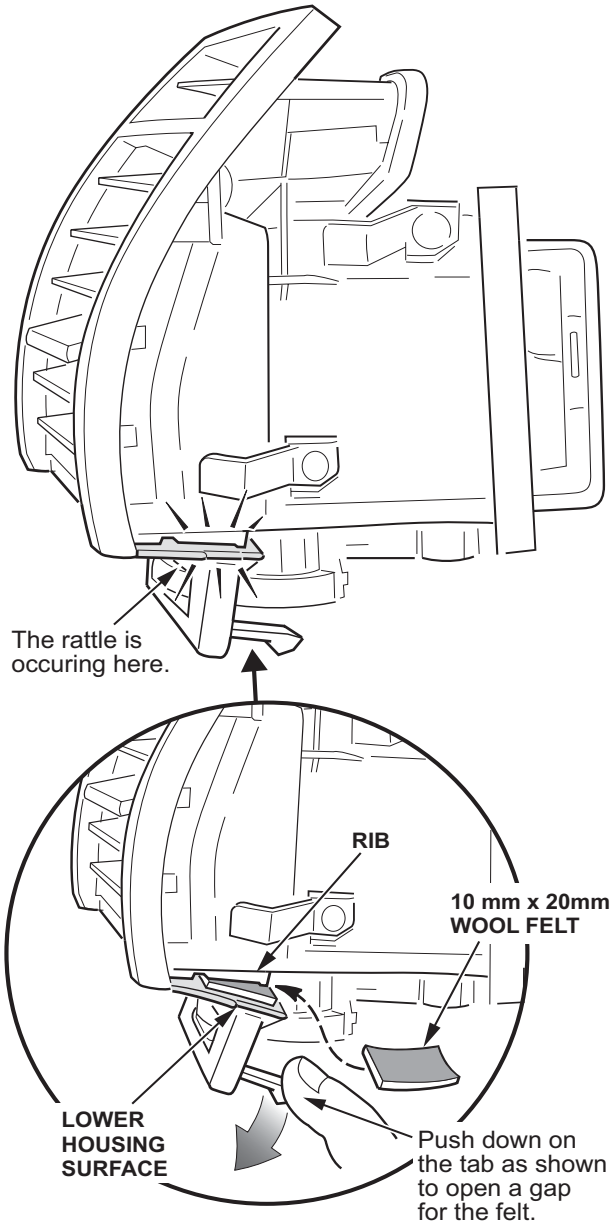
The vent's lower rib vibrates against the lower housing.

1. Remove the driver's dashboard lower cover:
   - Refer to the Body section of the appropriate service manual, or
   - Online, enter keyword **LOWER DASH**, and select **Driver's Dashboard Lower Cover Removal/Installation** from the list.
2. Remove the driver's side vent:
   - Refer to the Body section of the appropriate service manual, or
   - Online, enter keyword **DASH SIDE**, and select **Dashboard Side Vent Removal/Installation** from the list.
3. Cut a 10 mm x 20 mm piece of wool felt.
4. Gently rotate the aluminum trim downward about 1.5 mm (.059 in.), and slide the wool felt under the rib.

NOTE: Apply the felt so the adhesive backing faces down against the lower housing surface.
