## 2016-2017 MX-5, 2016-2017 CX-3, and 2016-2017 CX-9 - Blind Spot Monitoring (BSM) System Change (Update)

The 2016-2017 MX-5, 2016-2017 CX-3 and 2016-2017 CX-9 BSM system vehicle detection has changed. Although the overall function is the same as previous vehicles, vehicle detection is different. Below is brief BSM comparison between the 2016-2017 MX-5/CX-3/CX-9 and other Mazda vehicles. For detailed BSM system information, refer to Service Highlights.

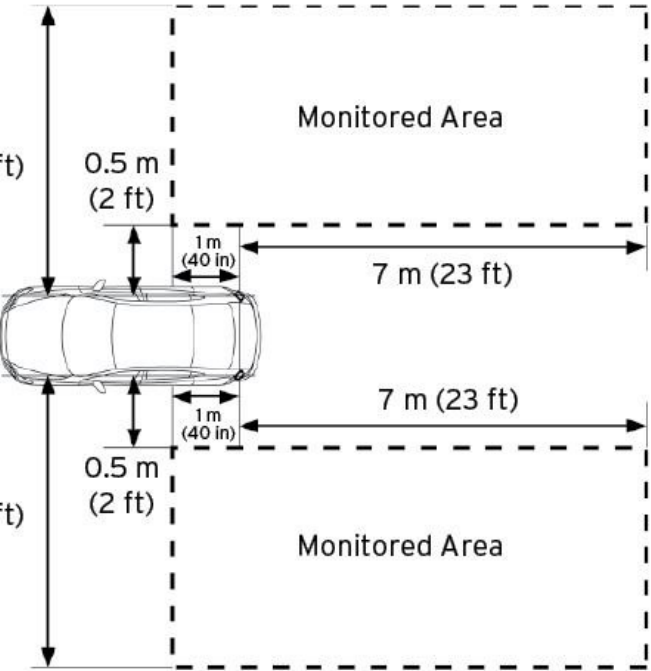
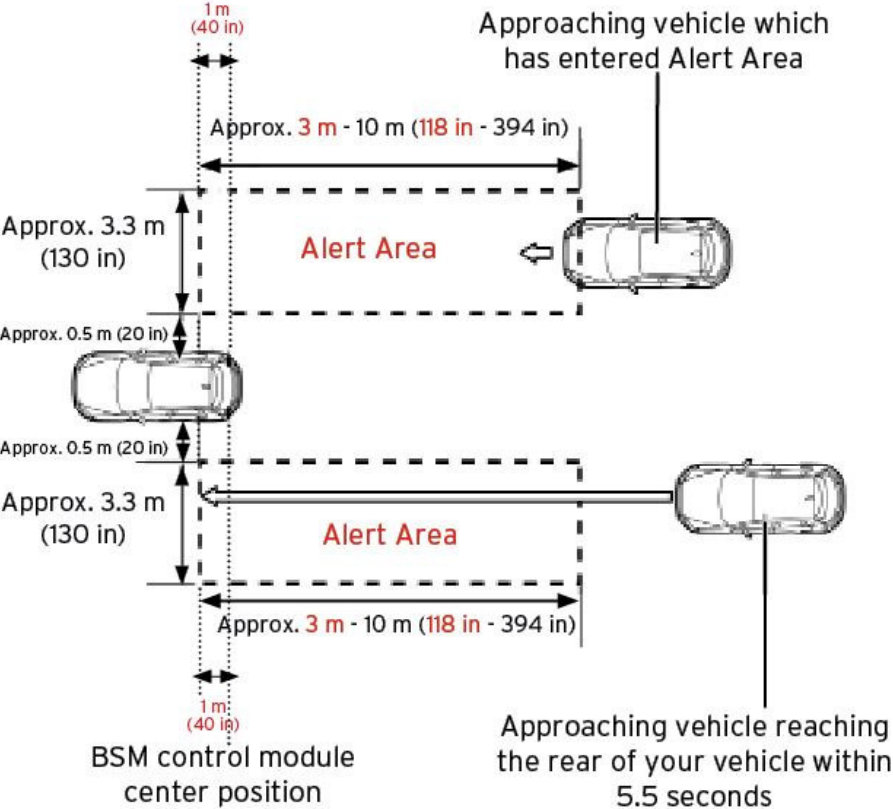
Other Mazda Vehicles Equipped With BSM	2016-2017 CX-3, 2016 MX-5 and 2016-2017 CX-9*
Detection area behind vehicle	7 m (23 ft)	<ul style="list-style-type: none"> <li>• 50 m (164 ft)</li> <li>• Within 5.5 seconds of vehicle approaching from rear</li> </ul>
Vehicle Detection

BSM Indicator OFF

- No vehicle detected in the MONITORED AREA
- High speed difference with vehicle in the MONITORED AREA.

- No approaching vehicle in the ALERT AREA
- Vehicle in the ALERT AREA is cruising at a lower speed

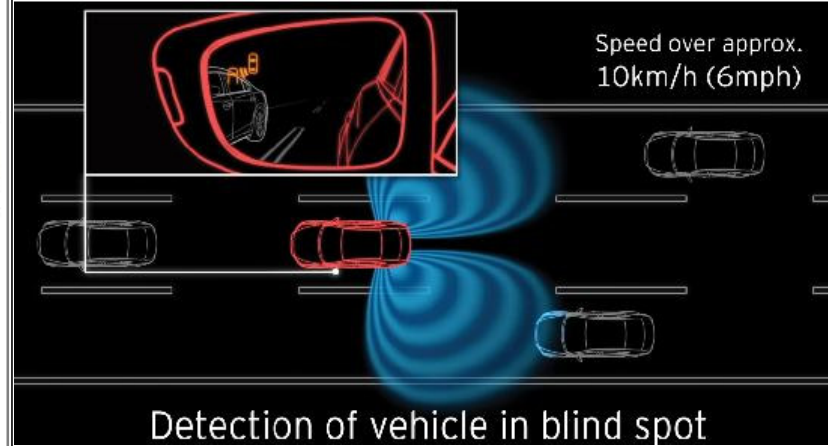
BSM Indicator ON

- Vehicle detected in the MONITORED AREA
- Low or similar speed difference with vehicle in the MONITORED AREA.

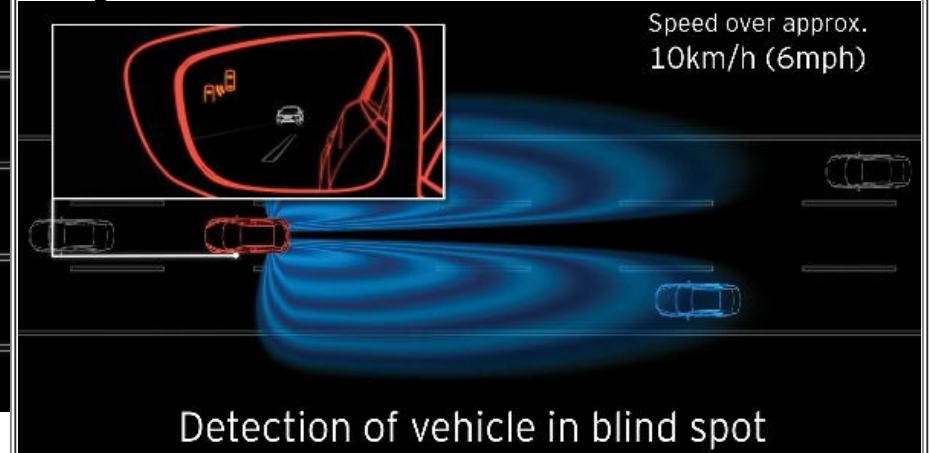
- Detected approaching vehicle in the ALERT AREA
- Approaching vehicle reaching the rear of your vehicle within 5.5 seconds
- Vehicle in the ALERT AREA is cruising at same speed or higher

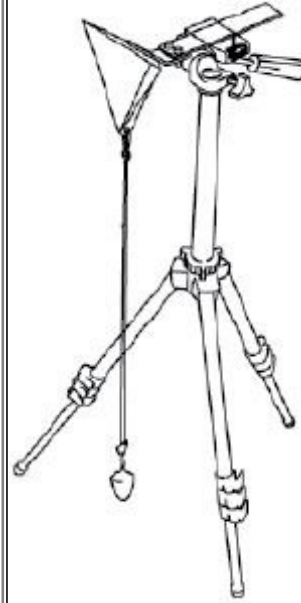
Reflector (\*Including 2016-2017 CX-9)

Special Service Tool  
(SST)
