L636-  
B.04.24

**Campaign code:**  
L636-B.04.24

**Campaign name:**  
Engine Control Unit software update

**Model:**  
URUS

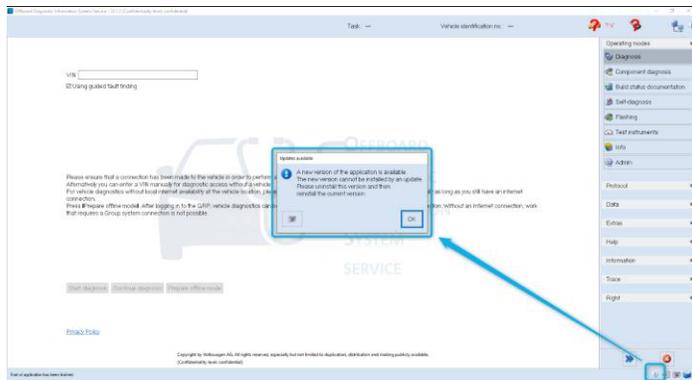
To do that, open O.D.I.S Service and check if are present one of the icons shown in the images below:

1. Update O.D.I.S Service by uninstalling and reinstalling the SW: further instructions available on the O.D.I.S Self Service APP.

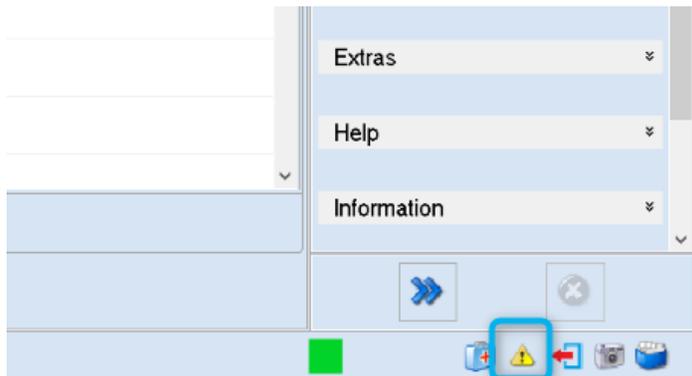
2. O.D.I.S Service “Automobili Lamborghini” post-setup update

If one of these icons appear, please proceeded to update O.D.I.S Service.

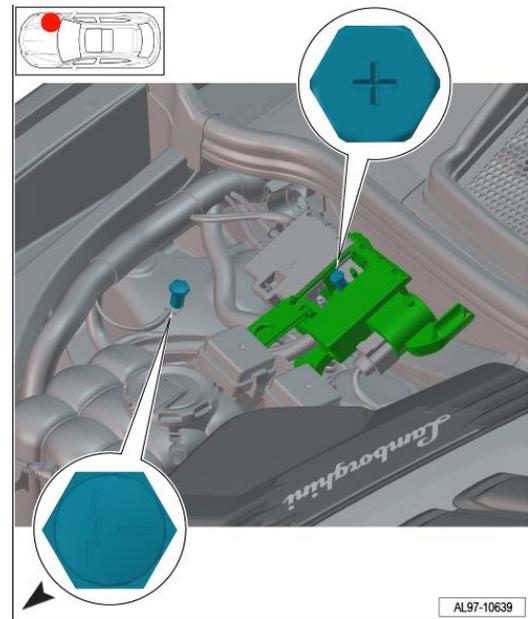
It is essential that you connect an appropriate battery charger to the charge points available in the luggage hood (front center of the vehicle). Please refer to the following figure.

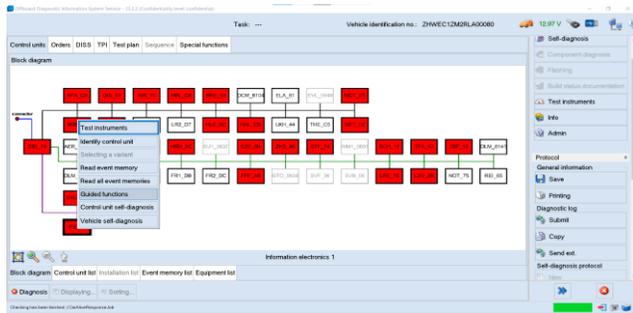
1. From the Guided Functions of the ECU 01 run the function **“01 - Identification”**.

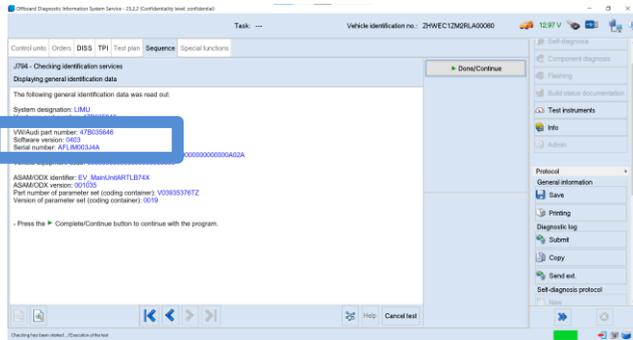
2. Check the information indicated in **“Software Version”** and follow the indications of the following table

Table of reference for control unit 01 (Engine Control Module)			
Software PN	Software version	Model Year	Market
4ML907589A	0005	19	NAR / Korea
4ML907589G	0002	20

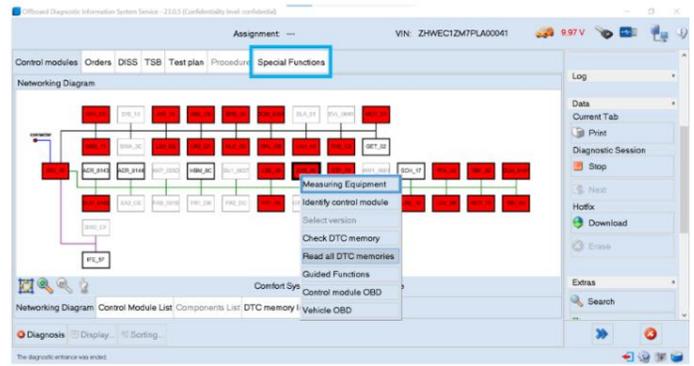
3. To start the procedure to execute an SVM code, select the **“Special functions”** tab in O.D.I.S. Service.

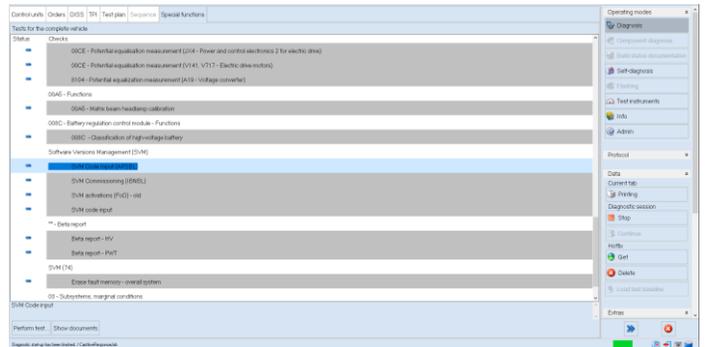
4. Click on **“SVM- Code input (APSBL)”** and then on **“Perform test”**.

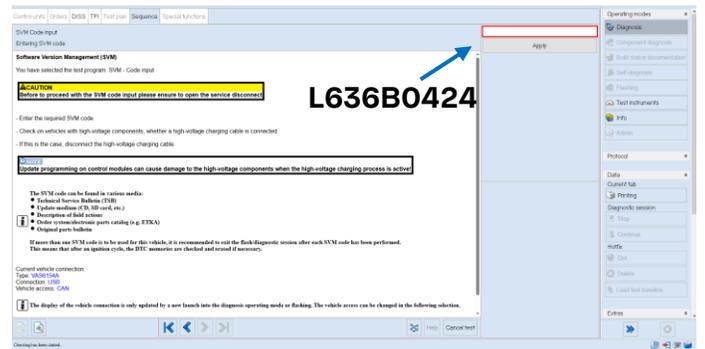
5. Enter the code **“L636B0424”** in the appropriate space at the top right and click **“Adopt”**.

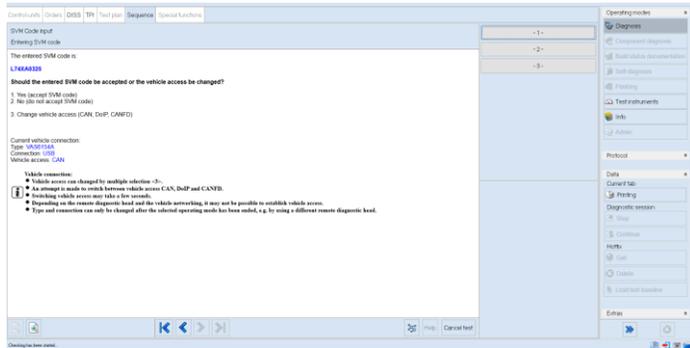
6. The SVM code entered is again displayed in the dialog box. If the entered code is correct, click on “Yes”. Otherwise click on “No” to cancel the SVM procedure.

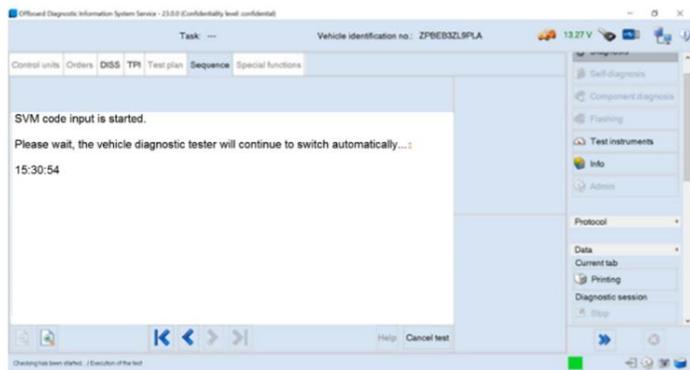
7. Wait for data to be acquired from all the control units. This operation requires a few minutes.

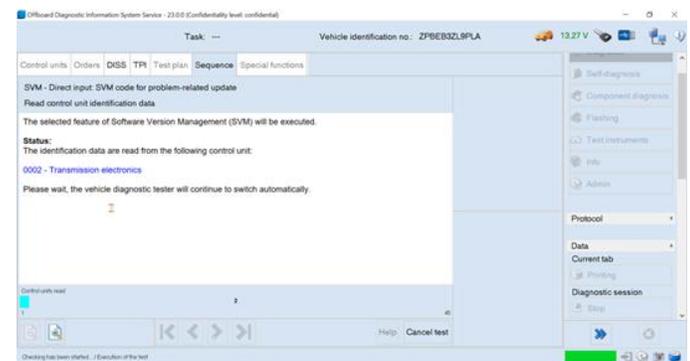
8. The SVM function will automatically continue with identification of the control units in the vehicle.

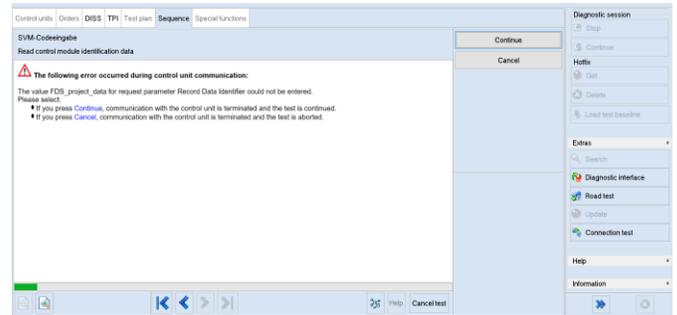
9. If the following error screen is displayed, the error does not indicate an issue, please press “Continue” and continue with the campaign.

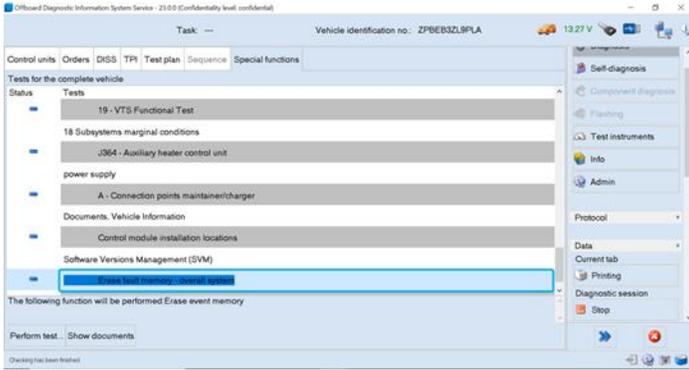
13. Select the “Special Functions” card and then “Erase fault memory - overall system” in order to delete all stored faults.

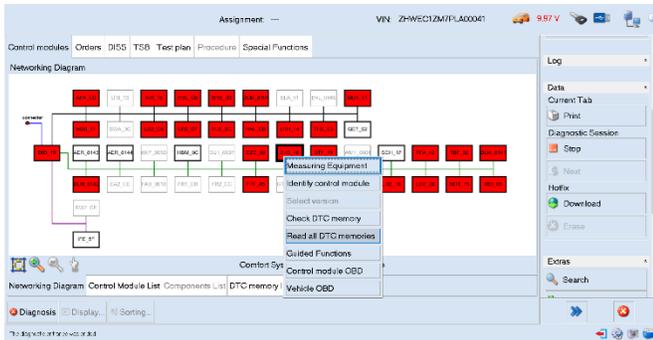
14. Go back to the “Block diagram” card and select “Read all fault memories” from one of the vehicle’s control units in order to update the display of the faults present after deletion.

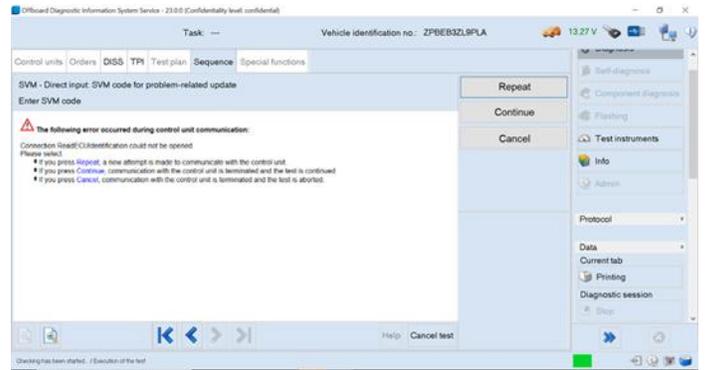
A. If the following error screen is displayed, abort the guided function by clicking on “Cancel Test” and contact Technical Support.

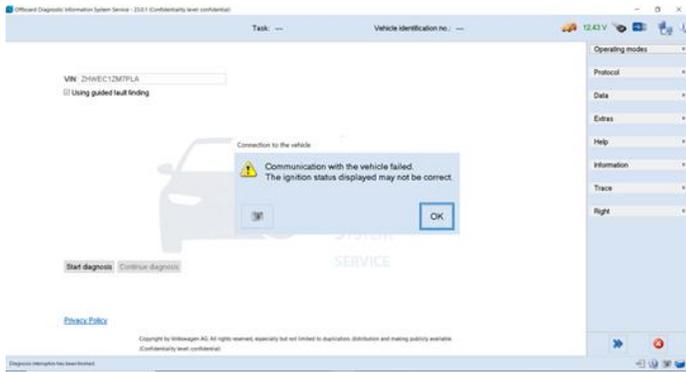
B. If an error is displayed that regards the hardware interface, and the "connection to vehicle" and "key state" icons appear as shown in the figure below:

- Click “Cancel”;
- Repeat installation of the interface 6154/6154A/6154B for the instructions in procedure (\*)“Checking the VAS 6154”, selecting the right-hand “Extras” menu in O.D.I.S. and clicking on the “Diagnostic interface” button.

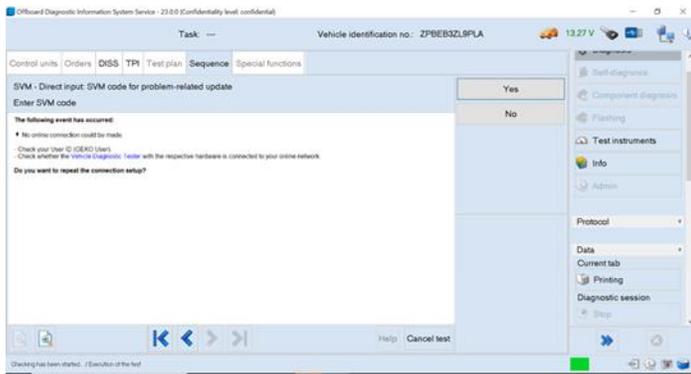
C. If the following connection error is displayed like in the following example screenshots:

- It is not possible to connect to the central server; check that your laptop is correctly connected to the Internet and retry by clicking on “Yes” or “Done/continue”, as appropriate.

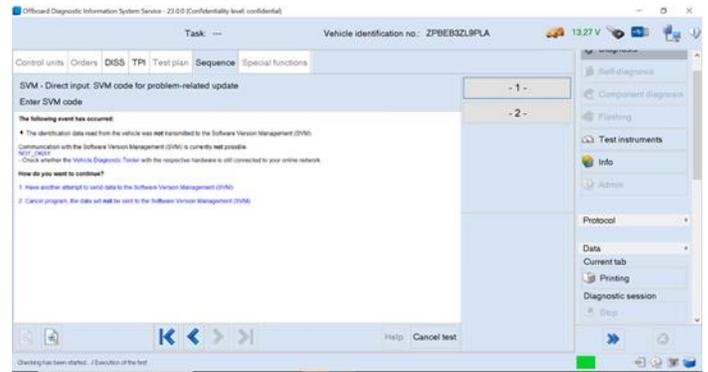
D. If the connection is dropped during the course of the target/actual comparison during the SVM procedure:

- It is not possible to connect to the central server; check that your laptop is correctly connected to the Internet and retry by clicking on “1”.

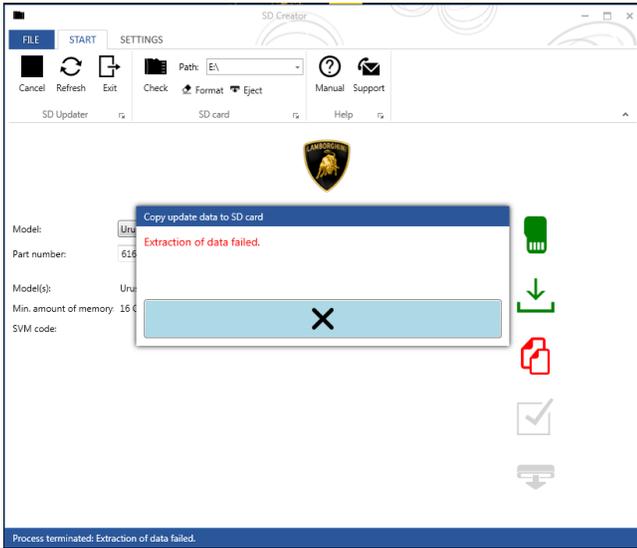
If the following error should occur, it is necessary to follow the instructions given in BI.25.18 (Rev.02), which can be downloaded on the Lamborghini HUB portal:
