<b>Authored Date</b>	05/06/2025	
<b>Doc No.</b>	IAMWO004251	
<b>Title</b>	Intelligent Speed Assistance Software update for North America and Mexico	
<b>Affected Vehicle(s)</b>	Grenadier	RF004677 – RF017814
Prior to starting any reworks, please make sure you check the vehicle is affected by checking the VIN using Vehicle Simple Search in the Warranty System.

**Procedure – Updating Head Unit.**

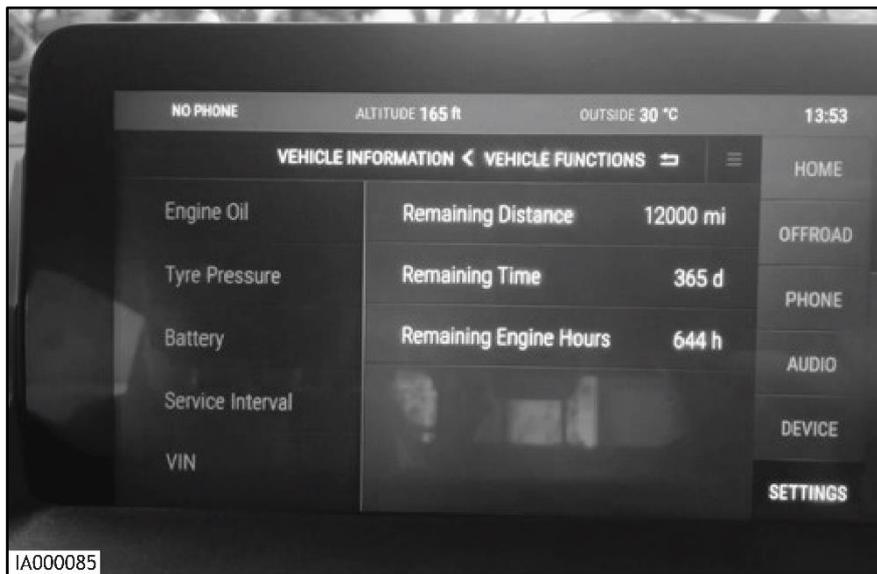
1.

Before the head unit is flashed. Write down the service interval information.

- Distance (Miles/Kilometres).
- Date.
- Engine running time.

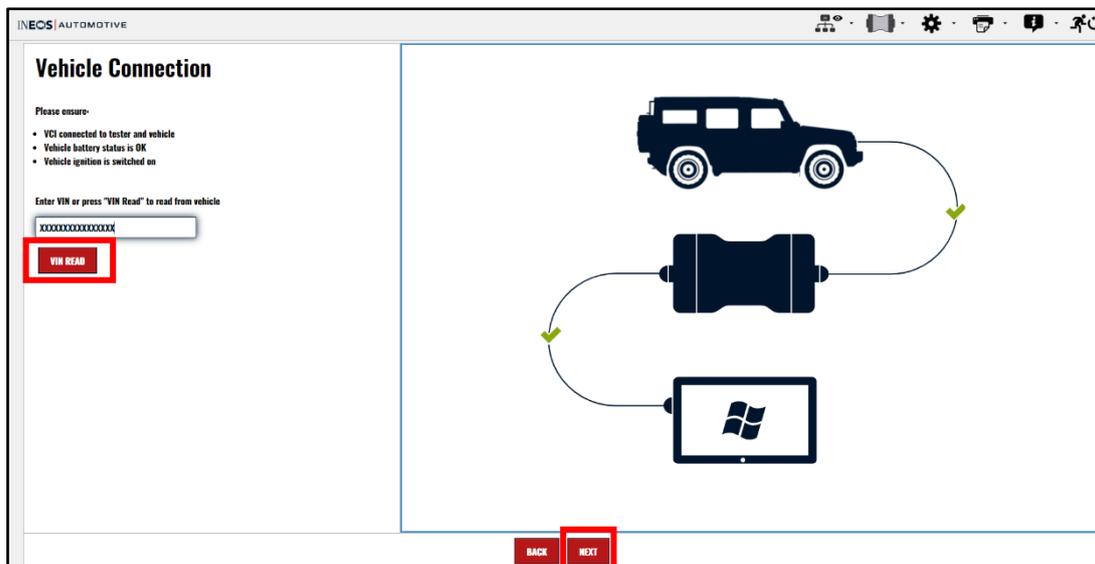
3.

Connect the vehicle to Grade-X using the VCI connected to the OBD port in the driver's footwell.

- 1) Select '**VIN READ**'.
- 2) Select '**NEXT**'.

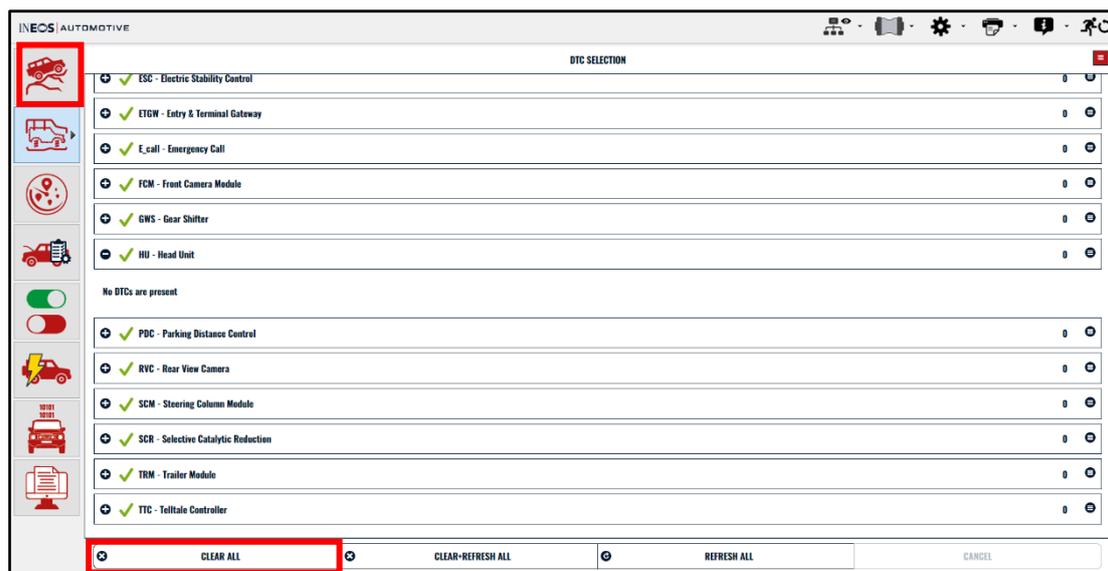
4.

- Select '**DTC Memory**' tab.

- Grade -X will start to read the ECU DTCs.
- Select '**CLEAR ALL**'.
- Grade - X will clear and read the vehicles DTCs.

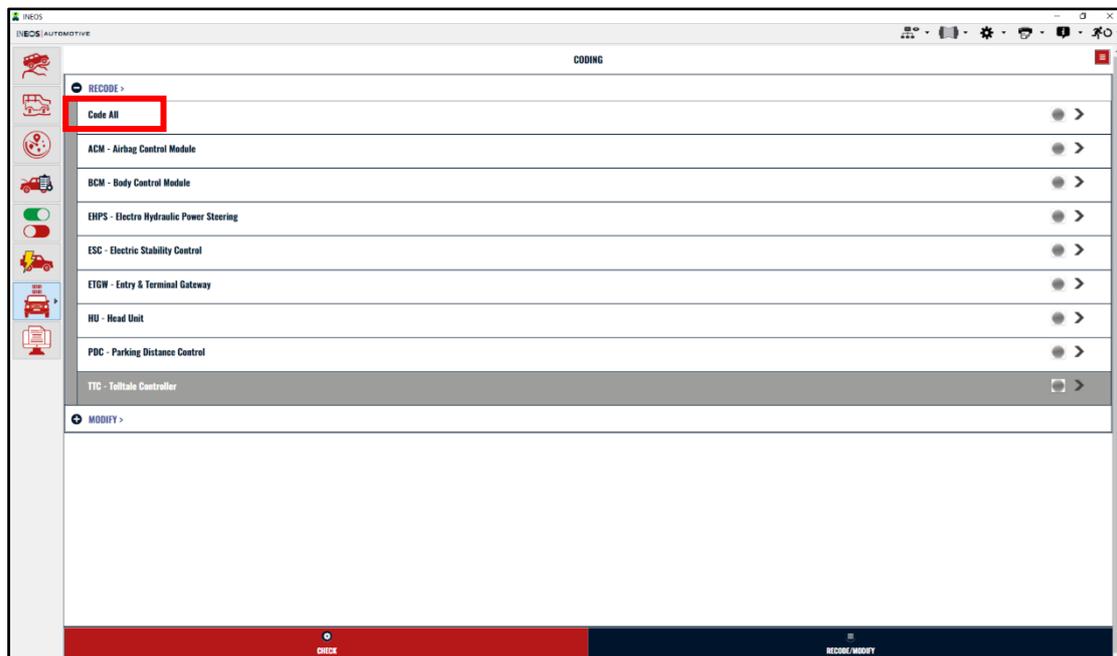
5.

- Select the coding tab
- Select '**Code All**'

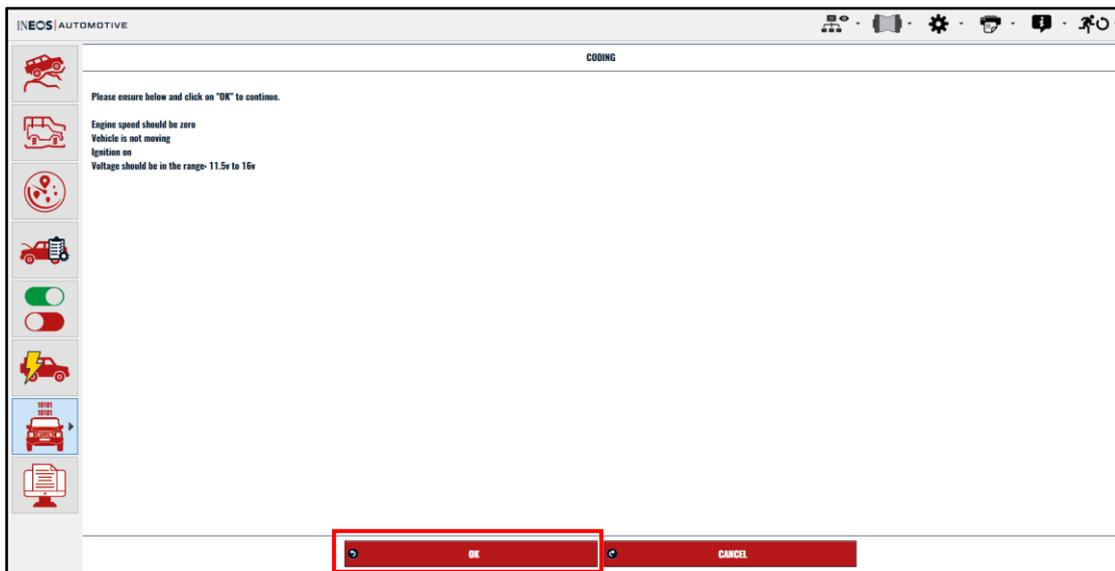
6.

Select 'OK'

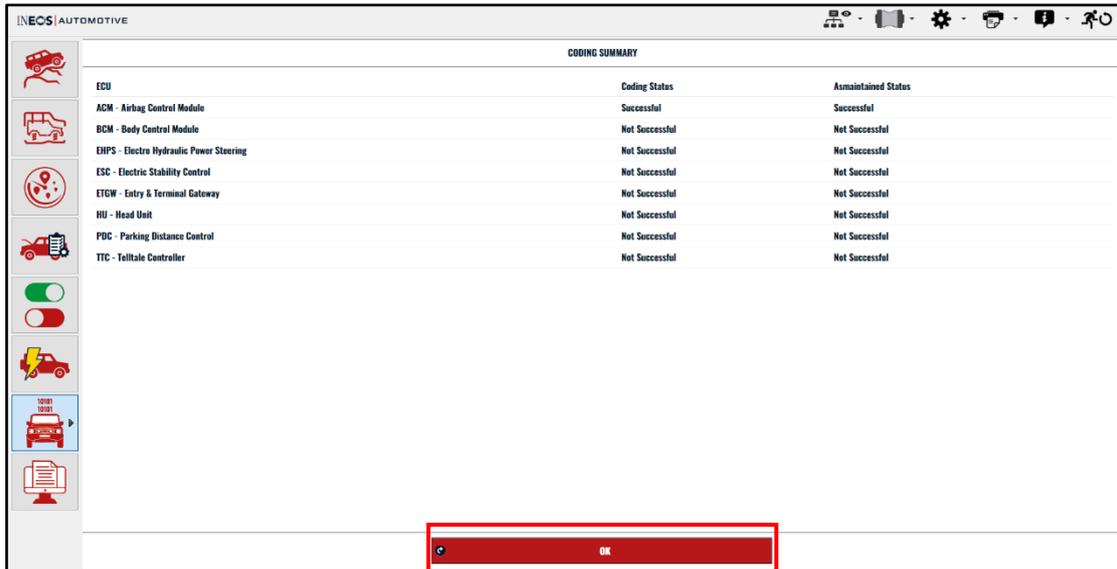
7.

Summary page shows the confirmation. Coding status is the priority, As Maintained is optional, but not an issue if it shows '**Not Successful**' as it will try after the session, and it's for reference only.

Select 'OK'

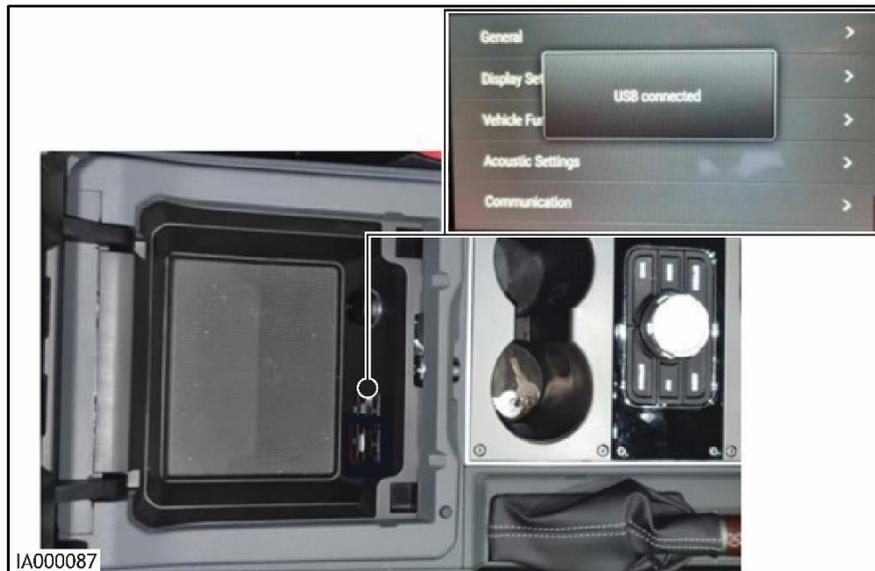
8.

- Download the latest software onto a suitable USB Stick [MY24.1 Software Update](#)
- Insert the USB stick into USB-A connection in the center console storage area with Head Unit (HU) 'update' software data from software pack SW-0000000969 (HU). A notification will display stating 'USB connected'

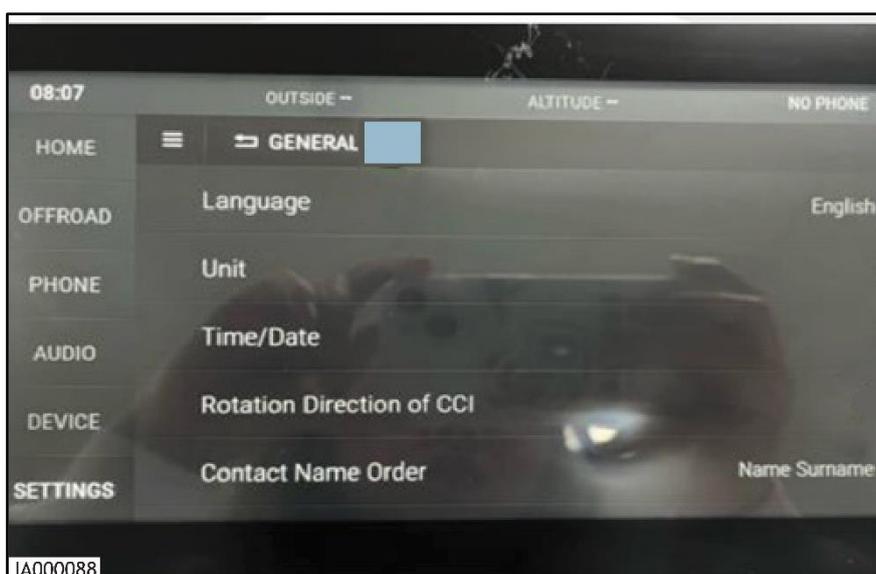
9.

- On the central display select '**SETTINGS - GENERAL**'.
- On the touchscreen, press and hold the area to the right of the '**GENERAL**' title for approximately 8 seconds. A screen will appear for PIN input.

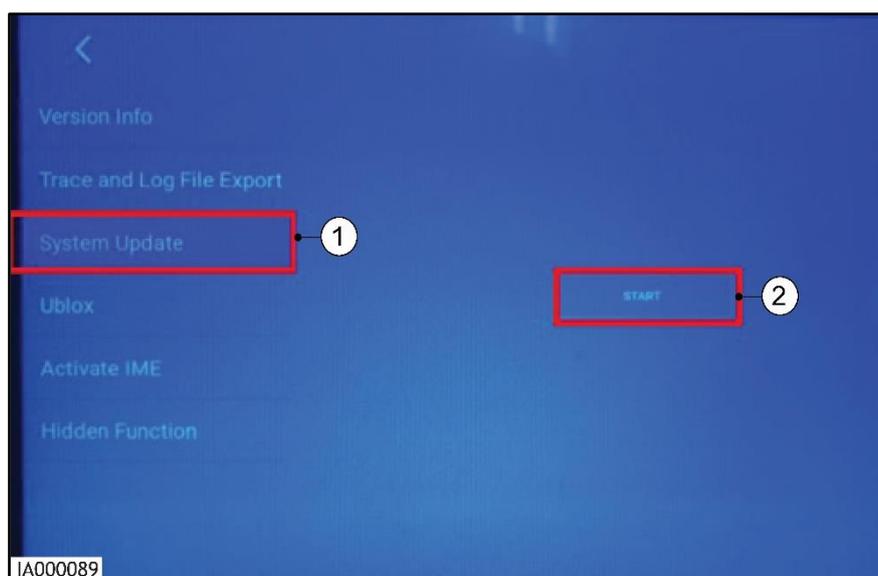
11.

- 1) Select '**System Update**'.

2) Select 'Start'.

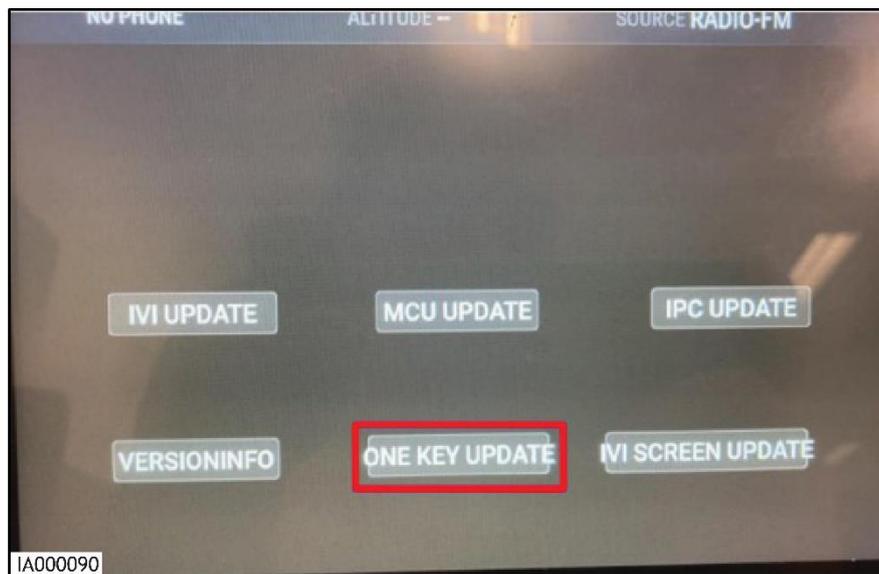
12.

Select 'ONE KEY UPDATE'

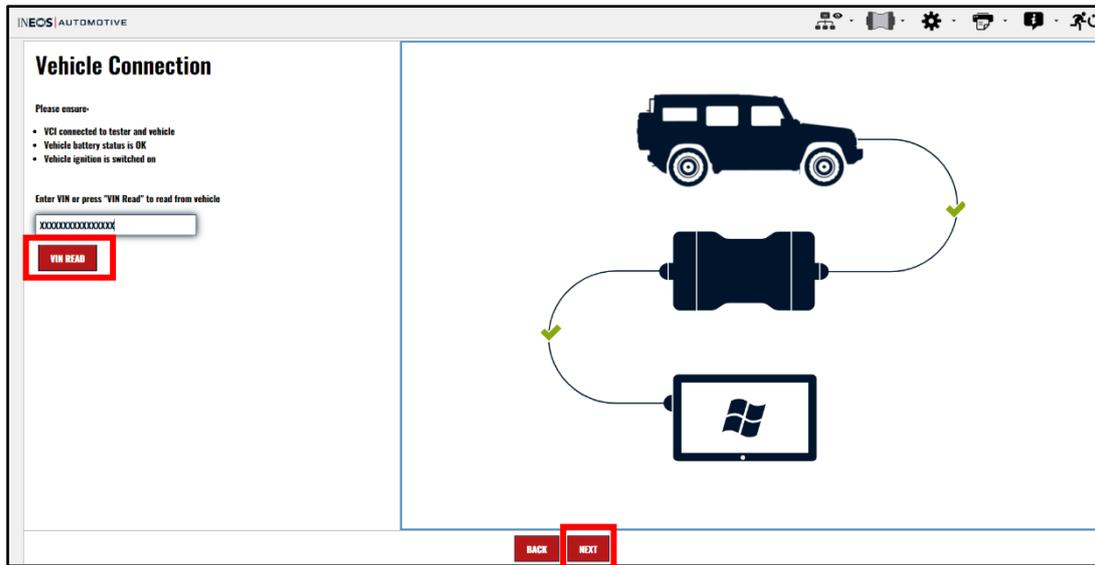
13.

Connect the vehicle to Grade-X using the VCI connected to the OBD port in the driver's footwell.

- 3) Select **'VIN READ'**.
- 4) Select **'NEXT'**.

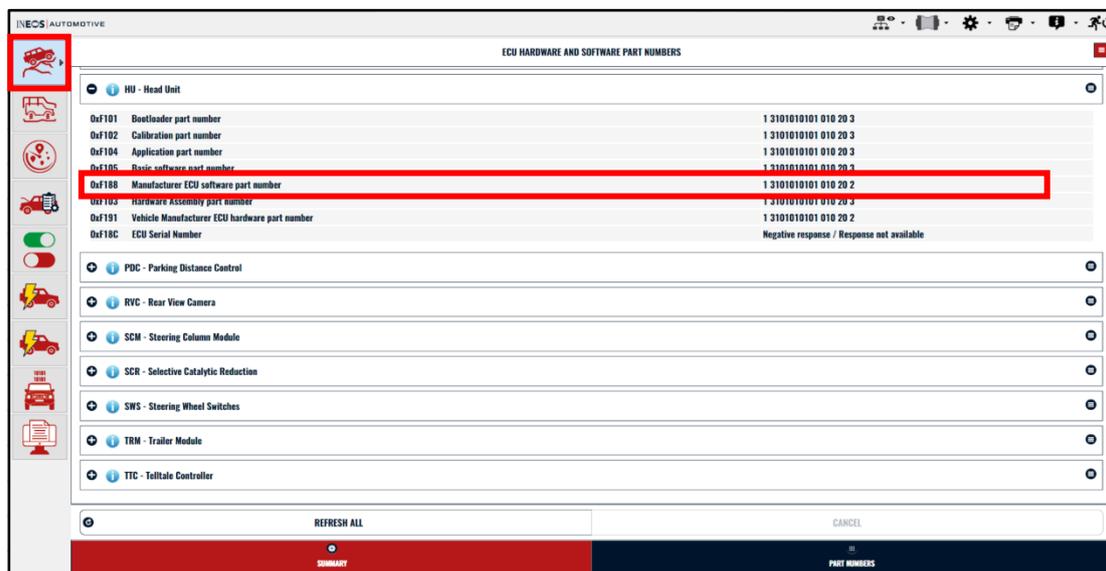
14.

- Open the vehicle summary page.
  - Select '**PART NUMBERS**'.
  - Select '**HU- Head Unit**'.
  - Review the '**F188 - Manufacturers ECU software part number**' check and ensure SW-0000000969 (HU) is displayed as the part number.
-

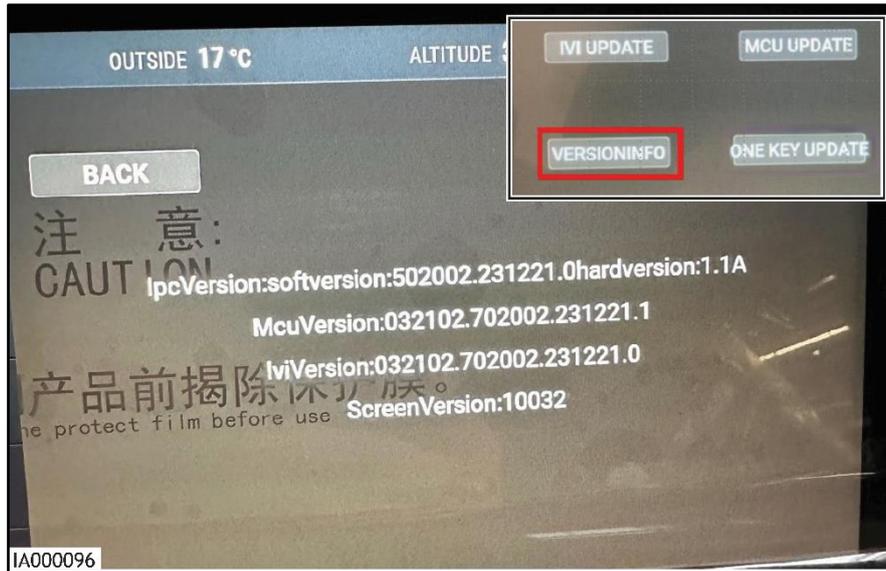
15.

Select '**VERSIONINFO**' and check that all 3 dates are exactly the same.

To identify the dates, the information is written in the below format (Image shown for illustration purposes)

IpcVersion:Softversion: XXXXXX.**YYMMDD**.0hardversion:1.1A

McuVersion: XXXXXX.XXXXXX.**YYMMDD**.X

IviVersion: XXXXXX.XXXXXX.**YYMMDD**.X
