## TURBOCHARGER COOLANT FEED AND RETURN PIPE O-RING LEAK – 3.0L / P6

### Range Rover

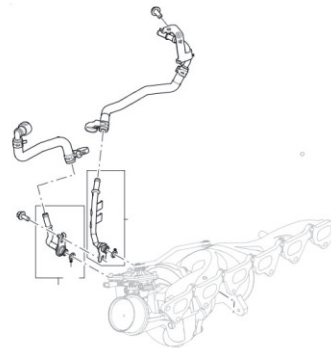
- The low coolant light may be illuminated/there may be a coolant leak from the engine area.
- TOPIx workflow must be run by selecting the relevant symptom dropdowns: *Powertrain* > *Engine* > *Fluid Leaks* > *Coolant leak*
- When running the workflow, a test plan titled “Turbocharger Coolant Pipe Leakage – Test” should be run.
- If fault is found during the test plan, autoFRED approval will be granted to replace the O-ring seals – *Refer to SSM 76268 (Jaguar) & SSM 76269 (Land Rover)*
- If there is visible damage to the coolant pipes, please submit a manual FRED with photographic evidence attached.
