GENERAL MOTORS
DCS7284
URGENT - DISTRIBUTE IMMEDIATELY

Subject: N252517721 - Service Update
Radio Reprogramming

Models: 2026 Buick Enclave
2026 Chevrolet Traverse
2026 GMC Acadia

N252517721 Radio Reprogramming

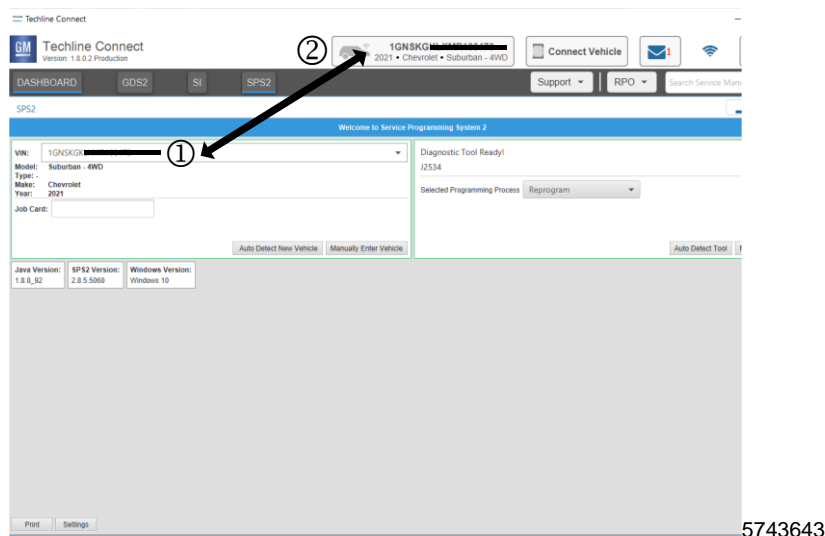
Caution: Be sure the VIN selected in the drop down menu (1) is the same as the vehicle connected (2) before beginning programming.

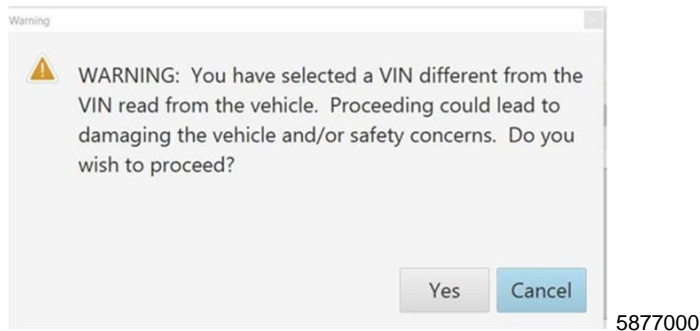
5877000

Important: If the vehicle VIN DOES NOT match, the message below will be shown.

Important: Techline Connect screens shown above.

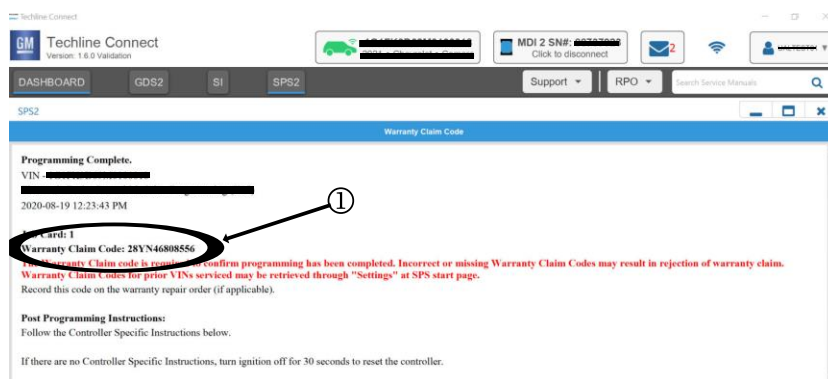
5644478

Note: The screenshot above is an example of module programming and may not be indicative of the specific module that is being programmed. Module selection and VIN information have been blacked out.
