2020-2025MY  
Telluride (ON) AWD

## TECHNICAL SERVICE BULLETIN

## AWD COUPLER NOISE/VIBRATION LOGIC IMPROVEMENT

926.ON, ON PE low-speed turning vibration AWD upgrade

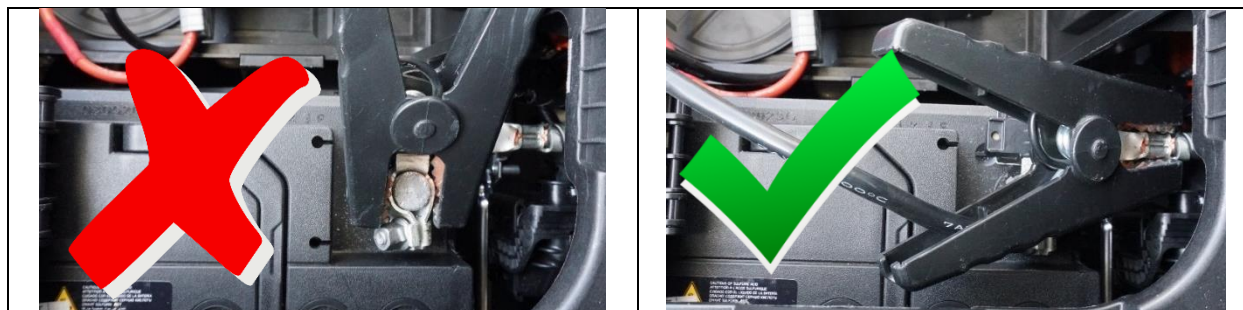
[Connect the negative \(-\) terminal to the battery as shown below.](#)

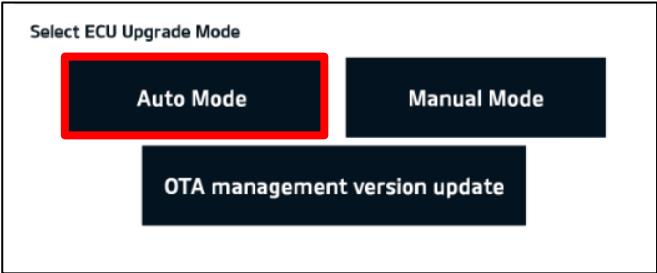
The required software must be installed by selecting the **'Auto Mode'** ECU Upgrade option.

**Note:** In some case, the 'Manual Mode' installation option may be required ONLY if the 'Auto Mode' function fails or is otherwise noted above.

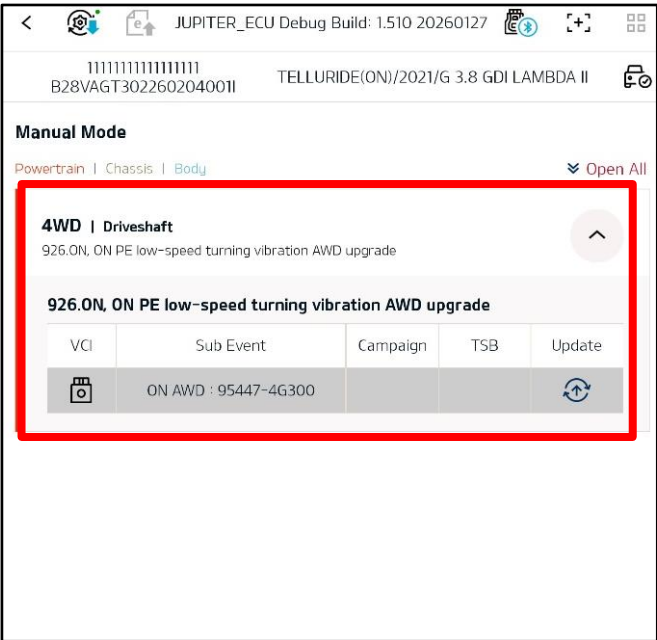
Select the applicable **'4WD'** system module and the Event Group.

- 926.ON, ON PE low-speed turning vibration AWD upgrade

Verify the affected vehicle Calibration Identification of the applicable ECU ROM ID and reference the Information Table on page 3 as necessary.
