# Service Action

## Code: 91FN

#### Software Update for High Voltage Battery Control Module - Version 3.2.1

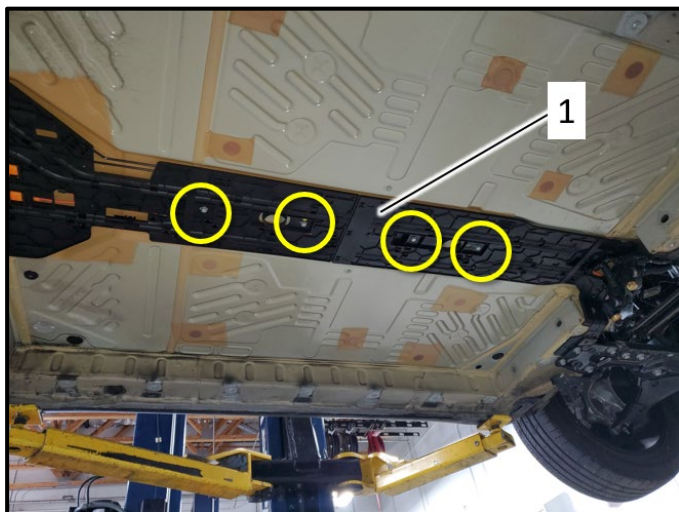
### Remove high-voltage battery:

- See ELSA Repair Manual: *Repair Manual > Motor > Electric Drive Motor 0EH, 0EJ > 93 Electric drive > High-Voltage Battery Unit > High-Voltage Battery 1 AX2, Removing and Installing, 82 kWh*
- Note the following when removing the high-voltage battery:
  - Mark the position of the scissor lift table on the floor to aid in re-positioning the table during reinstallation.
  - Pay close attention to all wiring harnesses when lowering the battery.
  - Pay close attention to coolant hoses when lowering the battery.

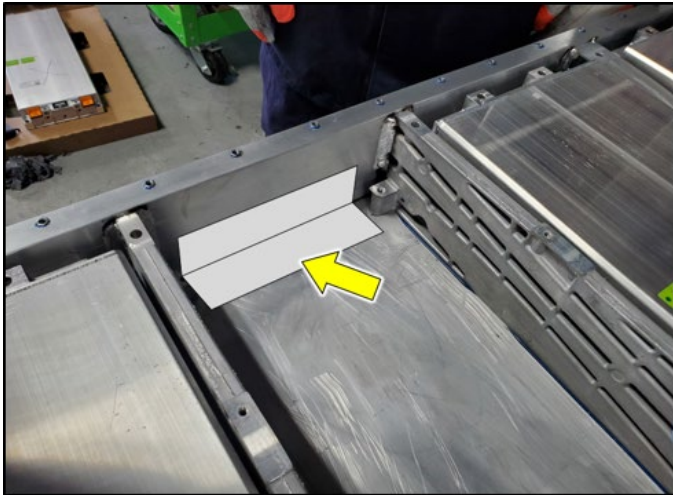
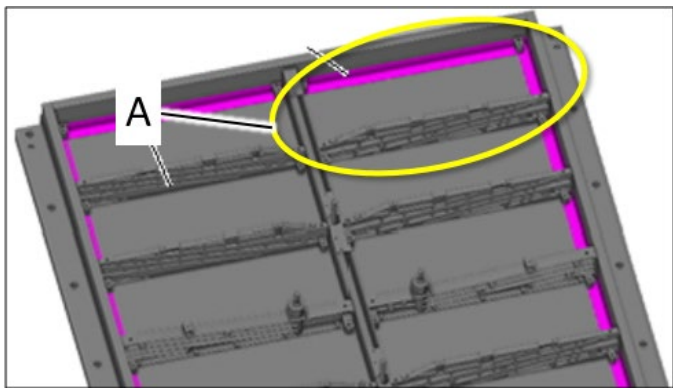
- Reference ELSA Repair manual: *Repair Manual > Motor > Electric Drive Motor 0EH, 0EJ > 93 Electric drive > High-Voltage Battery Components > Battery Module, installing*
- Note the following when installing the new cell module(s):
- Peel off the protective backing and apply the separating foil <arrow> as needed along the outer frame edges, in the area where the cell module is mounted.

- If the cell module being replaced is in the corner of the high-voltage battery, the separating foil must be applied to both outer frame edges as shown in area <A>.

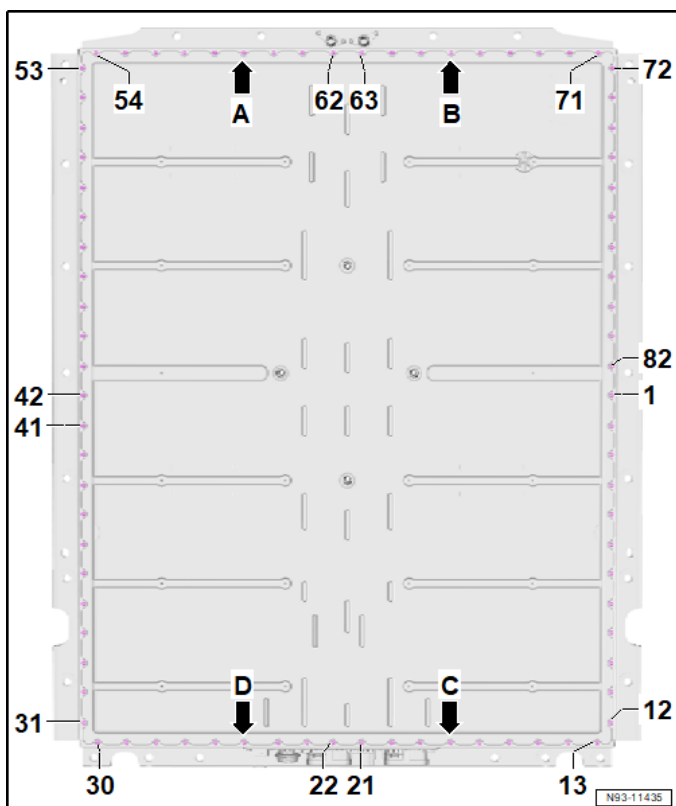
- Torque the new fasteners in the following order:
1. Connection element bolts <1 through 4> to 100 Nm.
  2. Middle bolts <5 through 26> to 5.5 Nm + 90°.

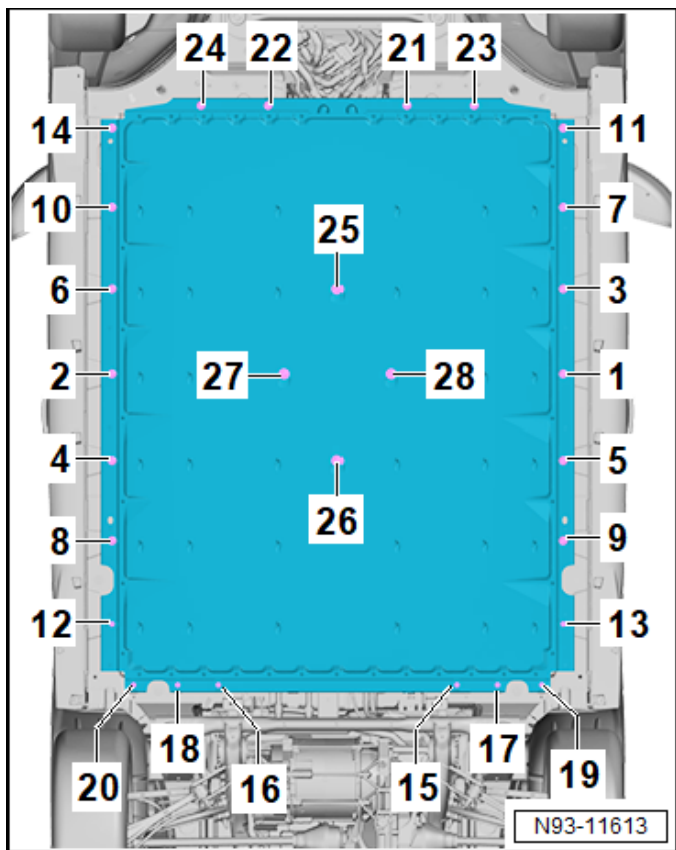
#### Re-install high-voltage battery:

- Installation is the reverse order of removal.
- See ELSA Repair Manual: *Repair Manual > Motor > Electric Drive Motor 0EH, 0EJ > 93 Electric drive > High-Voltage Battery Unit > High-Voltage Battery 1 AX2 , Removing and Installing, 82 kWh*
- Use new bolts.
