## Technical product information

| <b>Topic</b> | Navigation Map Update Process - MIB2 Infotainment Systems |
| <b>Brand</b> | Bentley |
| <b>Transaction No.</b> | 2081882/1 |

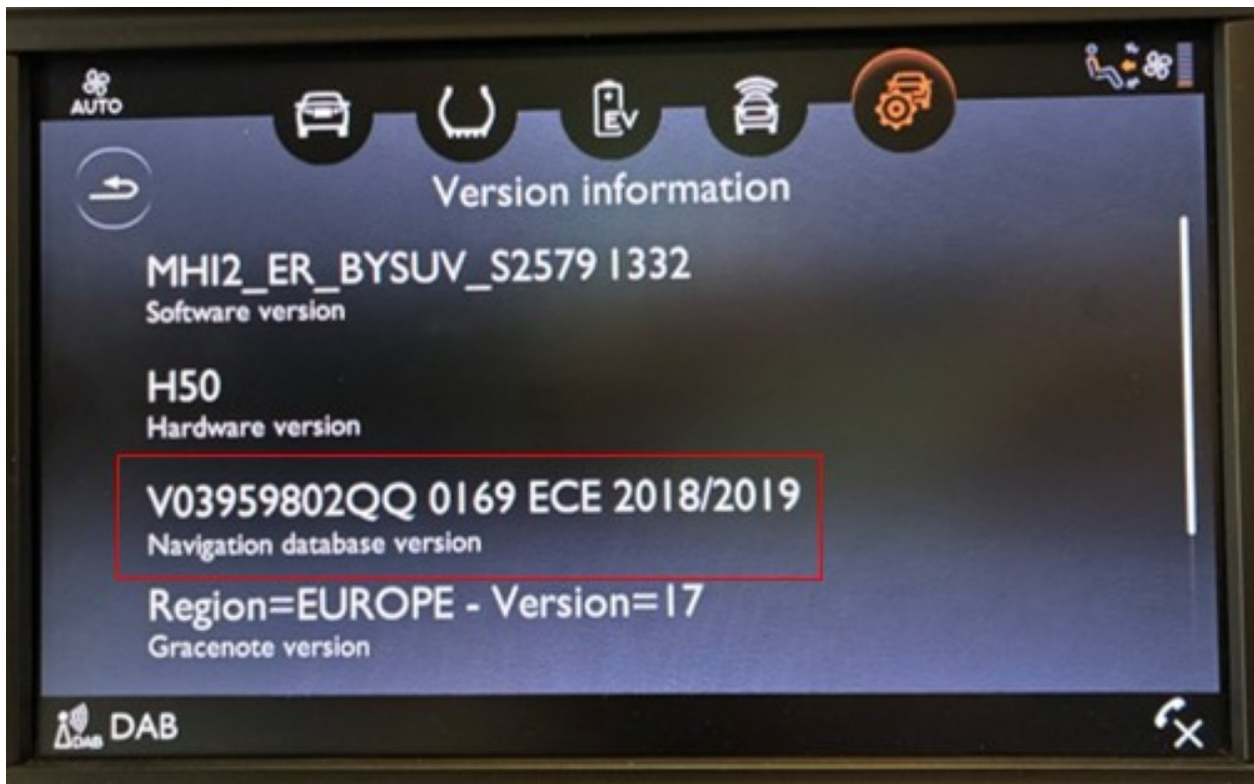
Main Menu → CAR → System Settings → System Maintenance → Version Information → Navigation Database Version

**Figure 1.** *Navigation Database Software Level Check*

**Figure 1 for reference only. If the software level shown is outdated, proceed with the onward instructions. If current, end the procedure.**

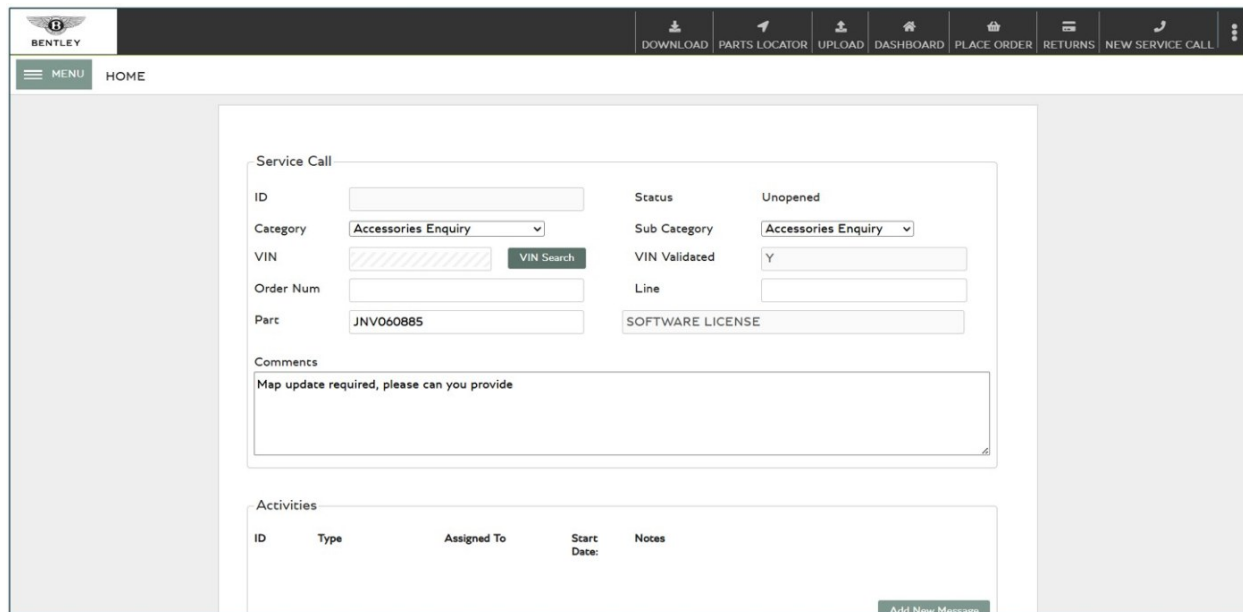
Retailers must raise an accessories service call to request the activation code. Ensure the customer has been informed of any applicable charges before proceeding.

The screenshot shows the Bentley BPS web interface. At the top is a navigation bar with the Bentley logo and links: DOWNLOAD, PARTS LOCATOR, UPLOAD, DASHBOARD, PLACE ORDER, RETURNS, NEW SERVICE CALL. Below this is a 'MENU' button and a 'HOME' link. The main content area displays a 'Service Call' form. The form has the following fields: ID (text input), Category (dropdown menu set to 'Accessories Enquiry'), VIN (text input with a 'VIN Search' button), Order Num (text input), Part (text input set to 'JNV060885'), Status (dropdown menu set to 'Unopened'), Sub Category (dropdown menu set to 'Accessories Enquiry'), VIN Validated (text input set to 'Y'), Line (text input), and a 'SOFTWARE LICENSE' field. Below these is a 'Comments' section with a text area containing the text 'Map update required, please can you provide'. At the bottom of the form is an 'Activities' table with columns: ID, Type, Assigned To, Start Date, and Notes. There is an 'Add New Message' button at the bottom right of the form.

Figure 3. BPS Activation Code Request

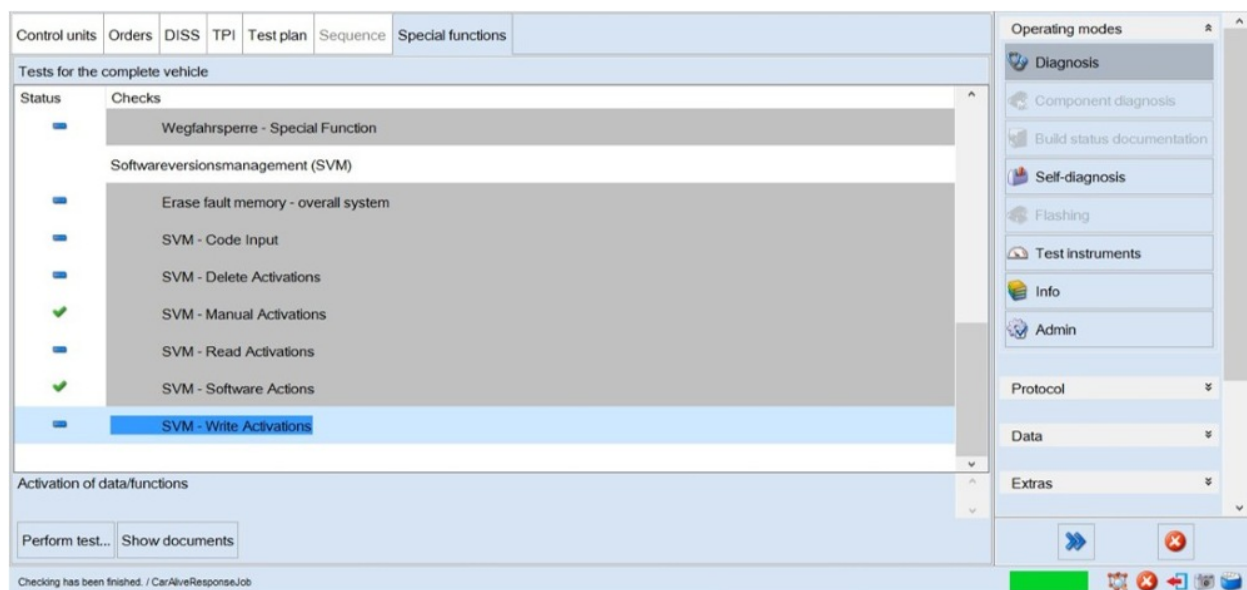
**Figure 4**

- a. Connect vehicle battery support
- b. Start an ODIS diagnostic session
- c. Select: Special Functions → SVM → Activations

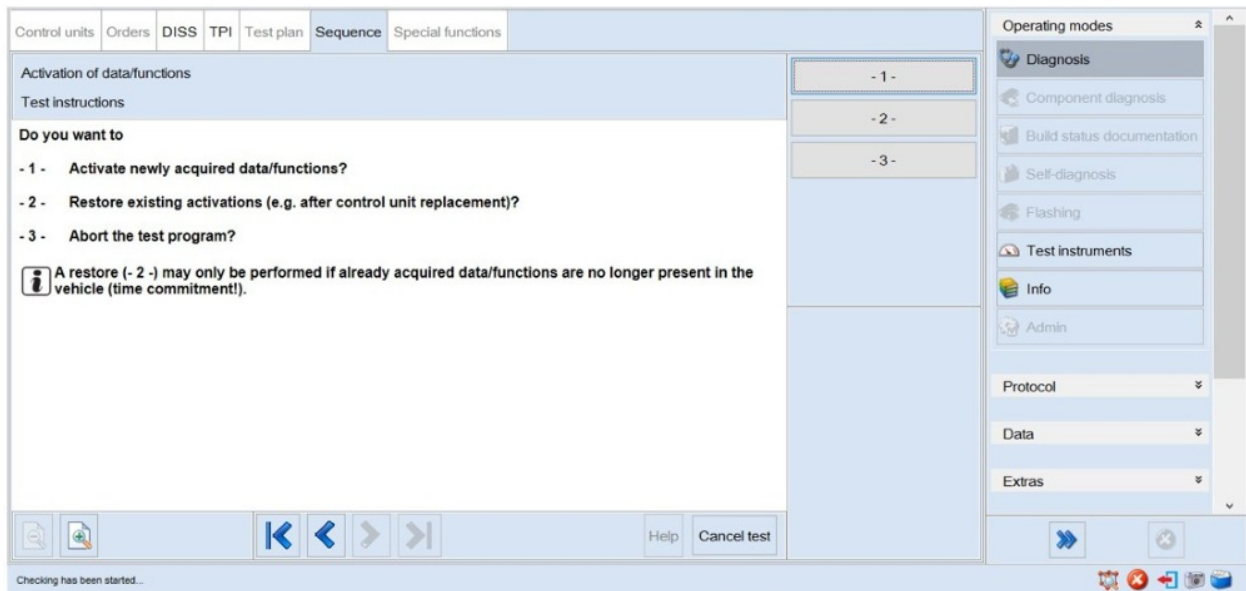
Figure 5

- d. Select: Option 1 – “Activate newly acquired data functions”

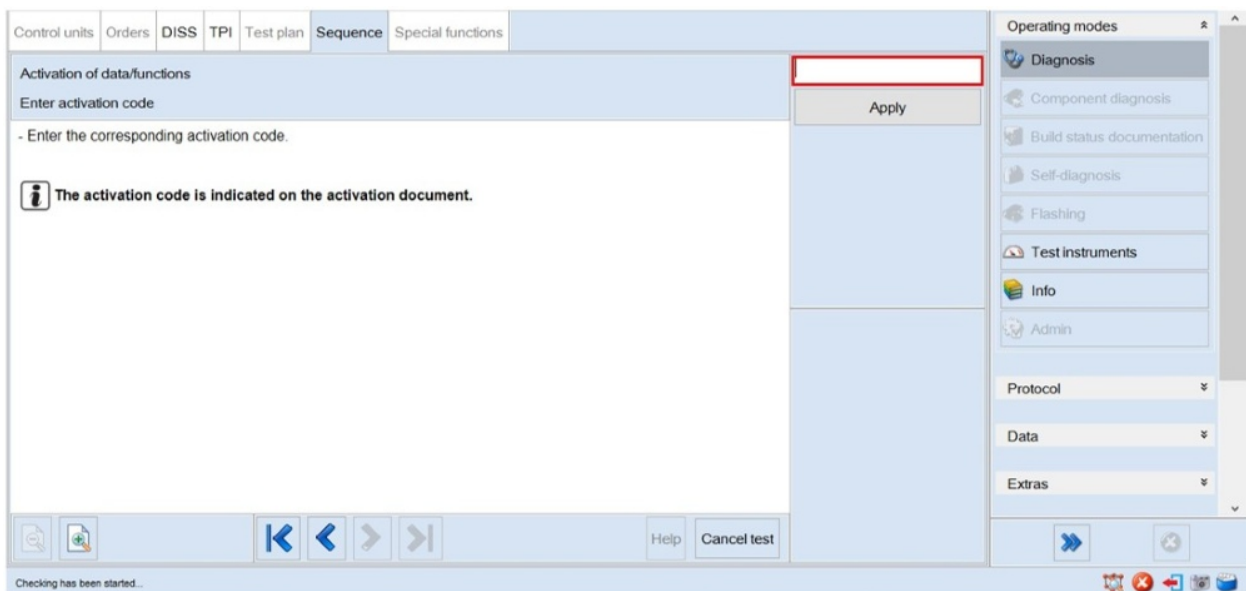
Figure 6

– Activation Code

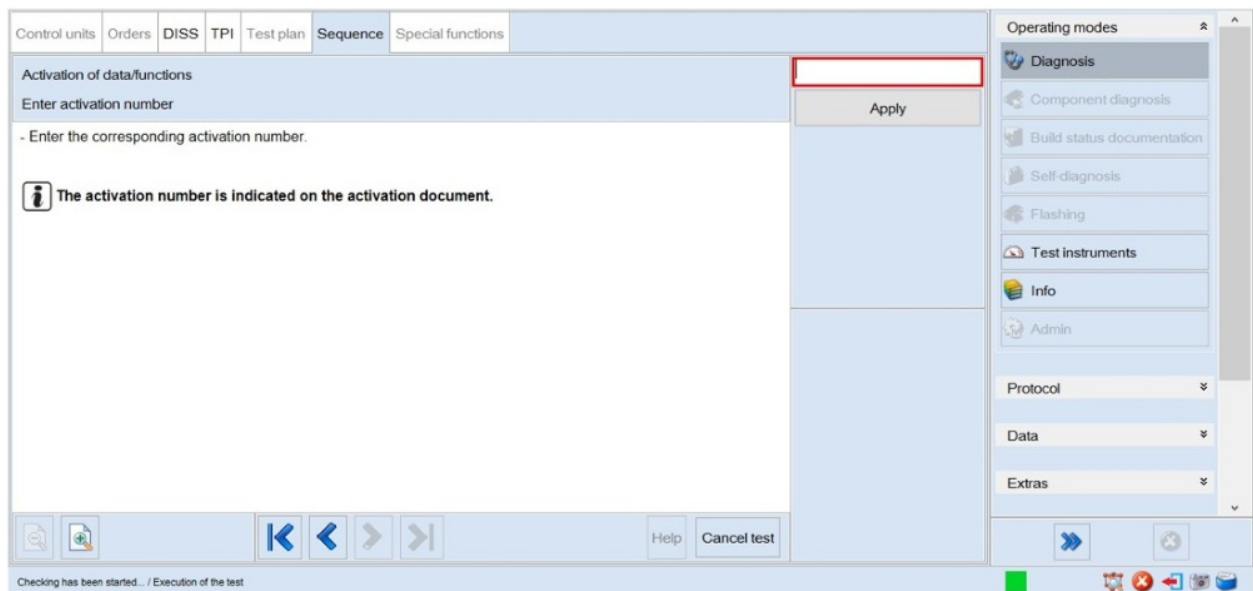
Figure 7

– Activation Number

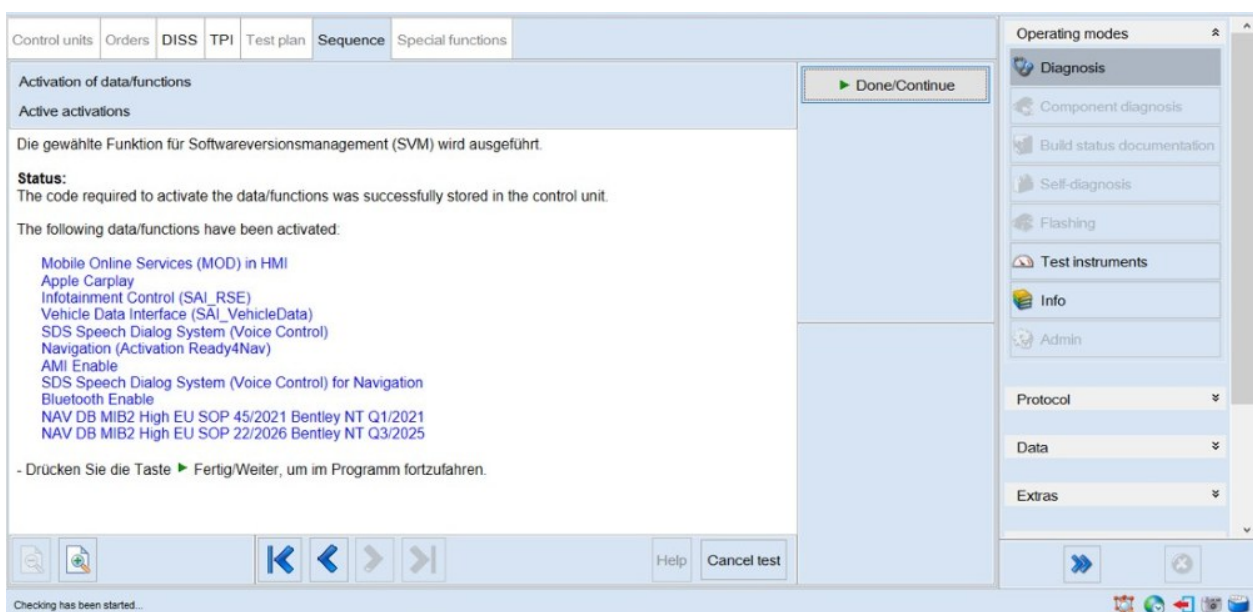
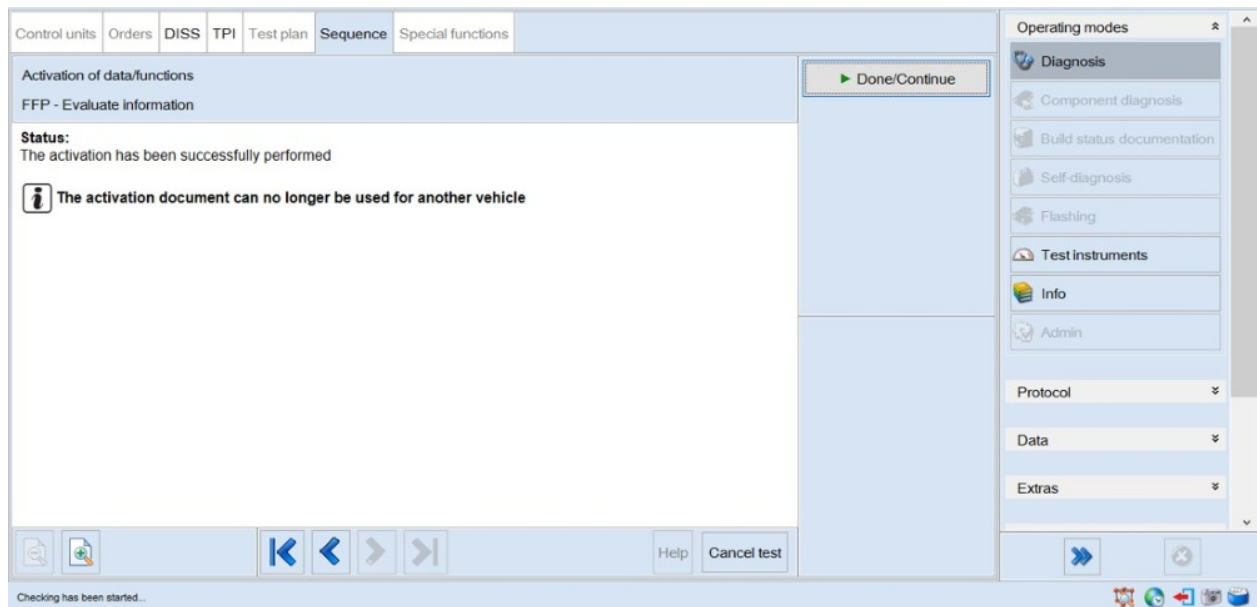
g. If the activation is successful, two messages will be displayed (shown below) confirming success and advising that the activation code has been used and can no longer be applied to another vehicle. If the update is unsuccessful or the expected screens are not displayed, refer to Step 6.

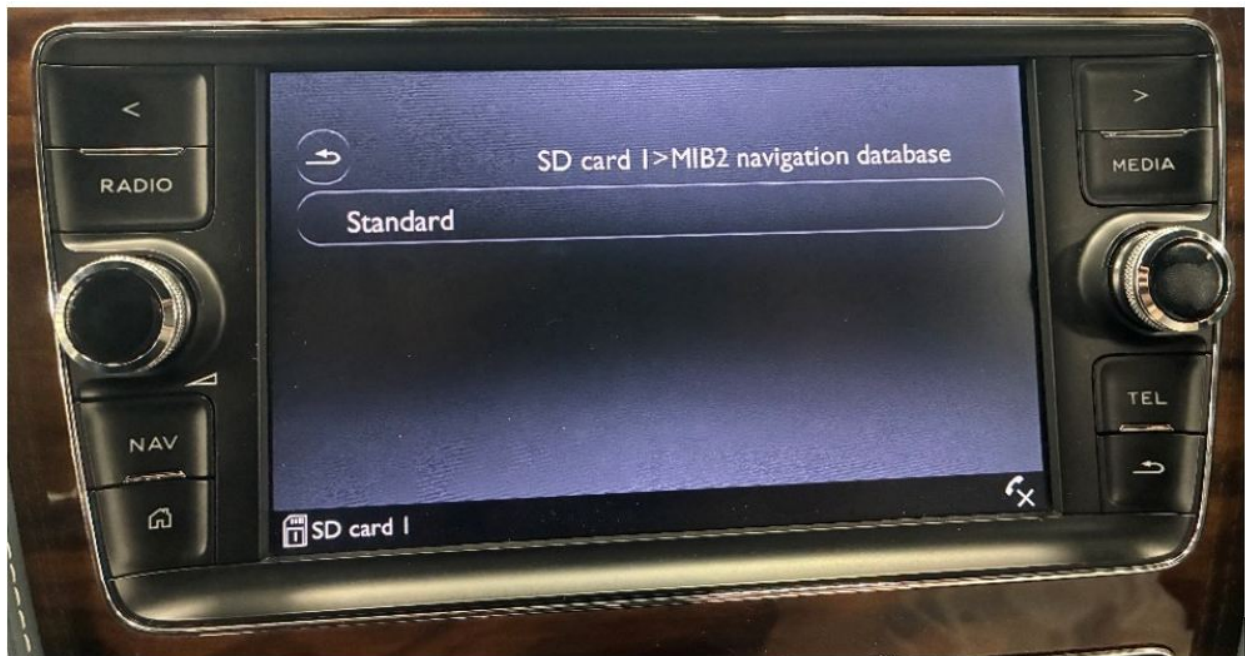
Figure 10

- a. Connect a charger to the vehicle.
- b. Turn the ignition ON.
- c. Insert the SD card containing the map information into either "Slot 1" or "Slot 2" in the control unit 1 for information electronics -J794- (located in the glove compartment).
- d. On the MMI display, simultaneously hold the Back and Media buttons for 5 seconds (push "Back" first).
- e. The MMI display will now ask which "Slot" the SD card is inserted into, select the relevant option.
- f. Select Standard

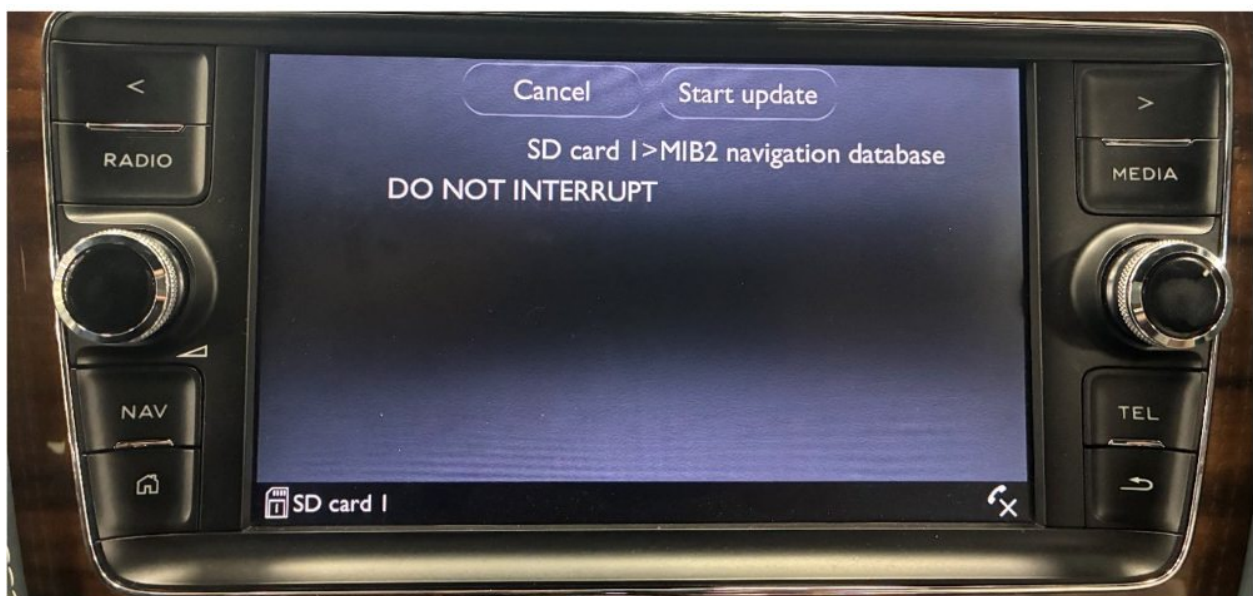
Figure 11

g. Select Start update.

To begin the update process, you may need to press "Start Update" twice

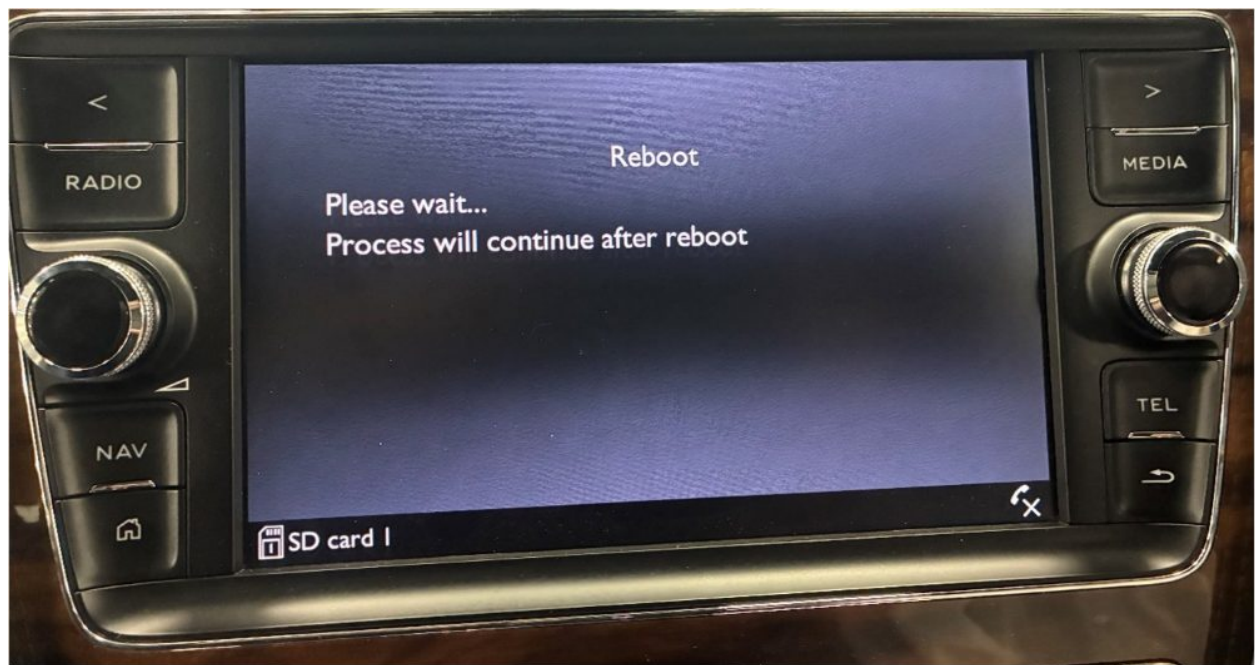
Figure 12

h. The Display will then Reboot

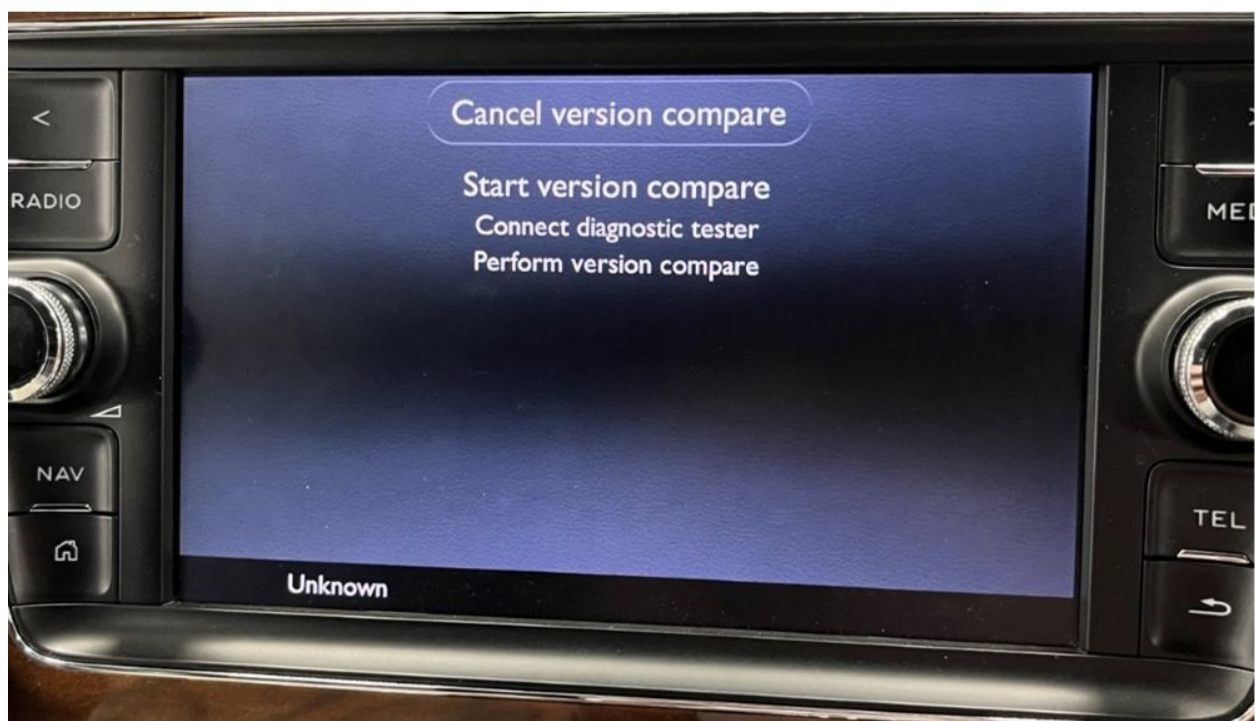
Figure 13

- j. Once the update is complete the screen will display "Compare version" press Cancel.

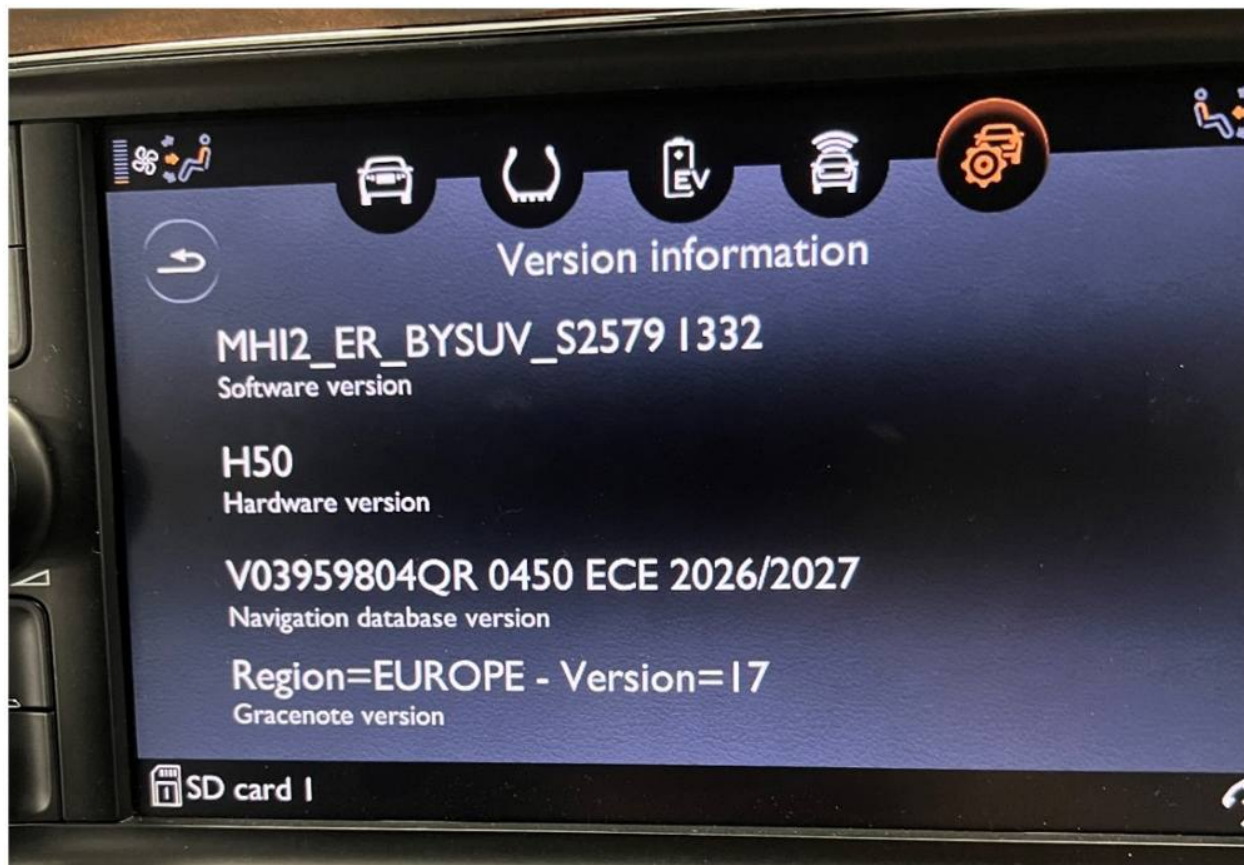
Figure 14

k. Verify map functionality and confirm that the update has been successfully completed.
