Mitsubishi Motors North America, Inc.
SERVICE - DEALER PDI - CAMPAIGN BULLETIN
(no customer notification)

SUBJECT: SERVICE / DEALER PDI CAMPAIGN ECU REFLASH	No: SC-26-001
	Version: 3
	Reason for change: Eligibility Clarification
	Date: May 29, 2026

2026 Outlander with 4B40 Gen 2 Engine

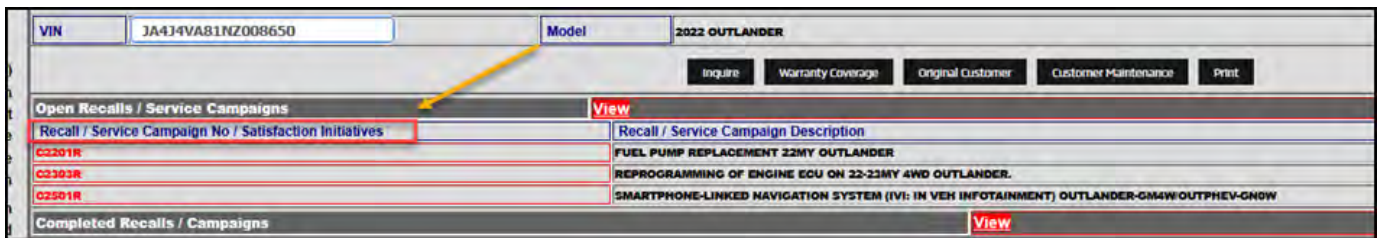
Dealers must check 2026 Outlander VINS on the Warranty Superscreen for eligibility. If eligible, perform ECU reprogramming as shown below.
