# HYUNDAI

## Technical Service Bulletin

| GROUP<br><b>FUEL SYSTEM</b> | NUMBER<br><b>26-FL-002H</b> |

**SUBJECT:** ECM SOFTWARE UPDATE FOR AIR-FUEL RATIO  
LOGIC IMPROVEMENT – DTC P219X00

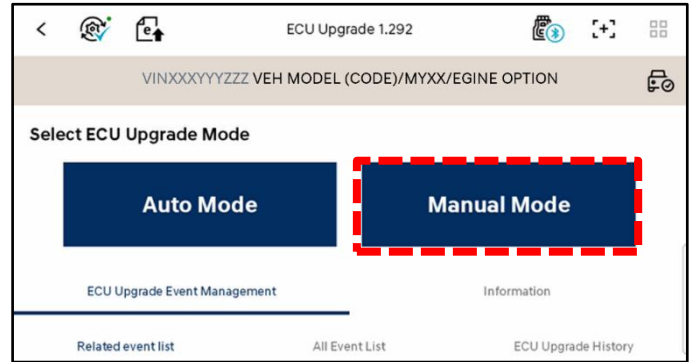
2. Verify the ROM ID by selecting the **Engine** system to scan the vehicle's current ROM ID.

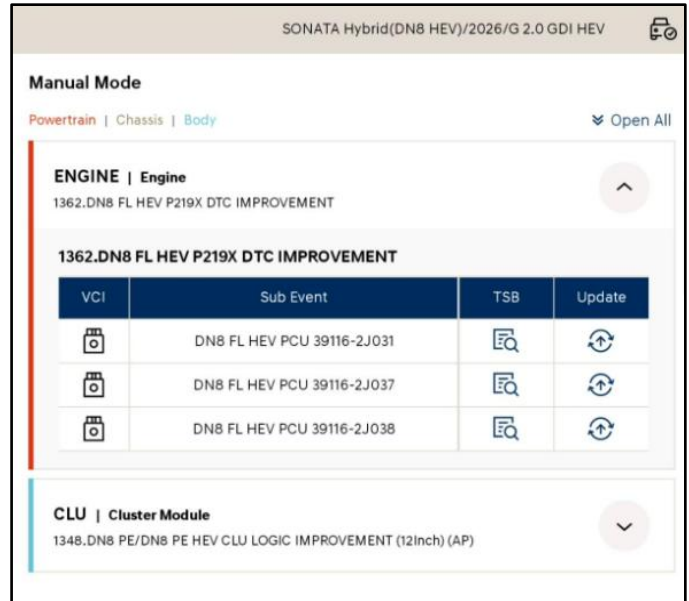
3. After the ECU update process shows 100% complete, follow the prompts on the screen to cycle the ignition **OFF** for at least **10 seconds** to reset the control unit (certain models may take up to **30 seconds**).

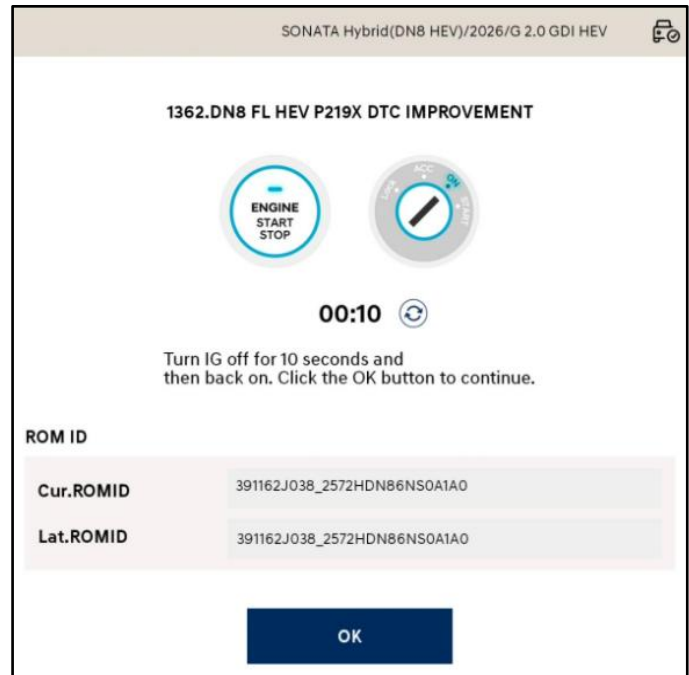
Use the **Refresh** button to reset the timer.

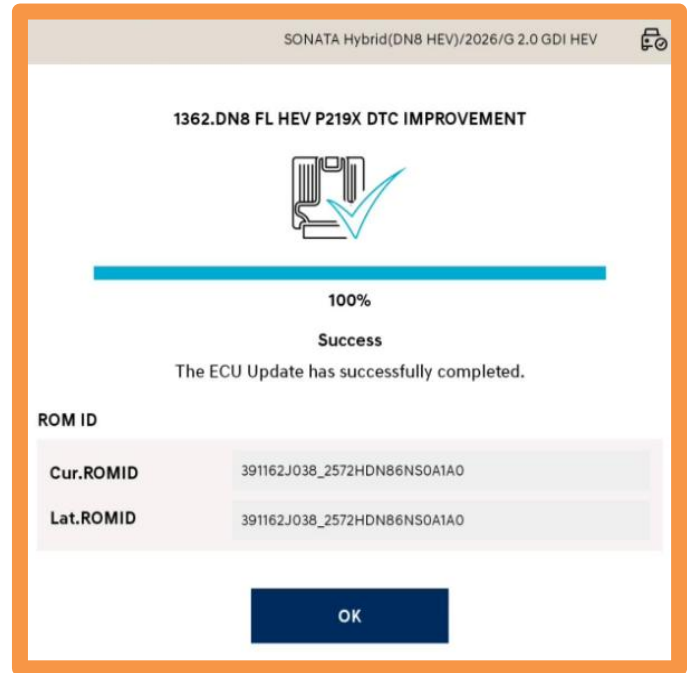
Using the tablet or GDS screen capture function, take a screenshot of the ECU Update “Success” result screen.

This TSB includes repair justification in the form of automatically uploaded DTC(s) via GDS e-Report at the time of diagnosis. To ensure adherence to the Digital Documentation Policy before claim submission, DTC history can be reviewed via the e-Report function within the GDS. Additionally, required photos include a capture of the ECU Update “Success” screen for the associated update events.

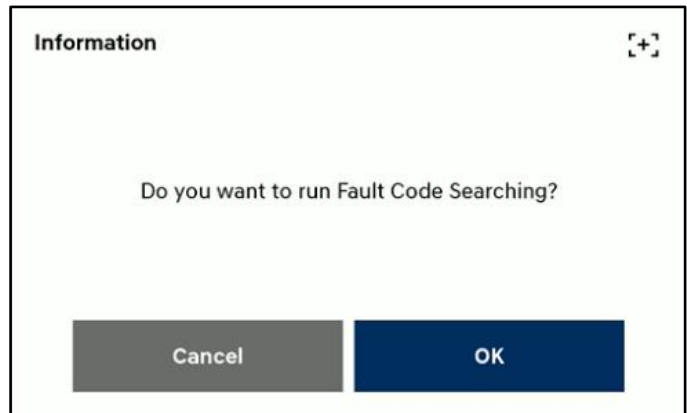
6. Perform an **All Systems Fault Code** search and erase DTC history that had incidentally occurred from the ECU update.
