GROUP	MODEL
ELE	2027MY Telluride (LQ2a, LQ2 HEV)
NUMBER	DATE
424	June 2026

TECHNICAL SERVICE BULLETIN

SERVICE ACTION: DIGITAL KEY BATTERY DISCHARGE LOGIC IMPROVEMENT (SA651)

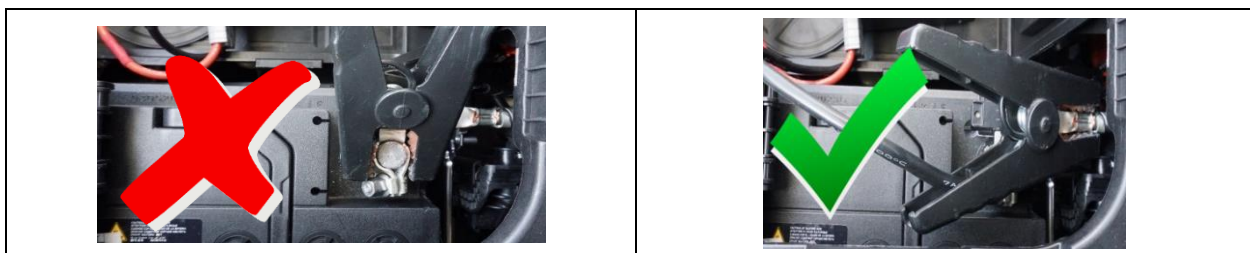
[Connect the negative \(-\) terminal to the battery as shown below.](#)

- Confirm a fully charged battery (12.3 volts or higher is necessary) is used or utilize a fully charged jump starter box connected to the battery.
- **Ensure the KDS GDS is sufficiently charged at 60% or higher prior to reflash.**
- All ECU upgrades must be performed with the ignition set to the 'ON' position unless otherwise stated.
- **Damaged VCI II units should not be used and promptly replaced.**
- Be careful not to disconnect the VCI-II or VCI-III connected to the vehicle during the ECU upgrade procedure.
- **DO NOT start the engine during ECU upgrade.**
- DO NOT turn the ignition key 'OFF' or interrupt the power supply during ECU upgrade.
- **When the ECU upgrade is completed, turn the ignition 'OFF' and wait 10 seconds before starting the engine.**
- **ONLY** use approved ECU upgrade software designated for the correct application.

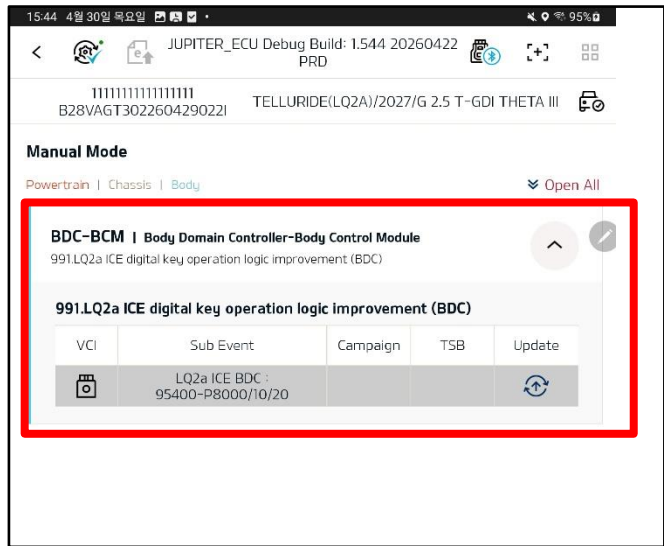
Select the applicable **'BDC-BCM'** system module and the Event Group.

- **991. LQ2a ICE digital key operation logic improvement (BDC)**
- OR**
- **998. LQ2a HEV digital key operation logic improvement (BDC)**
