# INSTRUCTION TO SERVICE

<b>ITS61783</b>		<b>6/4/2026</b>
<b>SECTION:</b>	290-Electrical Schematics & Programs	
<b>SUBJECT:</b>	Move all existing J1939 message routing from DPS instrument cluster to PVSG	
<b>ISSUE:</b>	Loss of required feedback signals results in numerous telltales on IP cluster and potential for interlocks to apply above 2 mph	
<b>SUMMARY:</b>	Flash latest released PLC, IP and PVSG programs to the vehicle

# ITS61783

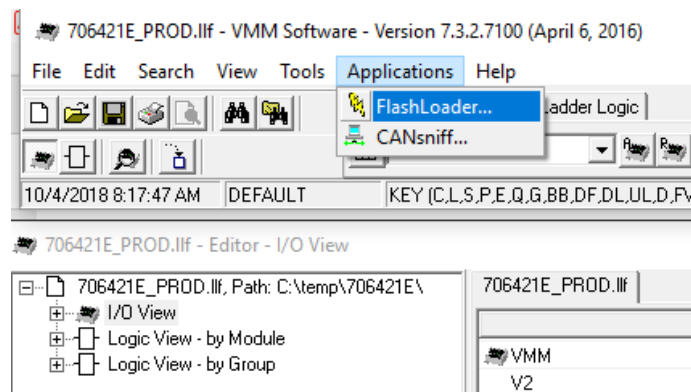
4. If the above USB port is unavailable, connect the USB interface of your NEXIQ to your laptop.
5. Connect the CAN interface of your NEXIQ to Channel 2 (Pins H and J, 250k baud rate) of the Front Green Diagnostic port (Vehicle Diag) behind the driver's seat.
6. Open the VMM software, select Applications and then FlashLoader as shown in Figure 5 below.

**Figure 4: Selecting FlashLoader**

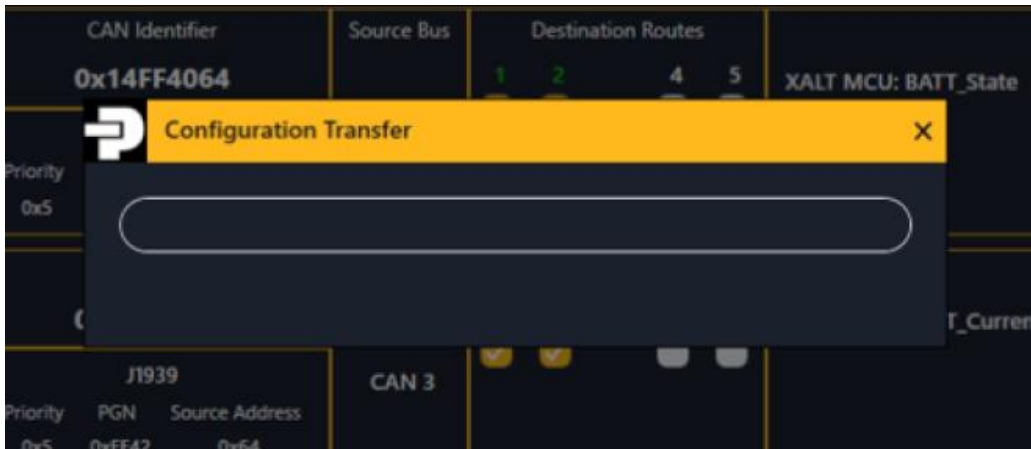
- A dialog box will appear asking to confirm, select Yes.
- A Configuration Transfer Bar will appear to inform on the programming progress.

**Figure 8: Configuration Transfer Progress Bar Window**

- Once completed, a new dialog box will appear to inform you that there is a restart required in order for the programming to take effect. Select Yes.
- While rebooting, the communication will be lost to the PVSG so the green “Connected” will change to a red “Not Connected” in the bottom left corner of the window. Don’t panic, this is expected.
- Once the green connected comes back, the process is complete.
