SERVICE BULLETIN

APPLICABILITY: 2026MY Solterra **NUMBER:** 15-332-26
SUBJECT: Reprogramming File Availability for Optimization of Denso-Ten Infotainment Systems **DATE:** 05/08/26
REVISED: 06/25/26

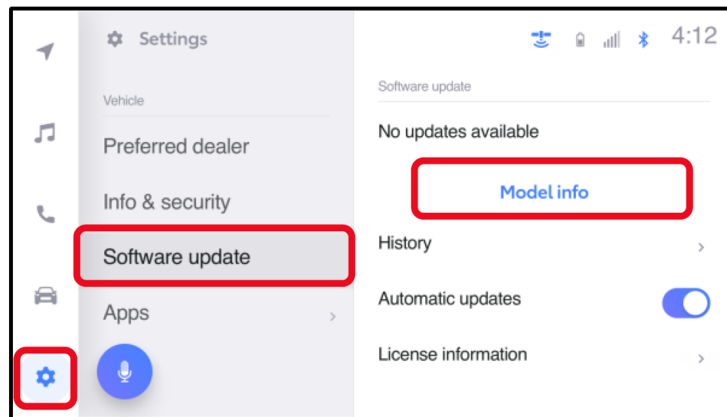
- 1a)** After starting the vehicle and allowing the head unit to boot up completely, from the HOME screen, press the **Settings (gear icon)** button.
- 1b)** Press >Software Update > Model info.

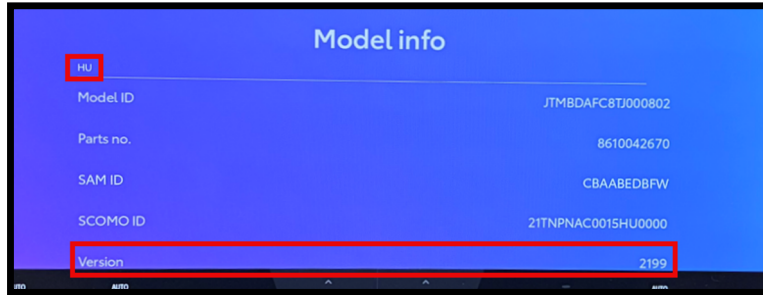
1c) Is the software version 2222?

- **Yes** –The system is up to date. Performs diagnostics as per the applicable service manual.
- **No** – Continue to Step 2.

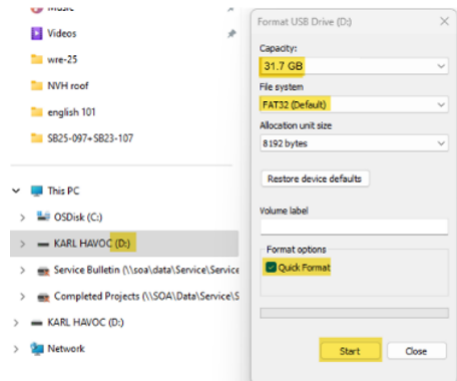
- Make sure the USB flash Drive is empty
- Right Click on the corresponding “Removable DISK”
- Select “Format”
- From the File System Drop-Down menu, Select “FAT 32”
- Check the “Quick Format” Box (if not already done).
- Click on “Start” to format the USB flash drive.

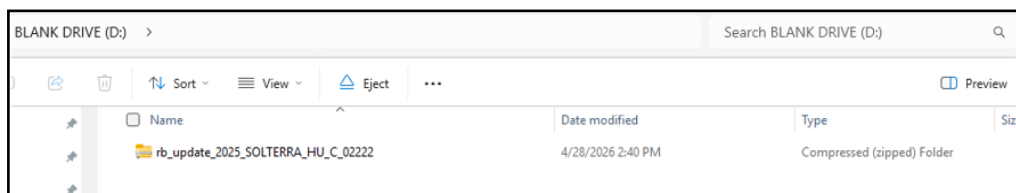
Note: Do not extract the files; the zip folder needs to be saved directly to the blank USB flash drive as shown below:

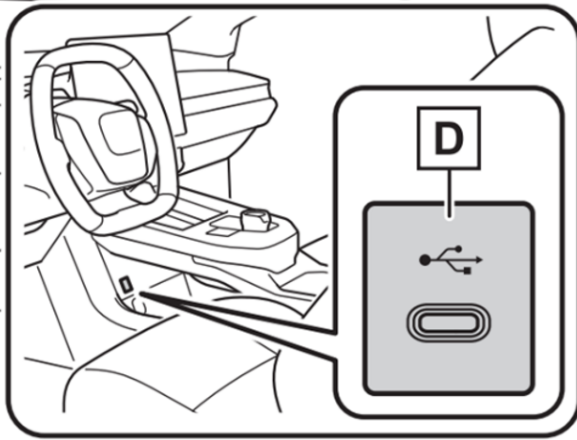
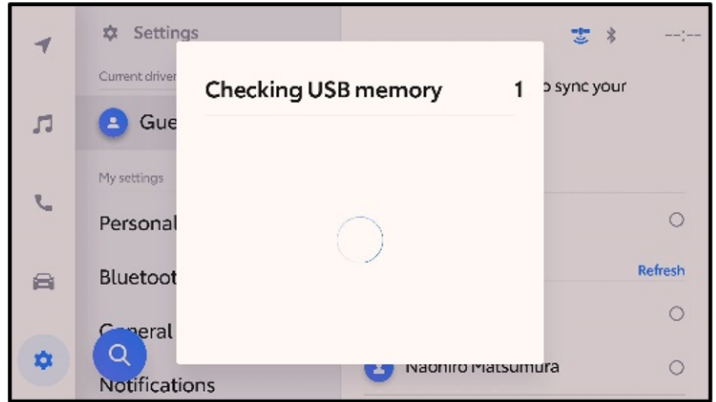
STEP 5: Insert the flash drive containing the correct software update into the vehicle’s leftside USB port marked with the USB (🔌) icon.

Note: A “Checking USB memory” message will display. This message can be displayed for up to 10 minutes.

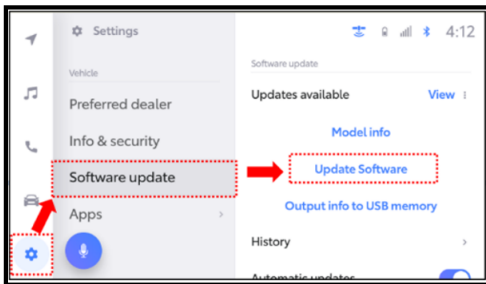
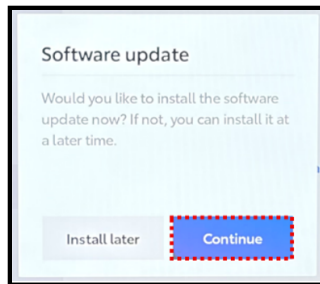
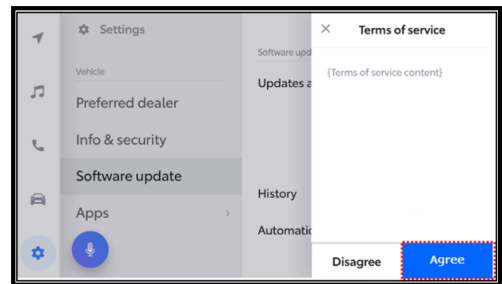
> Software update > Update Software > Continue > Agree

Note: The content displayed on the “Terms of Service” screen may not display correctly during the update process. This condition does not affect the update. Please continue with the procedure as instructed.

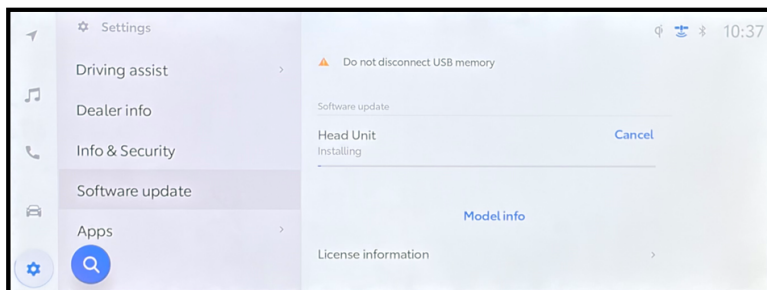
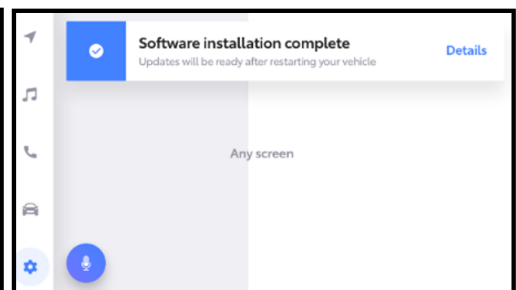
STEP 7: Wait for the update to finish downloading. A progress bar will display the installation status. A banner will appear when the update is complete, stating “**Software installation complete.**”

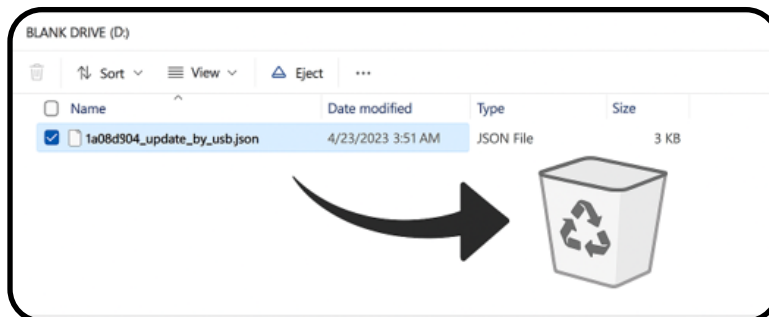
[Note: In some cases, the head unit may generate a completion report and automatically save it to the flash drive. This .json file is not required and should be deleted from the flash drive.]

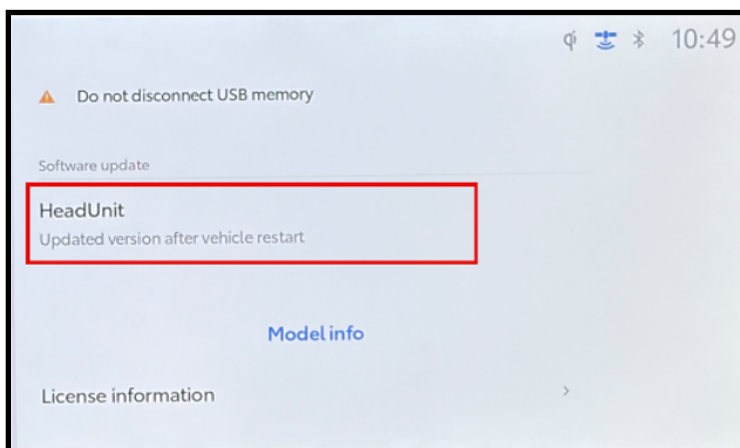
STEP 8: After “Updated version after vehicle restart” is displayed, restart the vehicle by turning the ignition switch off. Open and close the driver’s door twice. Then turn the ignition switch on and wait two minutes. Once the head unit has successfully booted up, remove the flash drive. Reperform the steps outlined in Step 1 and verify that the software version is **2222**.

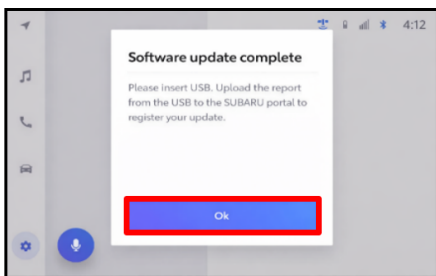
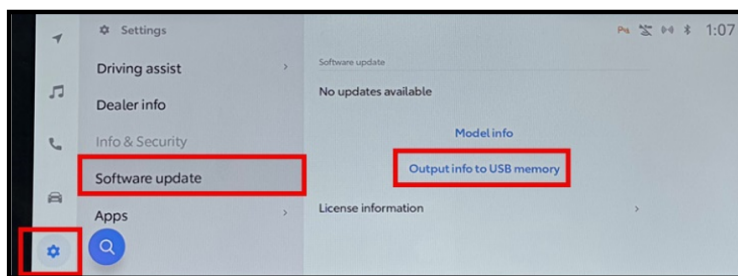
[Caution: Failure to perform step 8 can cause a pop-up shown below. If this pop-up appears, insert a blank USB drive. Press

>Software Update > Output info to USB memory. Remove the flash drive once the prompt that .json files are extracted. Delete these files from the USB flash drive.]

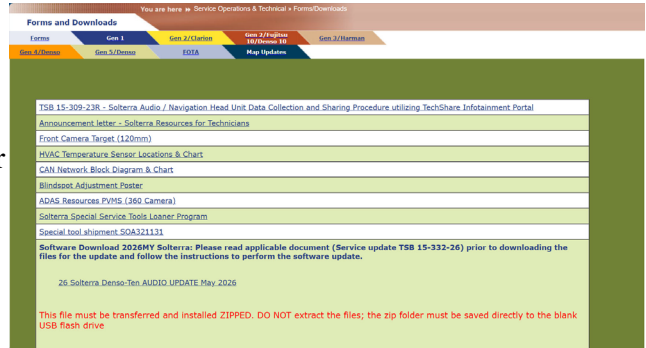
Using the normal audio / navigation system file update download procedure: Go to Subarunet, select Service Operations and Technical>>Forms/Downloads>>Solterra Resources then click on the applicable Hyperlink to download the file(s) to your SDS Notebook or PC:

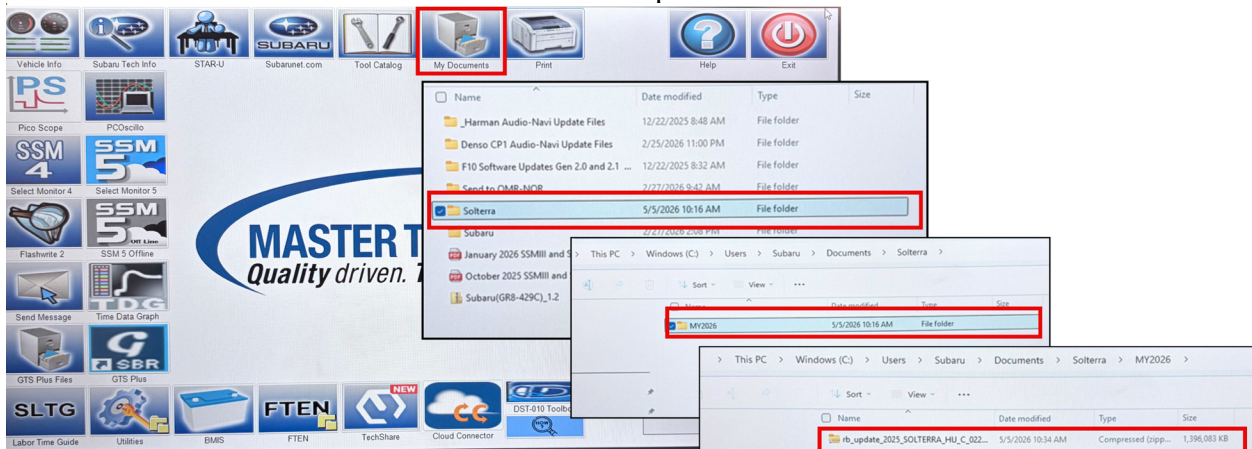
- **CAUTION:** After download is complete, **NEVER** change the file or folder names.
- Double-click on the required folder and the update file will display as shown.
- Select all the zipped files and either copy / paste or click / drag them to the USB flash drive.
- Once all files have been loaded onto the USB flash drive, right click on the drive and select “Eject”.

- Remove the USB flash drive after the prompt appears that says “Safe to Remove Hardware”.
- Mark the USB to indicate the head unit it will update.
